# **MINING IN WEAK MUDROCK - VOORSPOED MINE**

*Josef Ekkerd, De Beers Consolidated Mines*

## **Summary**

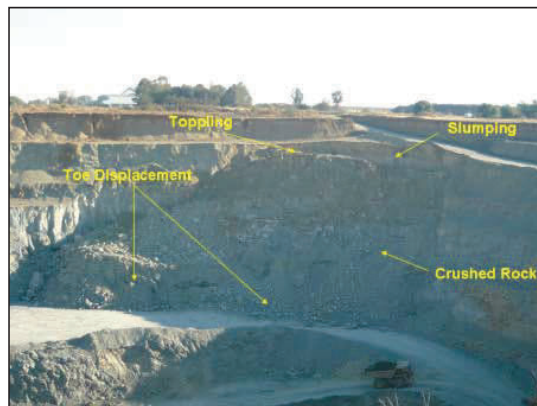
**Figure 4: Photograph of the First Stack-Scale Failure in the VO Unit**

The photograph in Figure 4 provides a front view of the failure indicating key observations after the failure. The bedding dip in the adjacent mudstone was nearly horizontal and

although a portion of the failure broke back to a large scale feature, back analysis of the geometry along with a careful review of the rockmass properties suggested that classical shear failure provided a plausible explanation for the root cause. For safety reasons, the failure was remediated by mining top-down and so the failure surface behind the broken rock could not be observed for visual confirmation.

Classical rockmass shear failure is not expected in competent structure rock where compound failures are more likely. However the Rippable VO is homogeneous and very weak and soil-like behaviour is not unreasonable. At shallow stack angles, the failures initially tend to slump with little run-out. In at least one instance, a failure occurred within the disturbed zone where bedding dipped away from the pit (Tect, 2013). This provides confidence that the failures are not always structurally or bedding related.

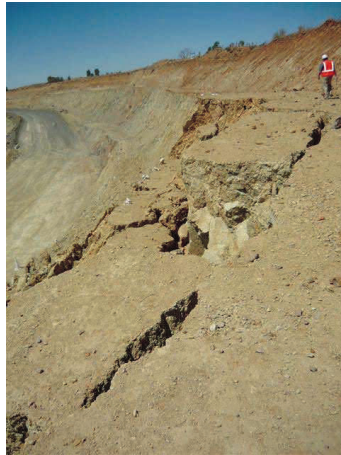
In the following months, a series of failures occurred in both the VO and VR mudstones in Cut 2 on the North-western and South Eastern sections of the pit. The aerial view in Figure 6 shows the location of all of the failures experienced at Voorspoed to date.

**Figure 5: Failure in VO - September 2010**

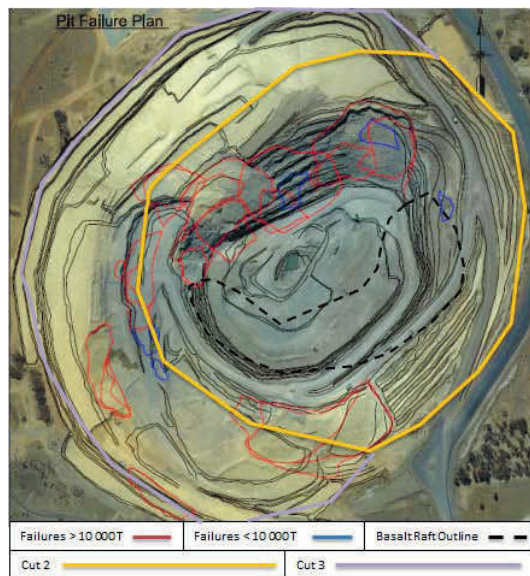
**Figure 6: Aerial photo of the pit showing the location of the failures**

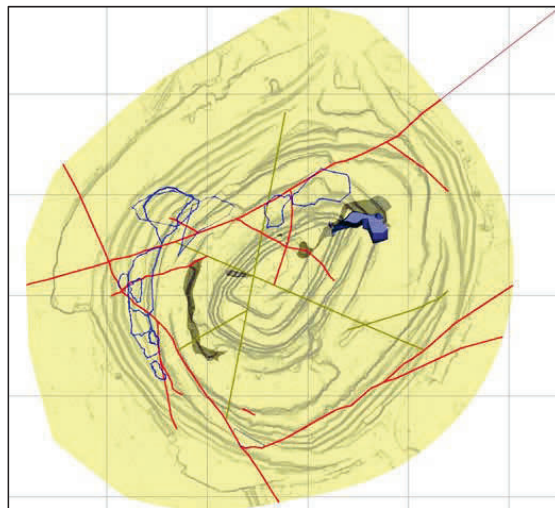
In 2011-2012, after sufficient country rock exposure, the structural geology model was updated through pit mapping and reconciliation with the feasibility study mapping and core logging. The resulting updated structural model is plotted in Figure 10 along with the outlines of the major failures of Cut 1 and Cut 2 at the time of the update. A review of the fault locations relative to the failure outlines indicates that a number of them were bounded by large scale features. Given that many of the large scale features form the boundaries of the Disturbed Zone previously described, it has been hypothesized that some of the failures could be attributed to slip along adverse and steeply dipping bedding within the blocks that appear to have collapsed into the diatreme during its emplacement. However, it is also observed from the figure that a number of the failures are not bounded by the structures or that the structures are not oriented and located to promote failure. It is concluded that major structures might have a role in creating release surfaces at the back for some of the failures but they are not considered to be a primary contributor to the instabilities.

**Figure 10: Early structural model and failure outlines plotted on the Cut 2 pit geometry. Major structures are red and the failures up to 2012 are outlined in blue (TECT, 2012)**

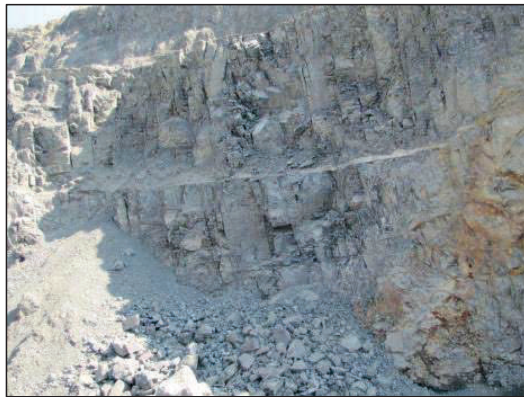
Some of the failures have occurred on bedding planes and clay horizons of tilted blocks. Their locations correlate with the Disturbed Zone identified during the update of the Geologic and Structural models. Using Sirovision™ data provided by the mine, one prominent weak layer has been interpreted to follow the base of the VRM-Consolidated unit (SRK, 2013). The layer, illustrated in Figure 11 is approximately 5-10cm thick and dips unfavourably into the pit in the North Wall. This failure mechanism has been confirmed by deformation measurements obtained by the mine radars that show outward displacement of the rockmass above the plane and no movement below it. However it is important to note that not all failures have occurred on this layer and consequently, it is considered a risk at the operation but not the root cause of all of the mudstone behaviour.

**Figure 11: Calcite/Talc layer interpreted as following the base of the VRM (Consolidated)  
*Basal Failure on Clay Layers***

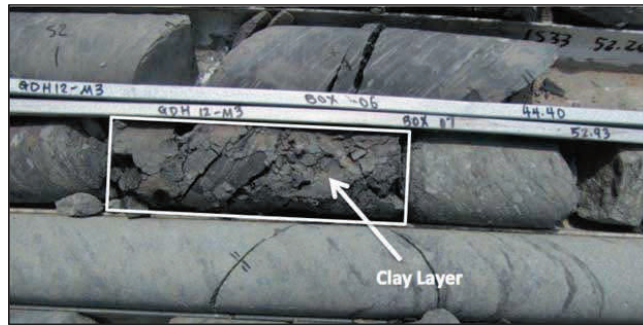
A likely explanation for many of the failures has been proposed by Martin (2012) and is congruent with the basal failure on tilted blocks mechanism. Martin has hypothesized that *time dependent* and *progressive failure* processes that are common in overconsolidated mudstone, are occurring at Voorspoed. As described by Martin, progressive failure occurs in layered materials exhibiting strain-weakening behaviour. These materials display dramatic strength reduction under small displacement. In mudrocks, the pit excavation induces deformations that concentrate in the softest (weakest) layer in a pit slope and in mudrocks these layers are those with the highest clay contents. The photograph in Figure 12 was taken from Voorspoed core and illustrates how clay layers of some thickness are readily observed in the stratigraphy. The localized strain causes the peak intact strength of the clay beds to rapidly reduce to its residual strength and failure occurs on a basal surface. The failure mechanism is graphically illustrated in the schematic in Figure 13.

**Figure 12: Clay seam observed in the Voorspoed core**

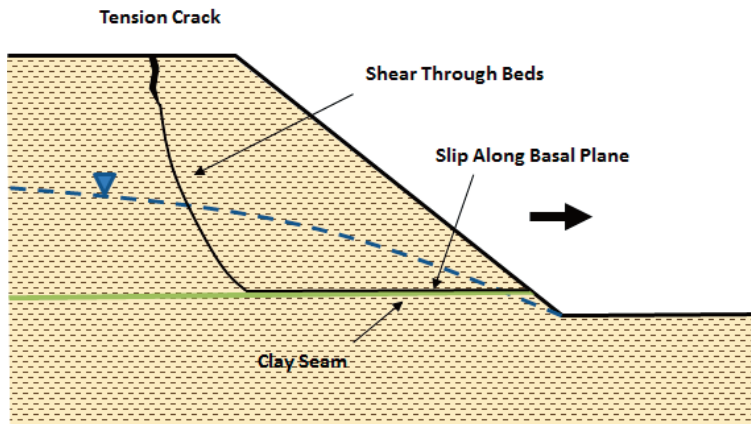
**Figure 13: Schematic illustrating basal failure along a clay seam**

As the overconsolidated layers in the mudstone are unloaded, groundwater is absorbed in the clays causing them to soften and lose cohesion. This process is normally longer term than the 5-10 day period over which failure occurs at Voorspoed and so this time dependency is likely a secondary process (Martin, 2012). Failures involving planar features are almost always observed only in the Disturbed Zone around the kimberlite ore body.

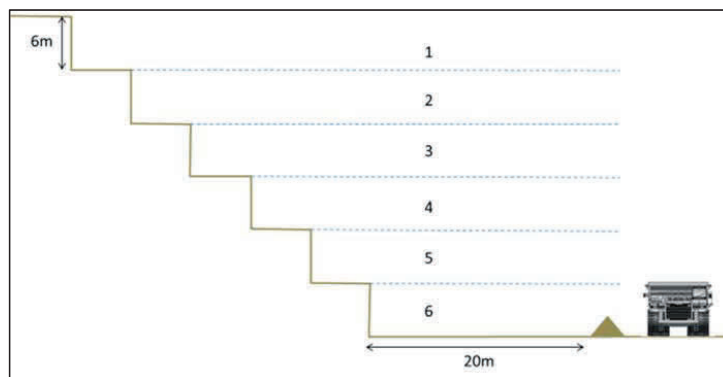
The stack failed as predicted and the initial spill width was less than 10m - well within the 20m design spill berm width. However based on previous Voorspoed experience, saturation of the muckpile after major rainfall events causes the run-out to extend as much as 50% beyond the initial failure base. The 20m design width was therefore deemed sufficient and has become the standard for the operation.

**Figure 14: The trial mining sequence. A 36m stack, consisting of 6m high benches, is conventionally developed (mined sequentially) and a 20m berm left at the bottom of the stack. The slope was then left to fail.**

In order to test the modelled spill berm in practise, a trial mining area was identified in the pit and it was designed at a slope that was steep enough to ensure failure. The South western quadrant of the pit was selected for this purpose and it was mined under controlled conditions at a maximum stack angle of 38°, at a stack height of 36m and with a 20m spill berm width as illustrated in Figure 14.

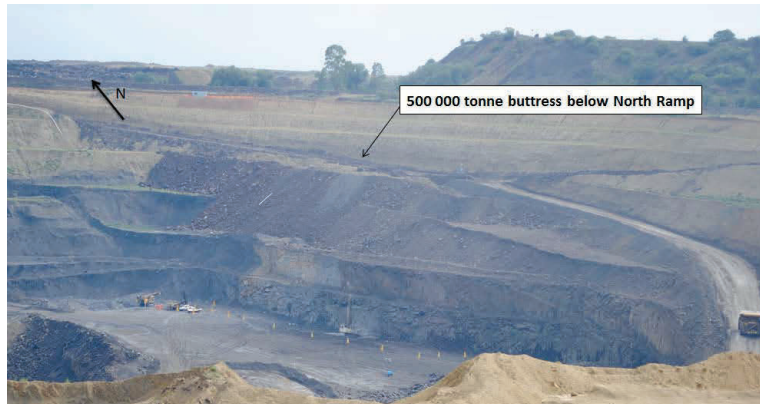
**Figure 15: Buttress below the North Ramp. Photo taken in December 2012.**

units and to buttress the portions of the ramp exposed to the mudstones as in Figure 15. Buttresses of this size take up a significant amount of space and take time and resources to construct and are not an ideal remediation solution for efficient production.

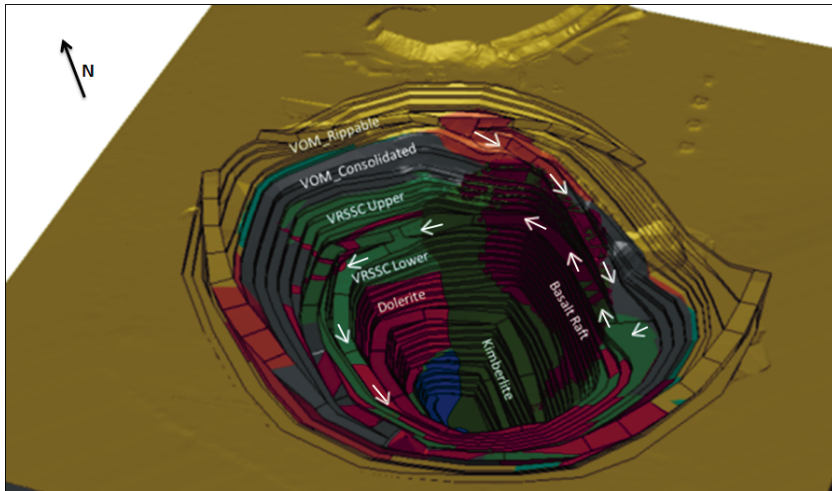
**Figure 16: Isometric view showing the new planned ramps system in Cut 3 on the west in competent ground: Basalt, Kimberlite, Lower VRSSC and Dolerite Sills.**

The lessons learnt from the initial challenges with ramp stability were incorporated into the design of the next cut with all of the ramps placed in the competent lithological units (Basalt raft, Dolerite sills, Kimberlite and VRSSC Lower). See Figure 16
