DESIGN METHODS FOR VARIABLE-STRESS, VARIABLE-GEOLOGY ENVIRONMENTS

Tristan Jones, Luossavaara Kiirunavaara AB, Malmberget

David Saiang, Luleå University of Technology

BeFo Report 229
Stockholm 2022
ISSN 1104-1773
ISRN BEFO-R-229-SE

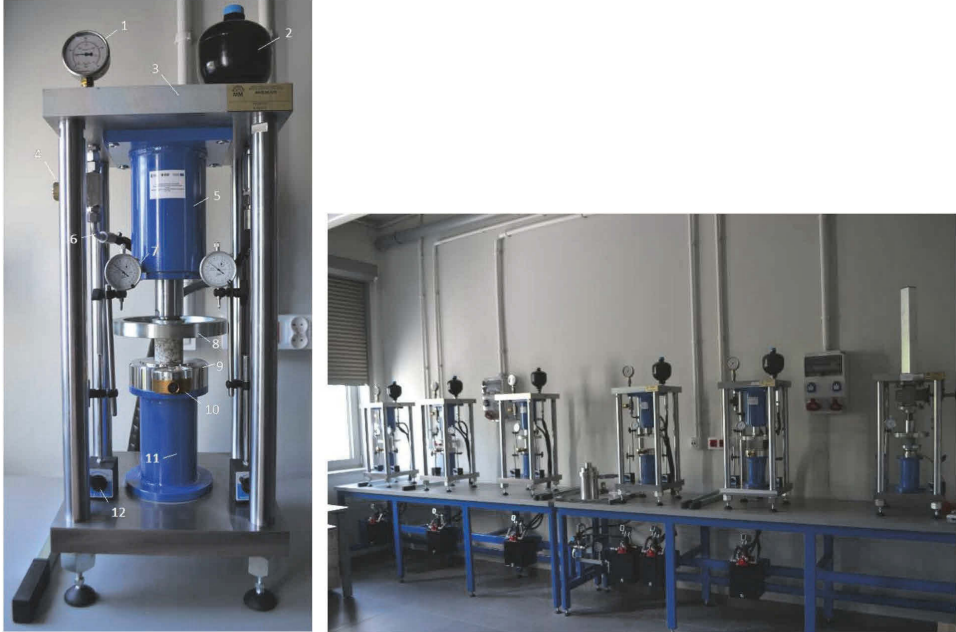
Figure 6: Creep test setup.

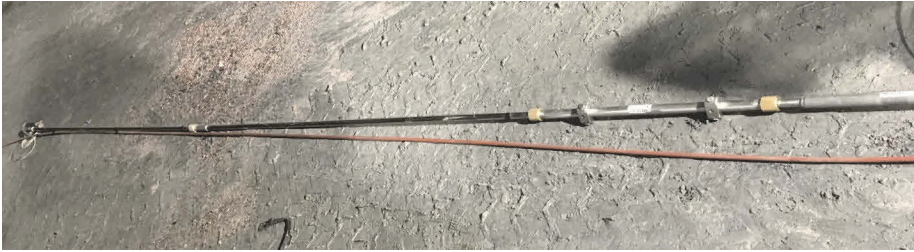
Figure 17: Using the snake-camera cable to transfer depths to the installation rods.

After drilling of the core was completed, a borehole camera was used to film the entire hole length. This was used, in conjunction with the recovered diamond core from the last 1 m of the hole, to assess the quality and smoothness of the hole. These things allowed forward determination of the ideal installation location for the stress cell. Electrical tape was also placed on the semi-flexible cable of the borehole camera to mark the actual depth of the hole and the desired depth of the stress cell's sensors (Figure 17). These depth marks were then transferred to the installation rods for the HID-Cell.

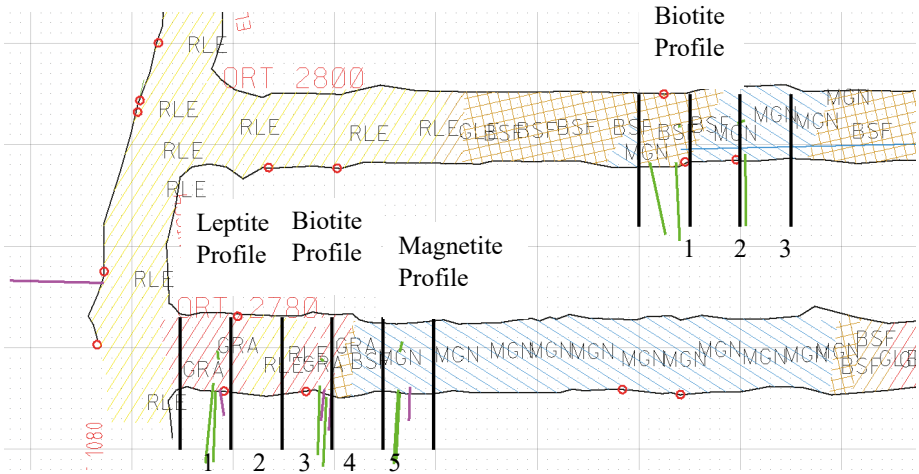
Figure 23: Geologic map of crosscuts 2800 and 2780, incorporating instrument profiles and damage-mapping section numbering. 10x10m grid included.

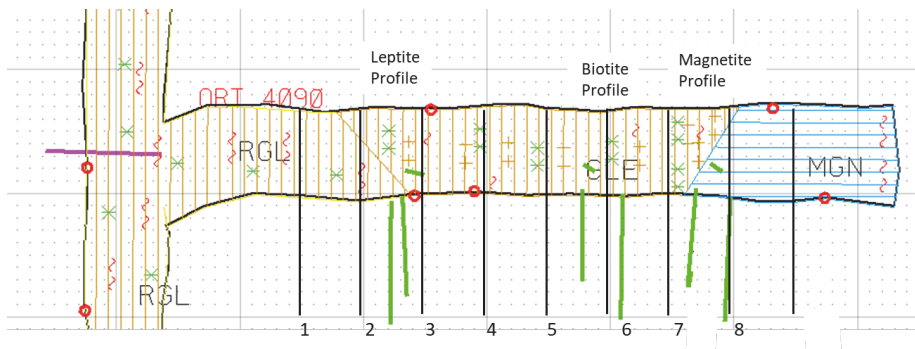
Figure 27: Geologic map of crosscut 4090, incorporating instrument profiles and damage-mapping section numbering. 10x10m grid included. No GSI collection was carried out for 4090.

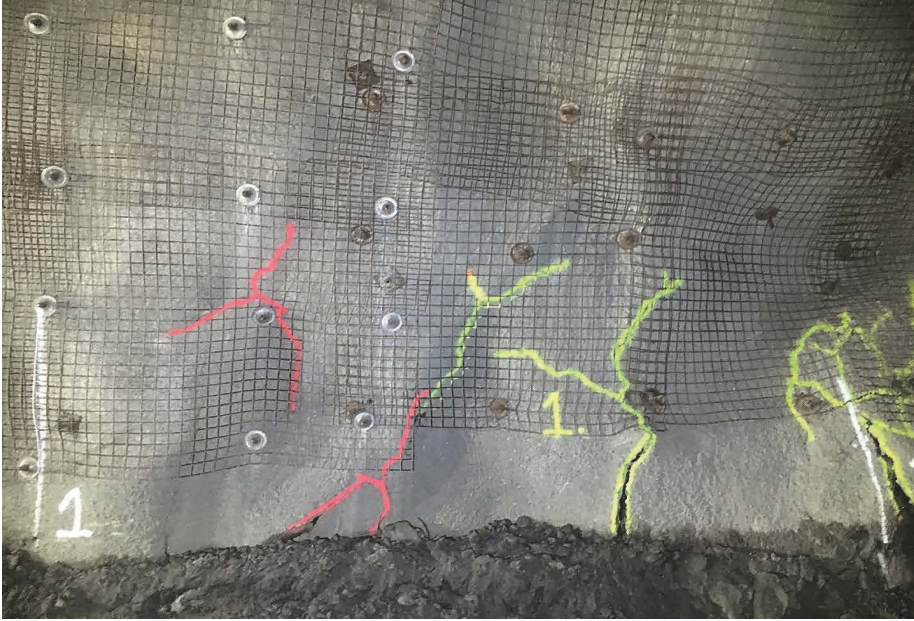
Figure 30: Example damage mapping section, crosscut 2800, Lw, Section 1, from 2019.05.23. White vertical lines and the white “1” are the section markers, yellow “1.” is a crack number. Colored crack painting occurred at different times to help show change between mapping periods.

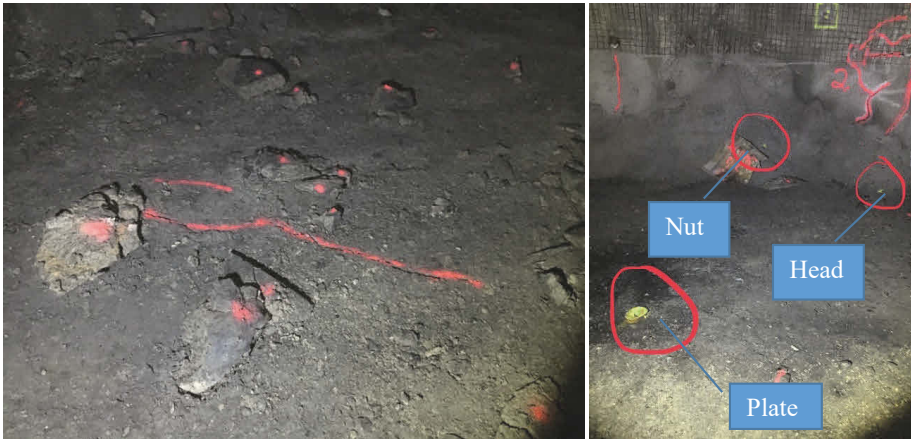
Figure 31: Fallen material painted on the floor identifies it as pre-existing (left). Bolt plate, bolt head, and nut painted as pre-existing (circled on right).

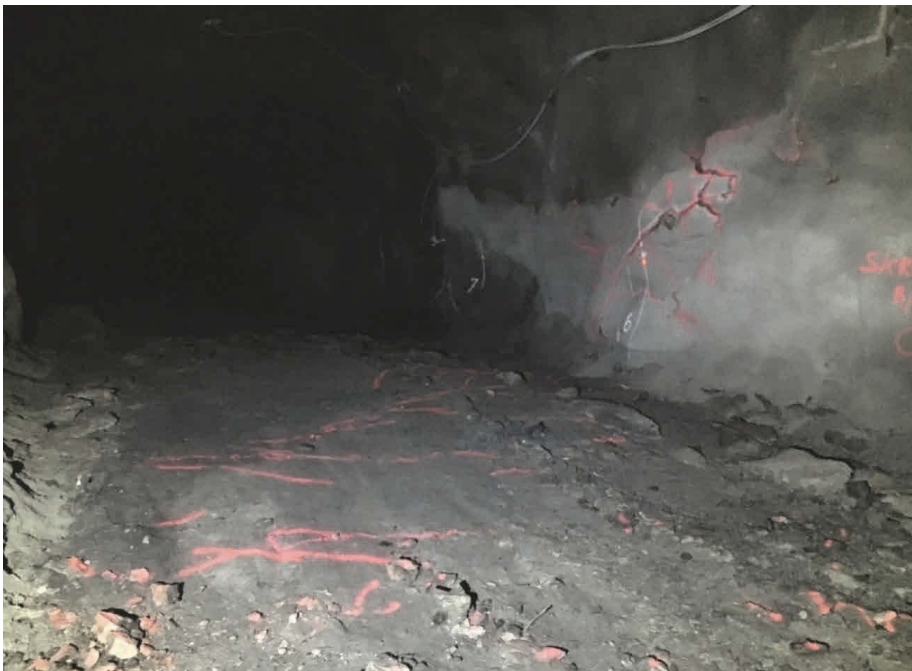
Figure 34: Crack propagation angling across the floor into the right wall of entry 4080.

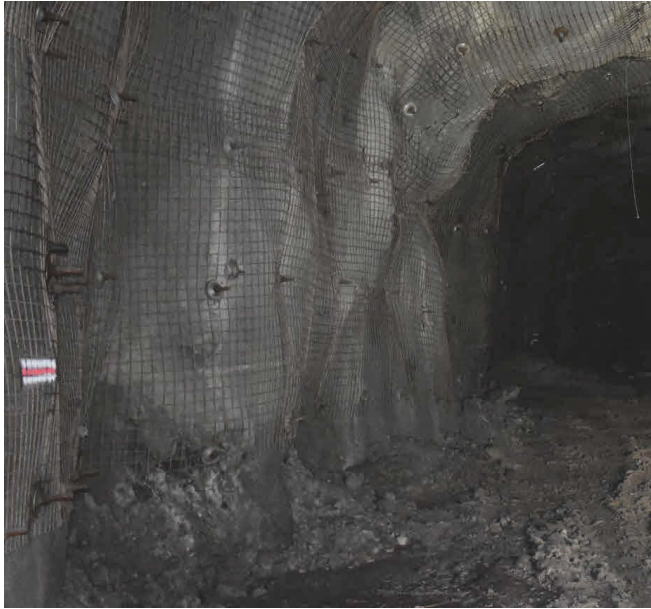
Figure 37: White-red-white reference lines marked on opposite walls for level-line projection.

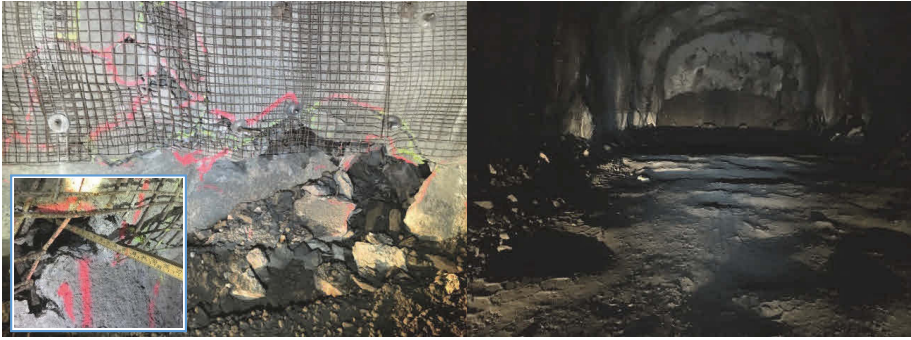
Figure 56: Excessive Lw deformation in 4090 S5 (left), large floor heave in S8 (right).

The entry ended up quite badly damage before the end of this reporting period, but two specific damages stand out as the most significant. The first was the floor heave which was directly measured as 134 cm in section 8 in September of 2020. The second was excessive Lw deformation, where the wall had pushed out nearly 1 meter into the entry in section 5 (Figure 56).

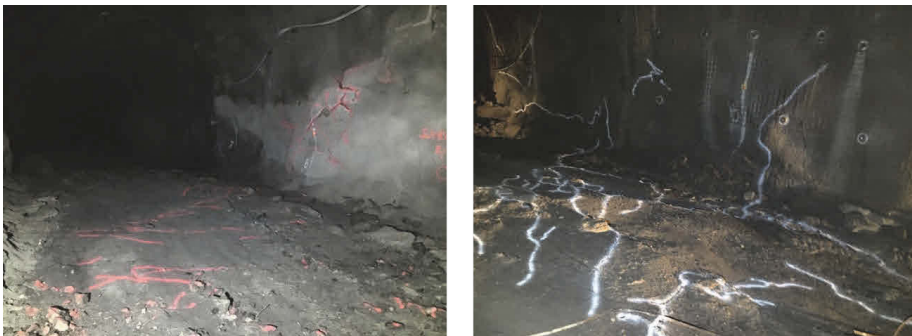
Figure 89: 4080 RW view of S5 and S6 in August 2019 (left) and August 2020 (right)

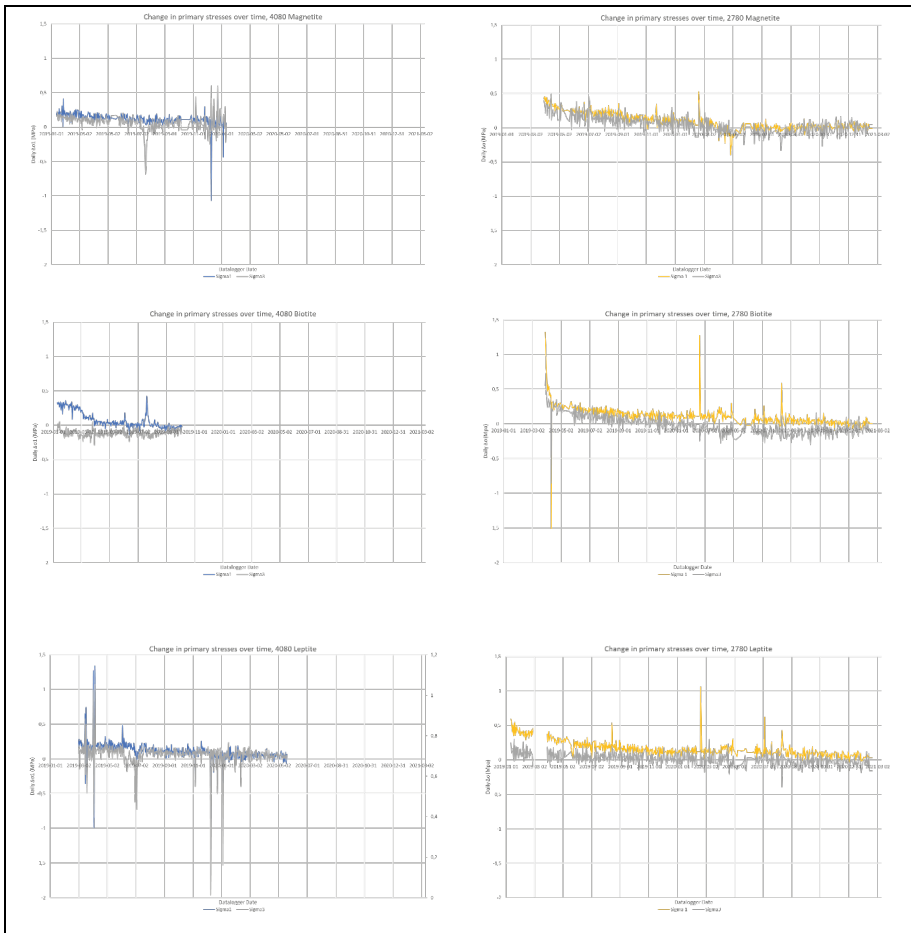
Figure 139: Stress change per day for the six instrumented profiles on AL1082 and PR1023. Larger versions are found in Appendix 3.

Noteworthy is that each of the graphs is slightly different, but all of them exhibit a general decrease in stress rate over time, regardless of the location of the instruments. This could lead to the conclusion that time is a factor in the stress redistribution. Results from the geotechnical testing indicate that these materials exhibit only minor creeping tendencies, and there has not been a constant shear-stress scenario in play. Thus, time itself is not likely related to the reduction in stress rate of change.

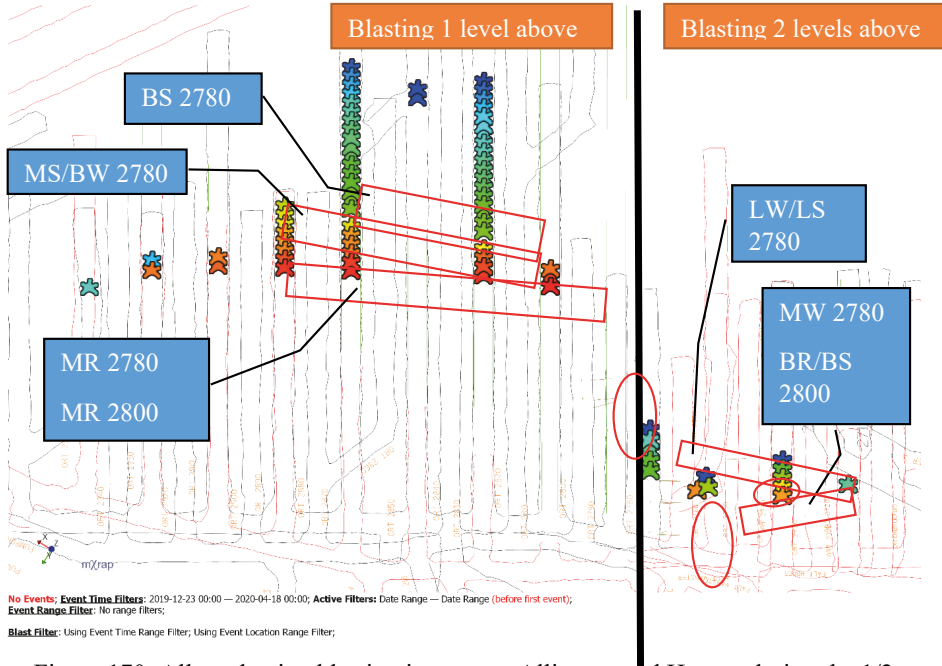
Figure 170: All production blasting in western Alliansen and Hoppet during the 1/2 transitions of the AL/HO instruments. Color shift indicates the passage of time between 2019.12.23 and 20.04.18. Particular blasts occurring at the same time as the shifts are indicated for each instrument. Because blasting occurs on multiple levels at once, those occurring one or two levels above are separated as well. Instruments circled.

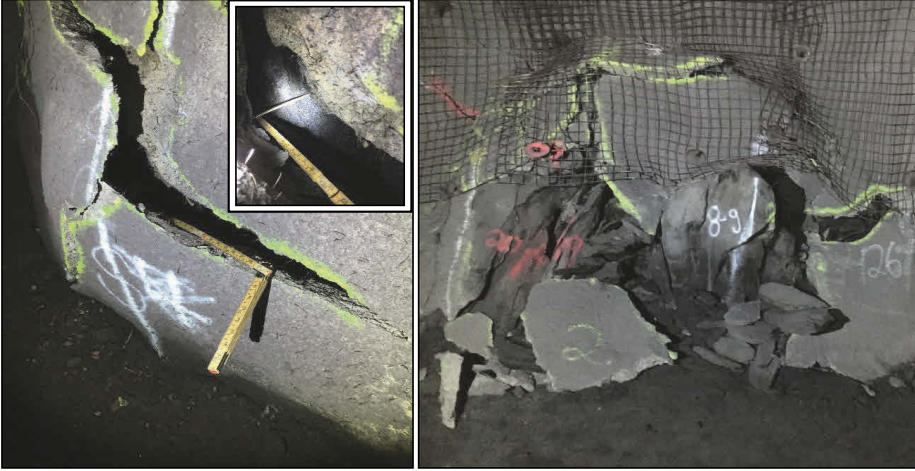
Figure 174: Buckling in the lower wall often caused wall damage and decoupling of the shotcrete from the rock.

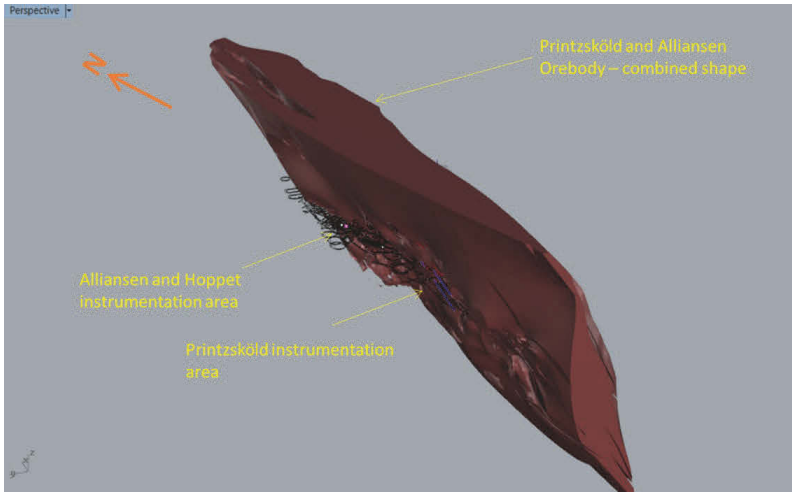
Figure 183: Instrumented areas in Alliansen and Printzsköld orebodies

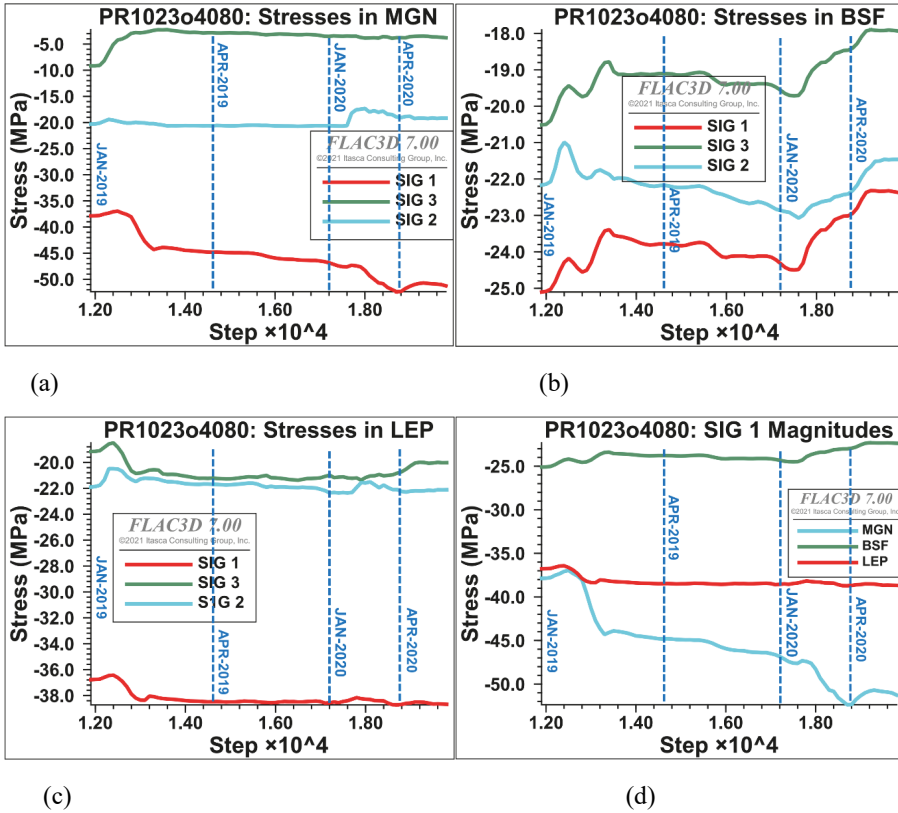
Figure 207: Stresses in PR1023-4080 resulting stain softening of BSF (a) stresses in MGN, (b) stresses in BSF and (c) stresses in LEP and (d) σ_1 variation in MGN, BSF and LEP.
