# **MINING IN WEAK MUDROCK - VOORSPOED MINE**

*Josef Ekkerd, De Beers Consolidated Mines*

## **Summary**

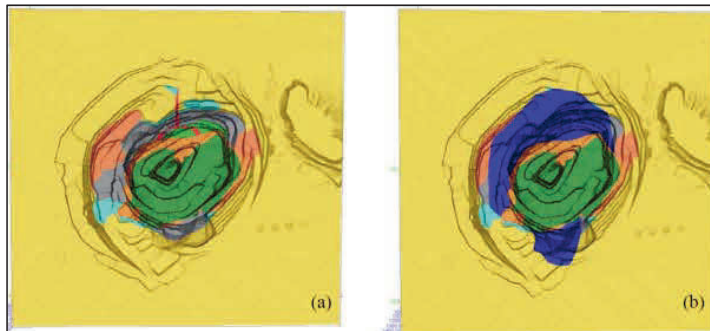
- the number and location of major structures;
- the location of a halo of disturbed country rock (as illustrated in Figure 7);
- the presence of a calcite rich layers at the base of the consolidated VRM; and
- the improved understanding of the offset in stratigraphy due to faulting.

**Figure 7: a) Plan view of Voorspoed showing the pit outline overlain by geology; b) Same view as in a) with the Disturbed Zone overlain in dark purple**

The regional bedding dip is 10° towards the southwest. However, the halo of disturbed country rock around the pipe consists of several large blocks that were tilted or rotated during the kimberlite emplacement (Tect, 2013). Within these blocks, the bedding can dip either into or away from the pit as steeply as 40°. In order to accurately represent the variation in bedding in the geotechnical block model, the disturbed zone was divided into sub-domains delineated by major structures. Bedding orientation obtained from mapping and core logs was then used to populate the bedding represented within the sub-domains of the model.

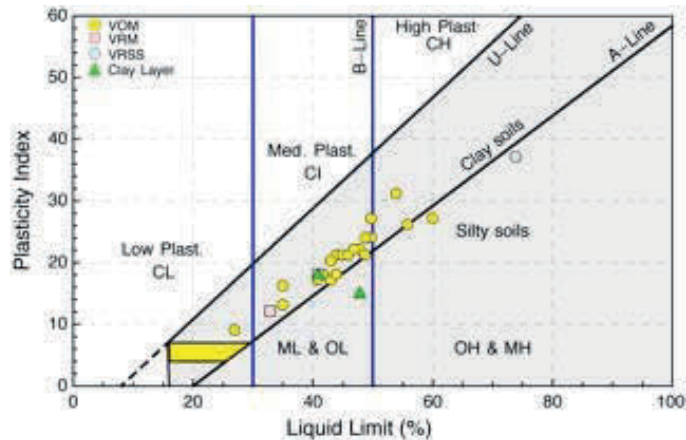
Standard soil testing and X-Ray Diffraction (XRD) analysis were performed on samples from the country rock to determine the clay content and type (Chlorite, Kaolinite, Illite, Smectite). Rock with a high Smectite content weathers easily so careful consideration was given to that mineral. The VO mudstone is of a deep water sediment origin while the VR mudstone is of a deltaic sediment origin. Not surprisingly, all of the VO samples contain some amount of clay and over half contain above 30% clay. However there is some variability in the VO with half the samples indicate less than 20% clay content. Interestingly, the number of samples of high clay content is roughly the same for both the Rippable and Consolidated VO. Smectite is the dominant clay mineral in the VO suggesting greater weatherability in that unit. The Cassagrande Chart in Figure 8 presents the Atterburg Limit tests performed on Voorspoed samples. Most of the samples plotted on the chart are VO and results are as expected for a high clay content but variable soil. Due to the lack of Smectites, the VRM plots much lower for plasticity and the VRSS plots with the silts.

**Figure 8: Cassagrande chart of the Voorspoed Atterburg Limit tests**

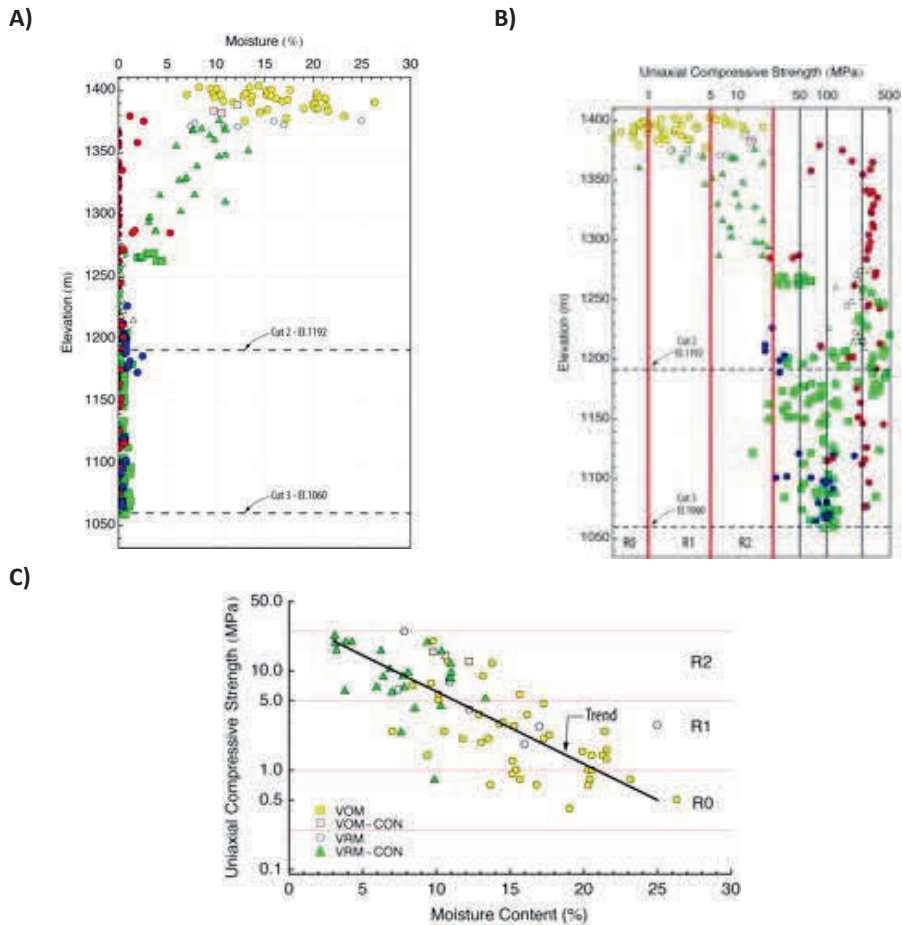
The difference in the clay mineralogy content and type between the VO and VRM is apparent in the moisture content and UCS plots provided in Figure 9 (A-C). The VO unit typically has variable moisture content from low to high reflecting the variability in the Smectite content while the VRM with low Smectite content has lower moisture content. The relationship between moisture content and UCS is typical of rock. While it was initially believed to be a pore pressure effect, many of the high moisture content samples were taken above the water table and so saturation in these would be less than one. The reduction in strength of samples with high moisture content is documented in Romana and Vasarhelyi (2007).

The plots of both moisture content and UCS with depth both reflect the presence of the hydrophylic minerals in the samples tested. It is not unusual to see a drop in moisture content with depth and age of clayey soils. However the plot for the VO, with variable quantities of Smectite, does not clearly show this trend though it is very clear in the VRM. This suggests that the clay mineralogy of the sample is as important as the depth the sample was taken from at Voorspoed. This trend is mirrored in the plot of UCS Vs depth. Again, there is a weak correlation in the VO results but a strong correlation in the VRM results. This again suggest that both the mineralogy and associated moisture content is driving the VO behaviour while only the moisture content is driving it in the VRM. The greater amount of clay minerals in the VRM explains the lower strength compared to the higher strength VRSSC.

Figure 9: A) Moisture Content Vs Elevation; B) Compressive Strength Vs Elevation; C) Moisture Content Vs Compressive Strength
