Karteringsblad för sprickor med rörelseindikationer

Project:	BeFo 369		
Site ID:	Hasselby (01)	Site name:	Hasselby
Geologist (s):	Ann & Yanling	Field date:	2015 08

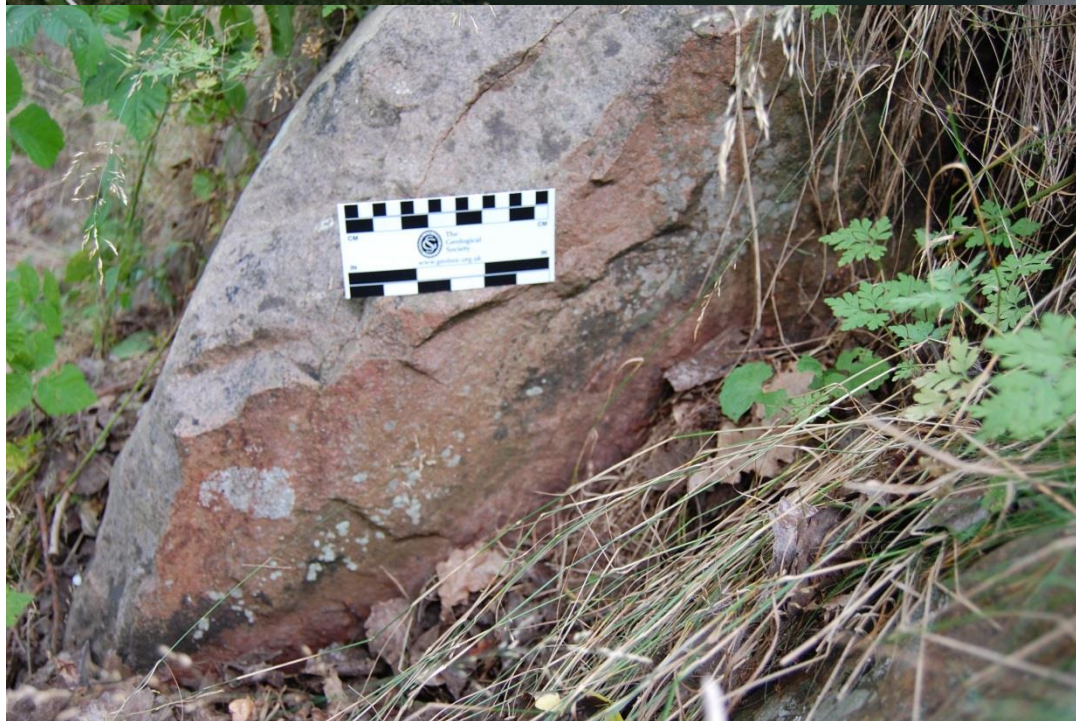
01001

Rock type:	Gneiss
Fracture ID:	0001
Location:	
Fracture plane type:	
Fracture strike:	35
Fracture dip:	90°
Rake of slip line:	56° riktn

Conf. Level (C, P, S, X):	P	Grooves
Weight factor (0 - 9,9):	0,5	
Activ. Type (1-3):		
Striae Intensity (0-4):

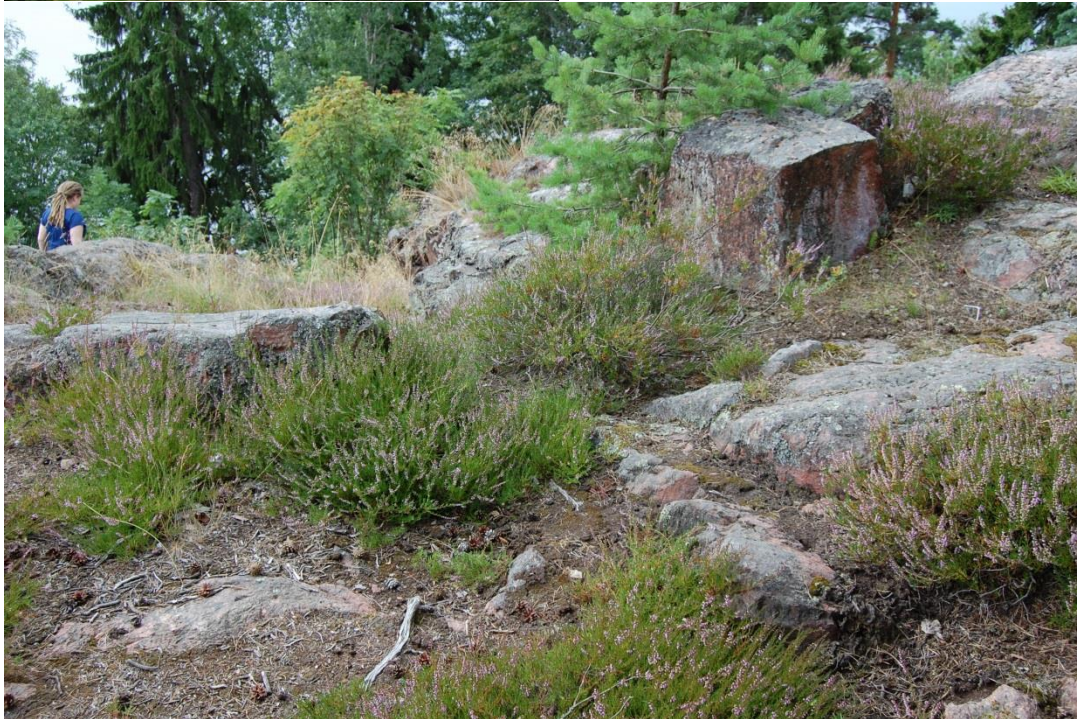
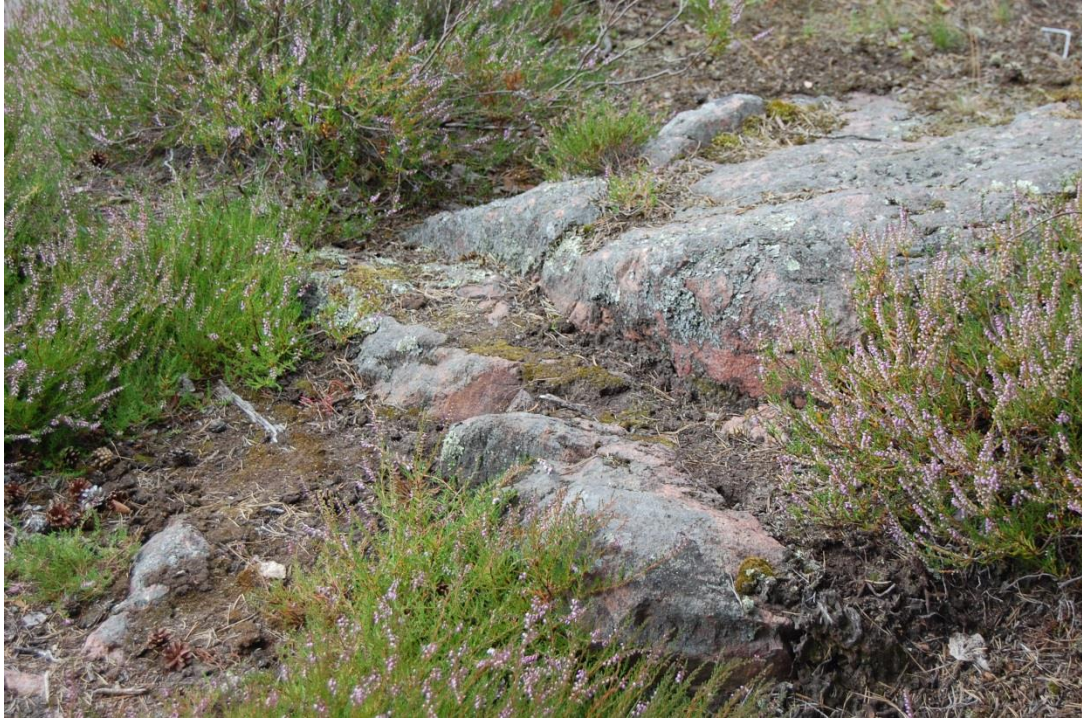
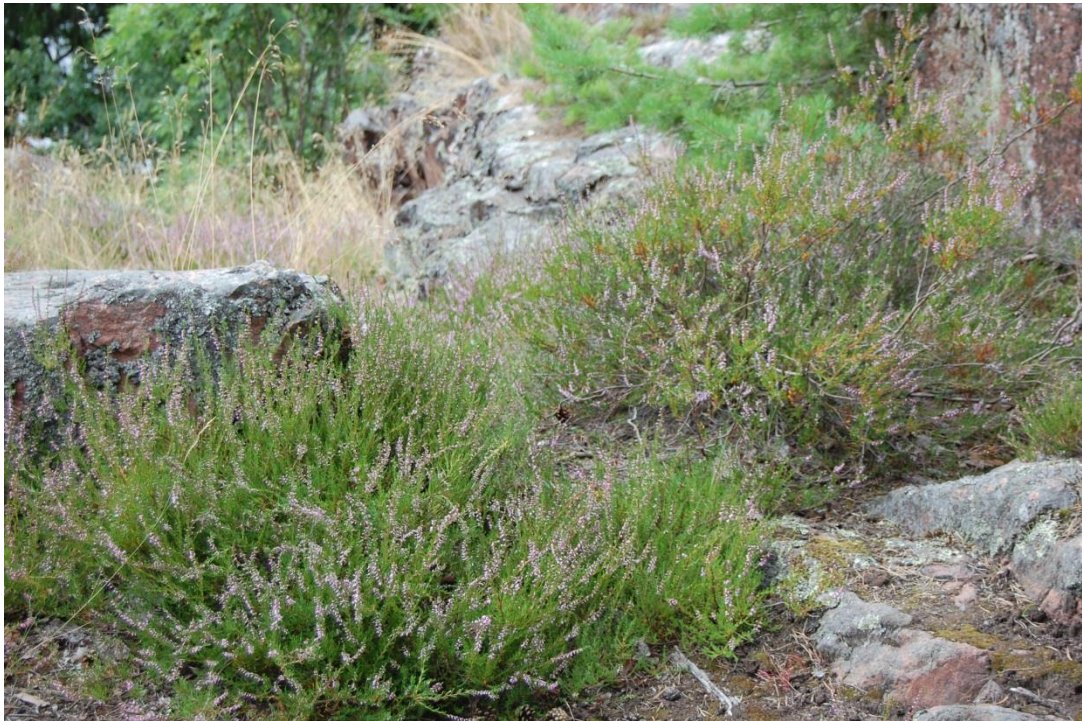
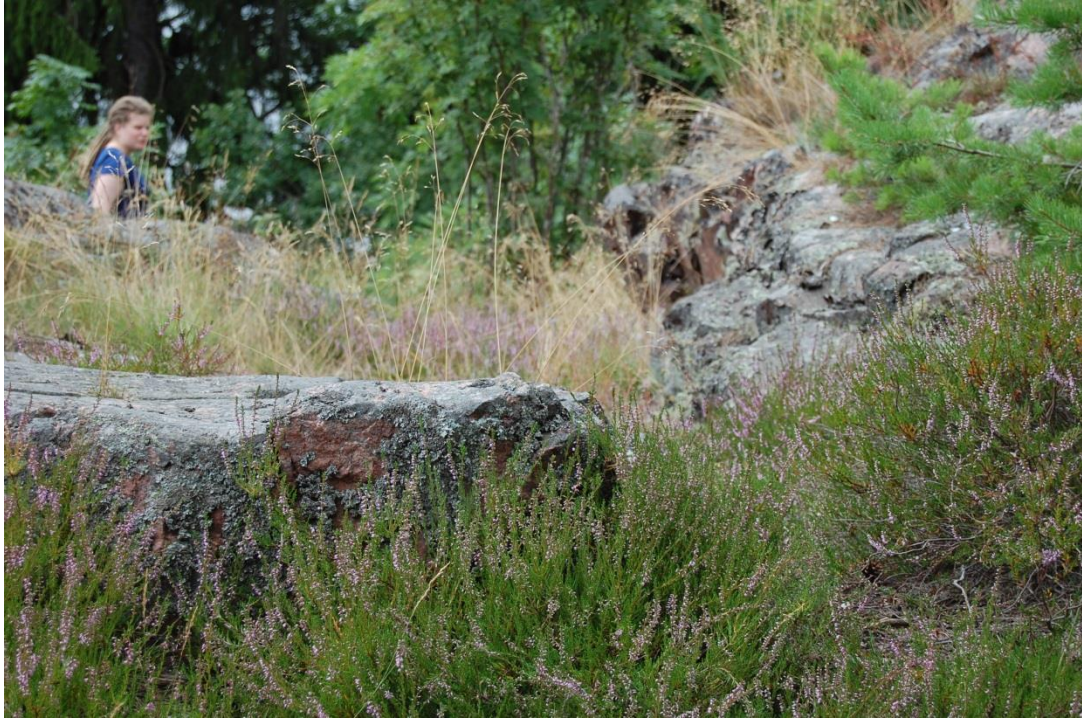
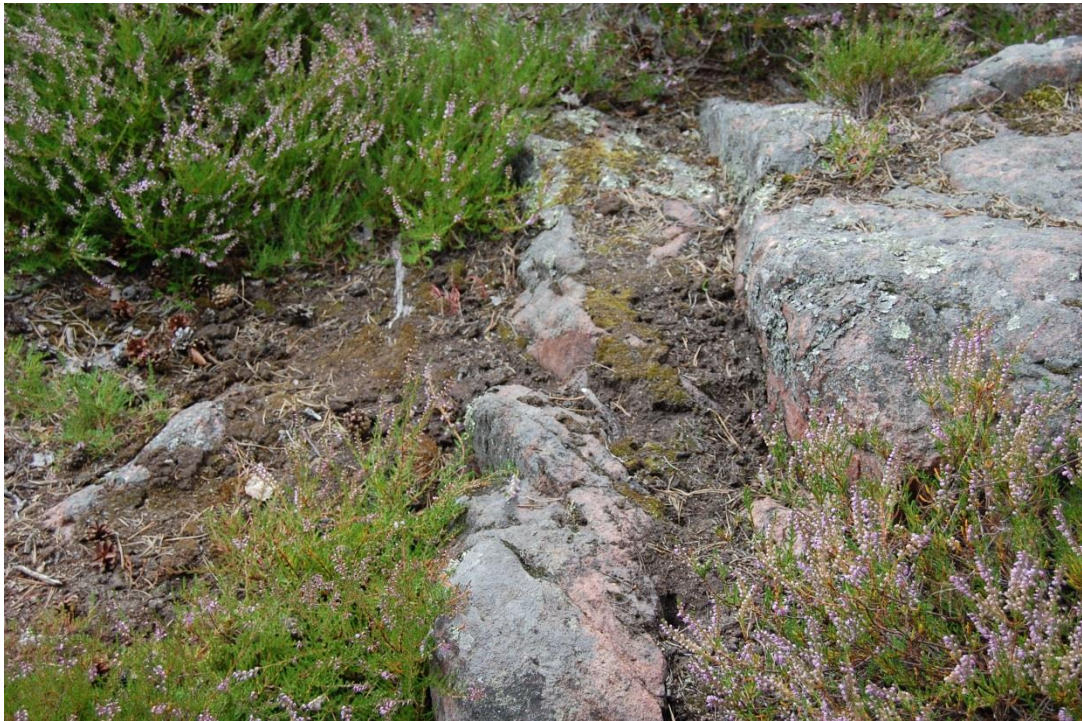
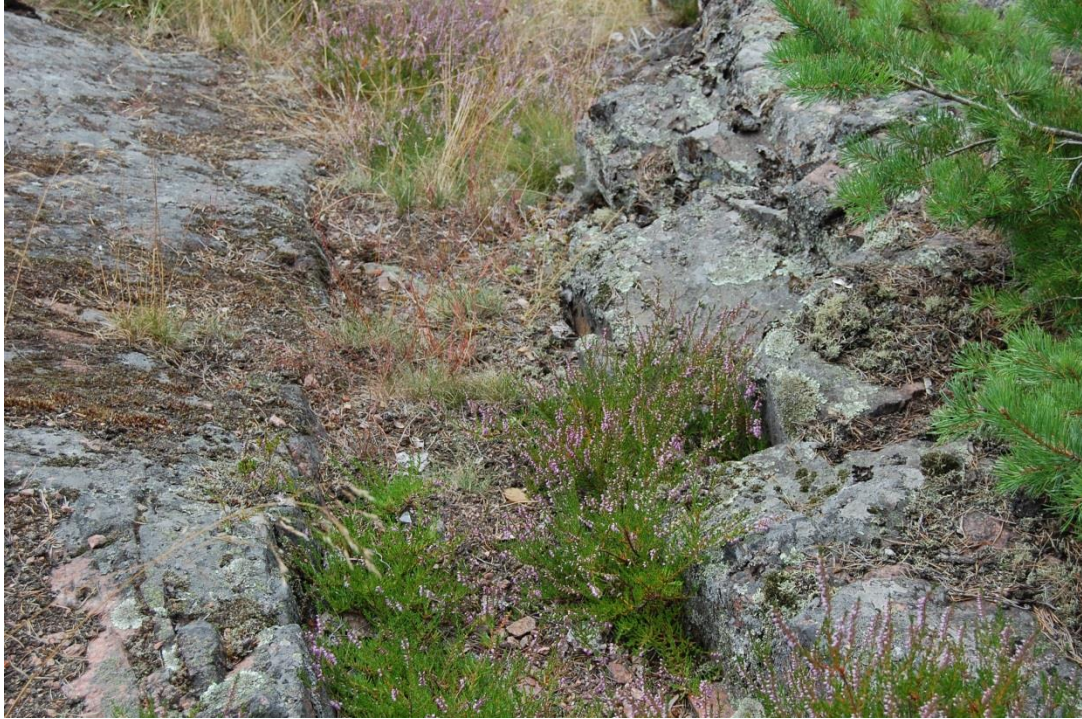
Rock type:	Granit röd finkorn		
Fracture ID:	01002		
Location:			
Fracture plane type:			
Fracture strike:	203	(220)	
Fracture dip:	60		
Rake of slip line:

Conf. Level (C, P, S, X):	S	Vertikal komp. okänd
Weight factor (0 - 9,9):	0,5	
Activ. Type (1-3):		
Striae Intensity (0-4):

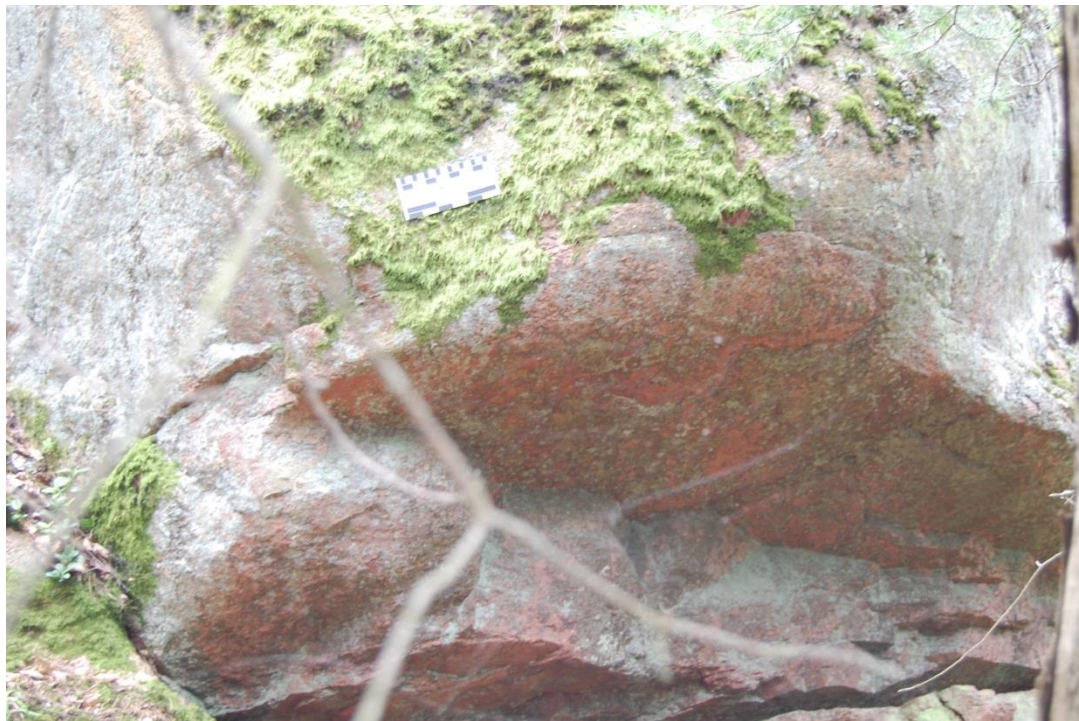
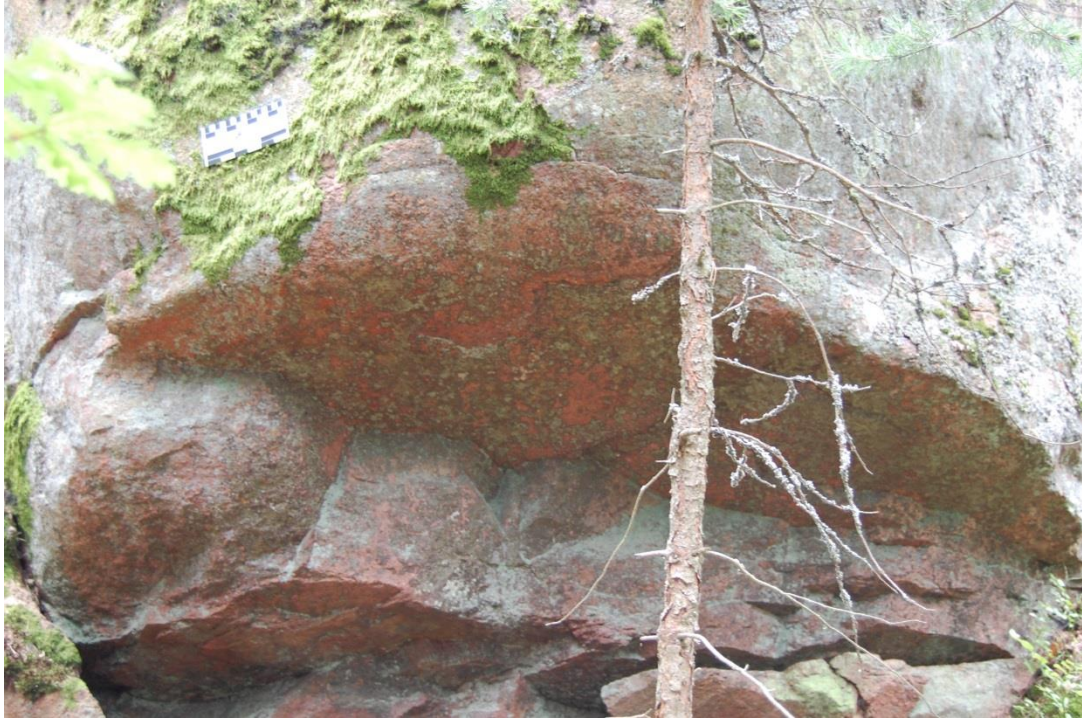
01003

Rock type:	Röd fink granit
Fracture ID:	0100.3
Location:	
Fracture plane type:	
Fracture strike:	94
Fracture dip:	35
Rake of slip line:	12° riktn

Conf. Level (C, P, S, X):	red f	
Weight factor (0 - 9,9):		
Activ. Type (1-3):		
Striae Intensity (0-4):

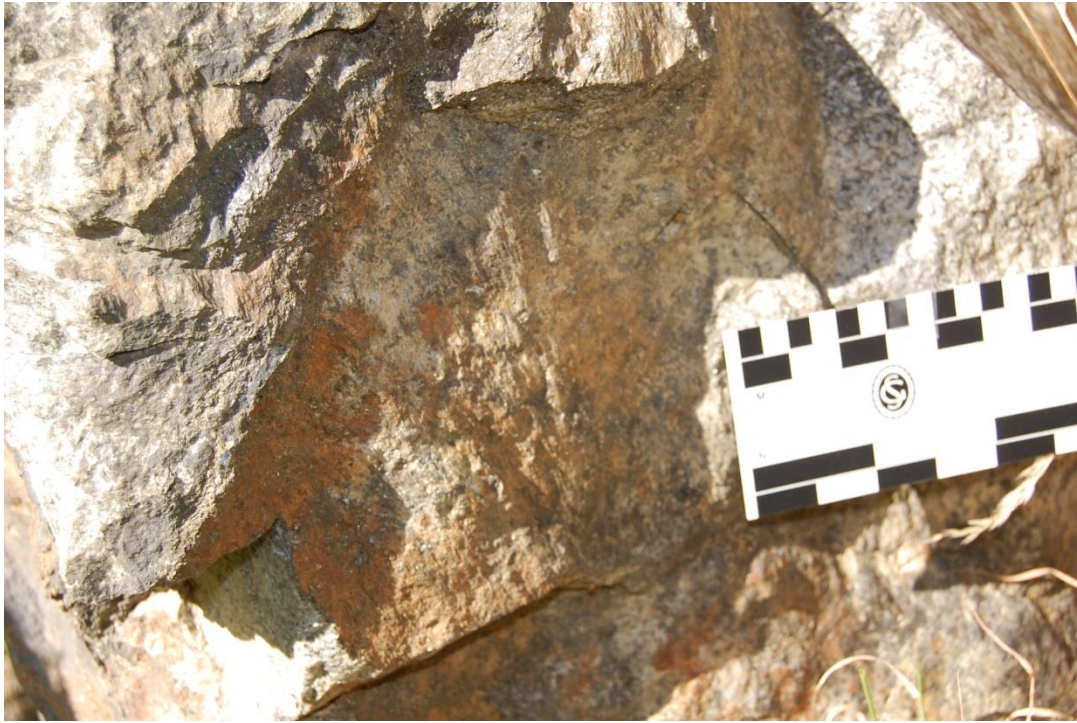
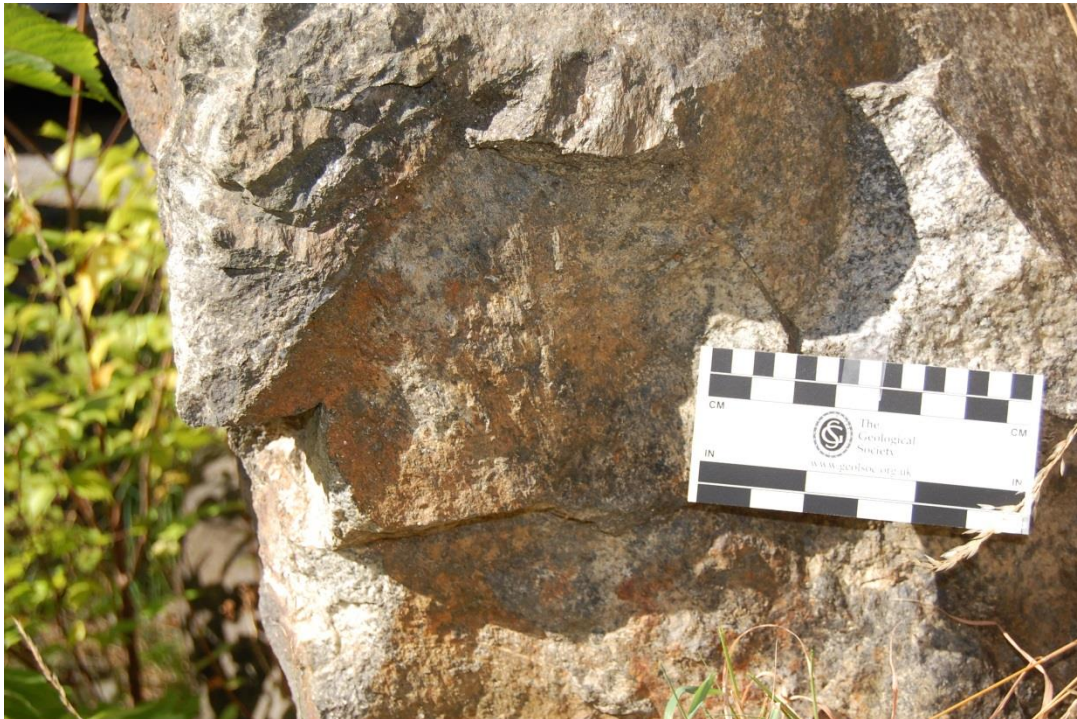
Rock type:	Gnejs glimmer
Fracture ID:	02001
Location:	Söder om bron 32m
Fracture plane type:	
Fracture strike:	320
Fracture dip:	80
Rake of slip line:	75°

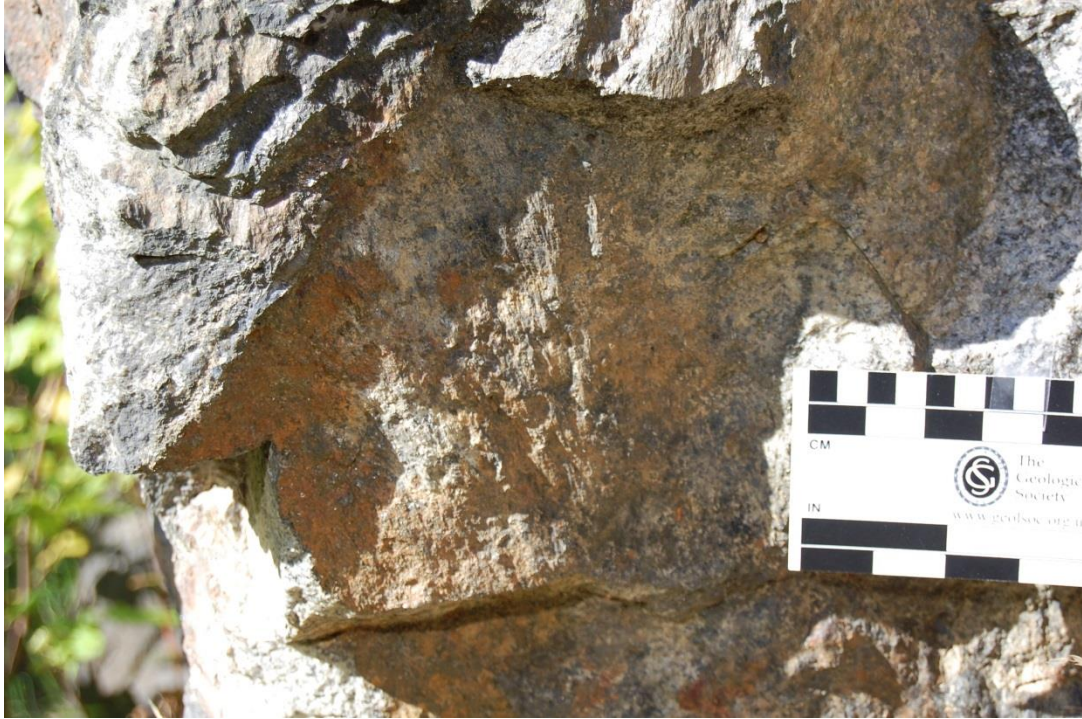
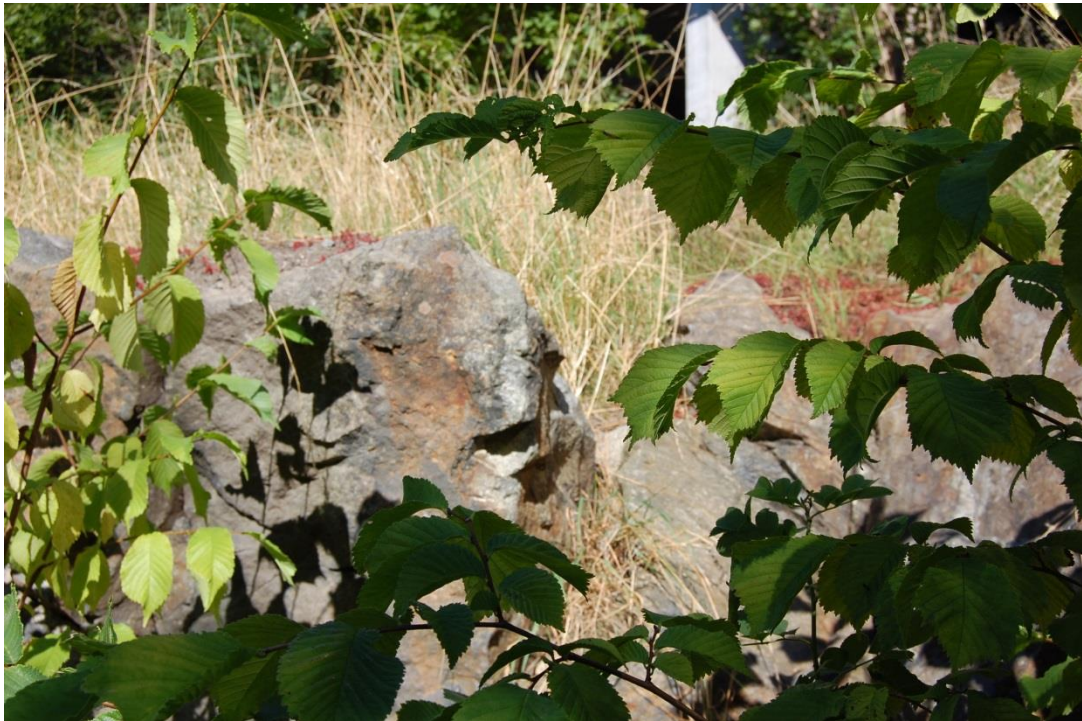
Conf. Level (C, P, S, X):	P	
Weight factor (0 - 9,9):	0,5	
Activ. Type (1-3):		
Striae Intensity (0-4):

Reverse

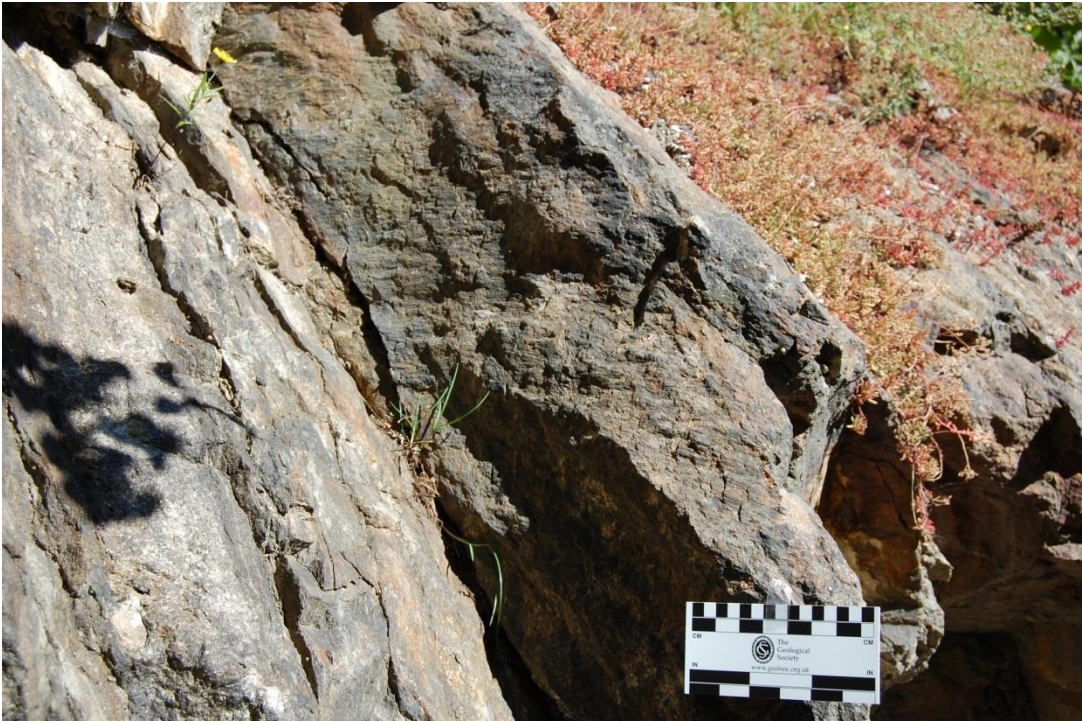
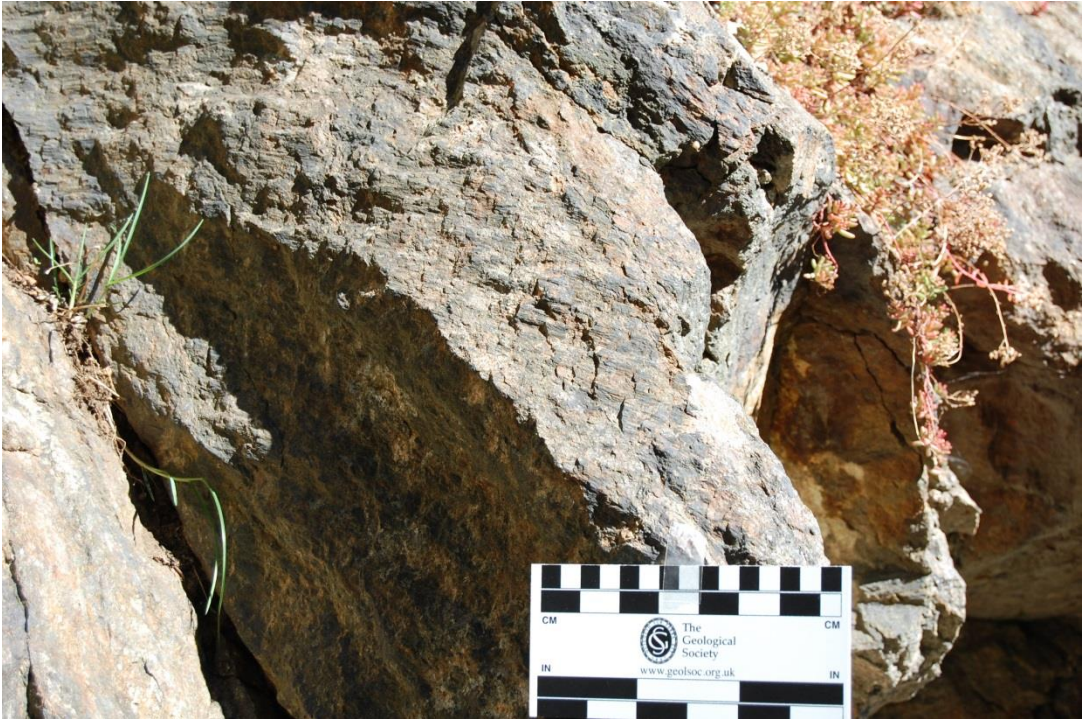
02002a

Rock type:	Gnejs
Fracture ID:	02-002a
Location:	Söder om bron 32m
Fracture plane type:	1
Fracture strike:	102
Fracture dip:	60
Rake of slip line:	160

Conf. Level (C, P, S, X):	D	
Weight factor (0 - 9,9):	1	
Activ. Type (1-3):	2	
Striae Intensity (0-4):	2

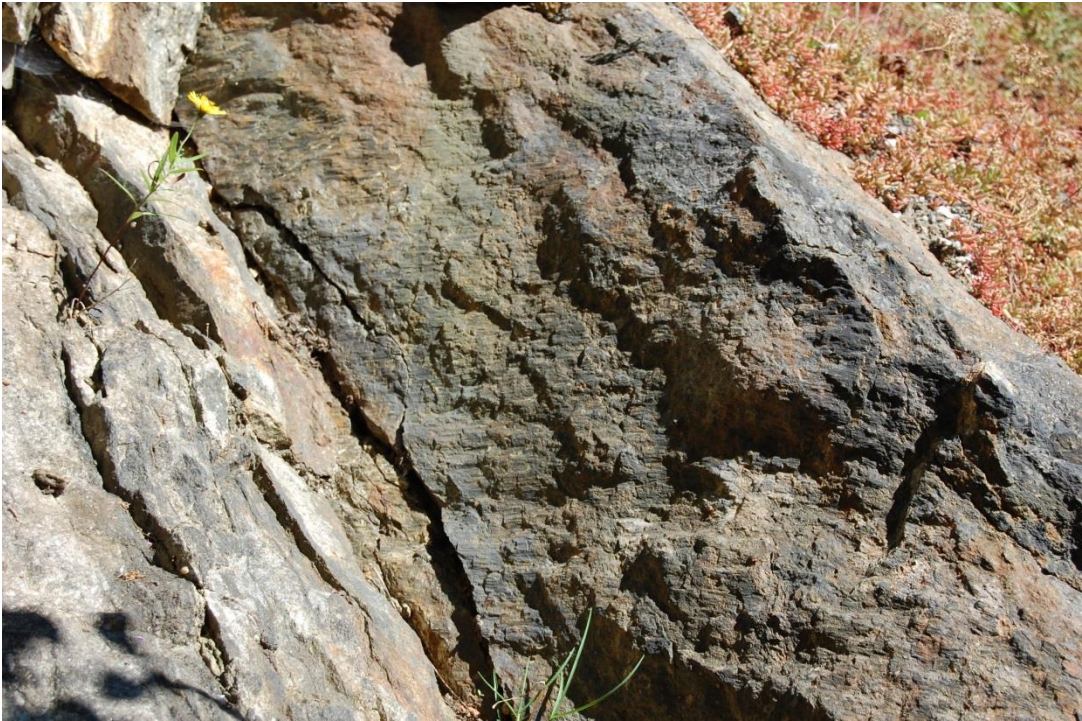
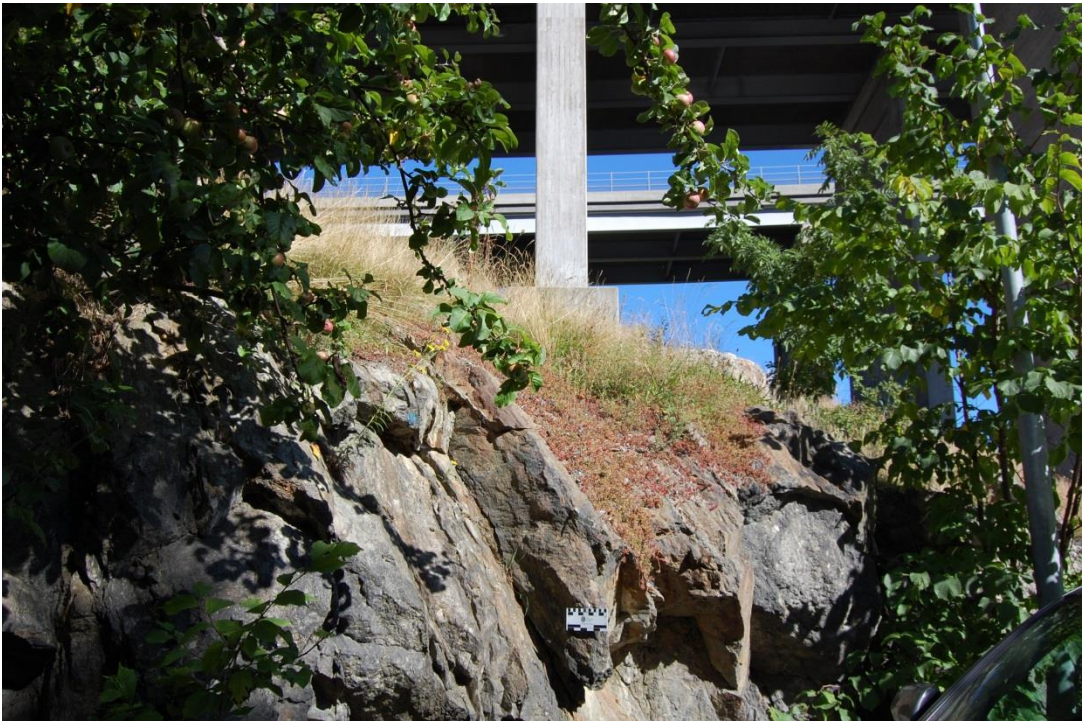
02002b

Rock type:	Gnejs
Fracture ID:	002b
Location:	Söder om bron 32m
Fracture plane type:	1
Fracture strike:	112
Fracture dip:	75
Rake of slip line:	5

Conf. Level (C, P, S, X):	P	
Weight factor (0 - 9,9):	1	
Activ. Type (1-3):	2	
Striae Intensity (0-4):	2

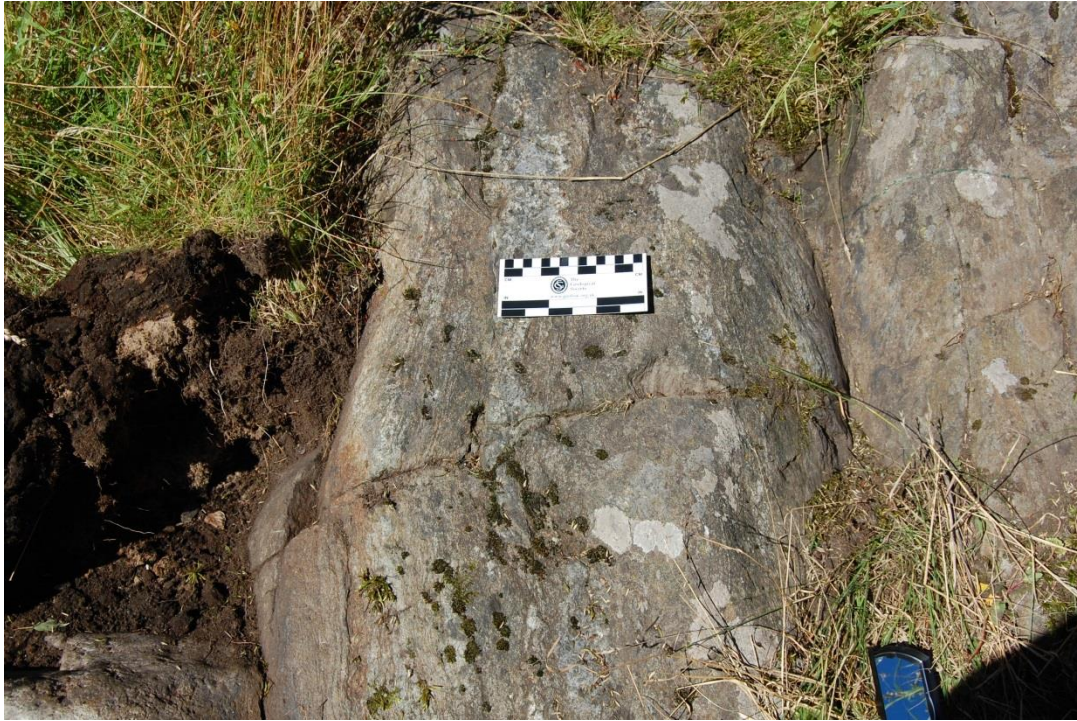
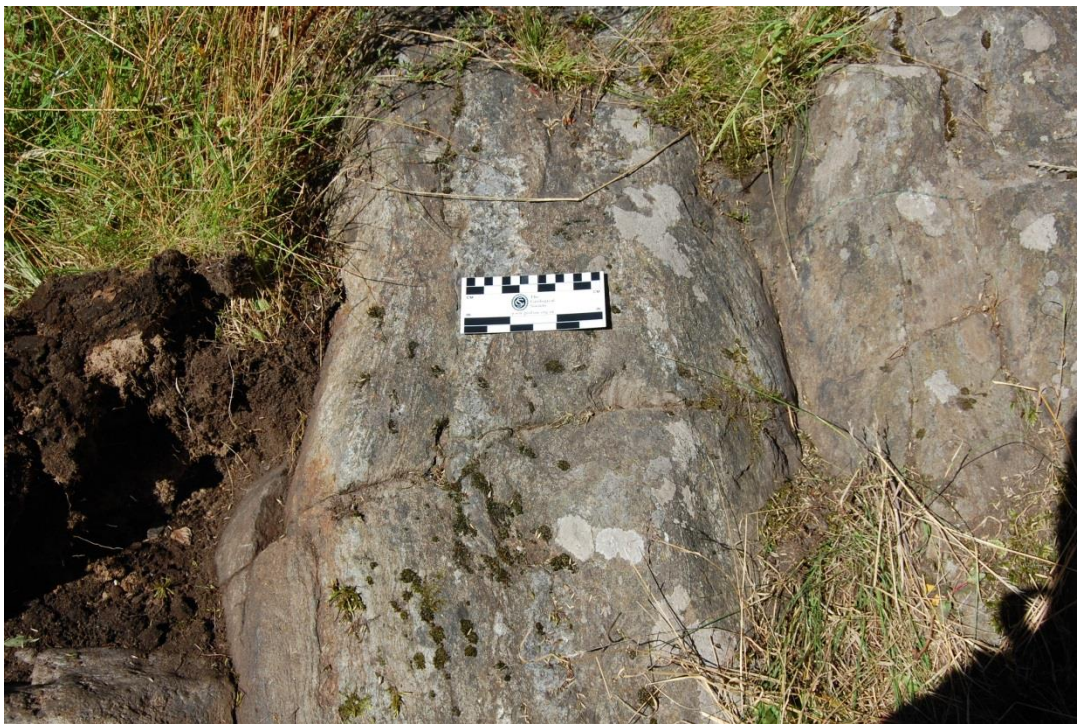
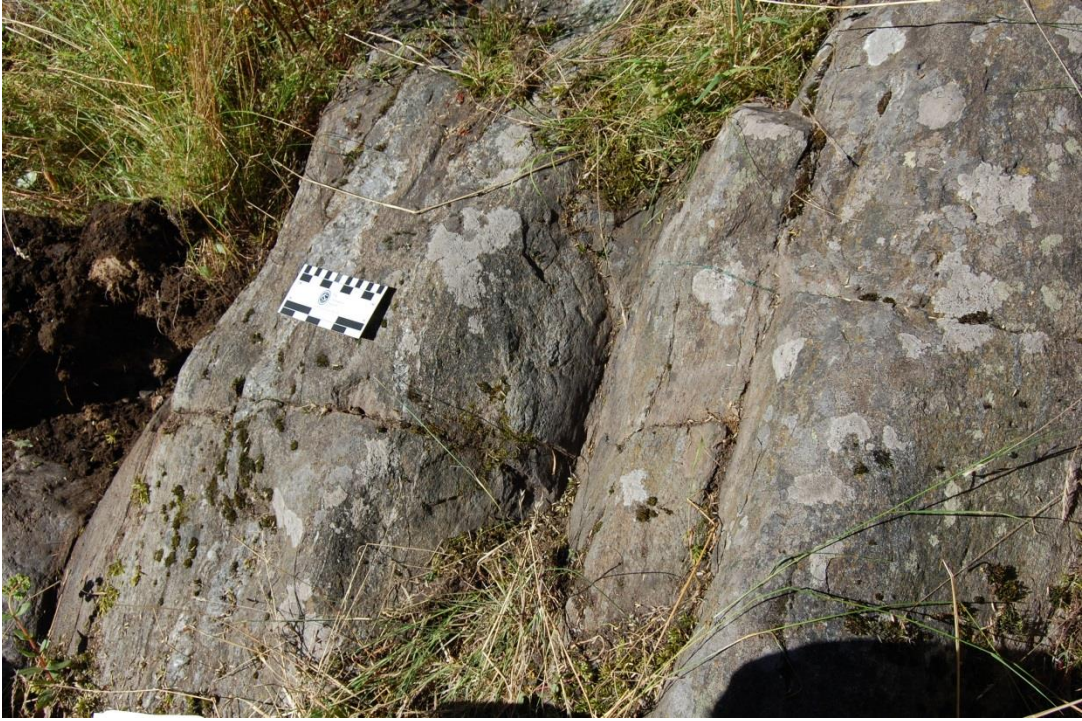
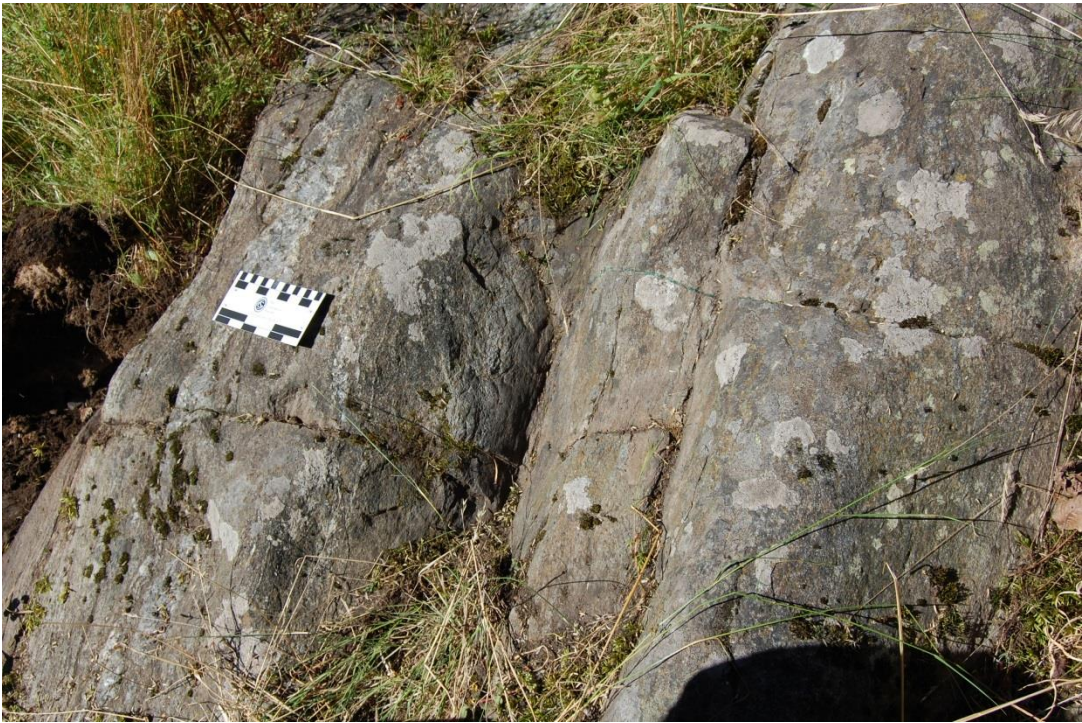
02003

Rock type:	Gnejs
Fracture ID:	003
Location:	
Fracture plane type:	1
Fracture strike:	96
Fracture dip:	60
Rake of slip line:	60

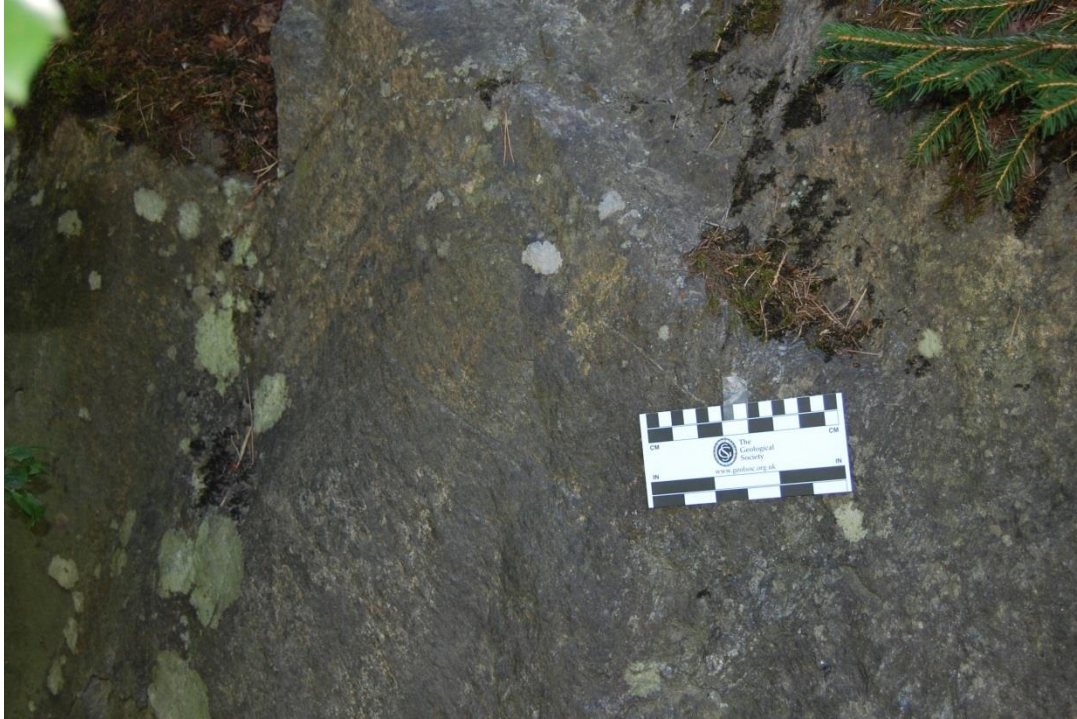
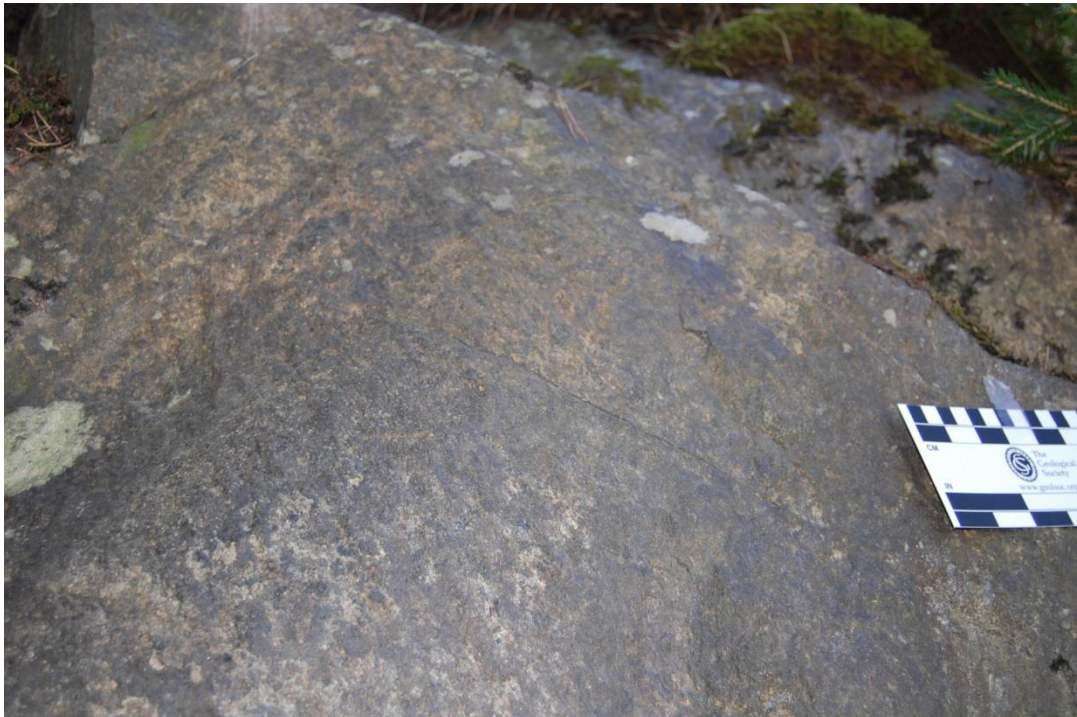
02004

Rock type:	Gnejs
Fracture ID:	004
Location:	Nockeby
Fracture plane type:	1
Fracture strike:	300
Fracture dip:	15°
Rake of slip line:	-50°

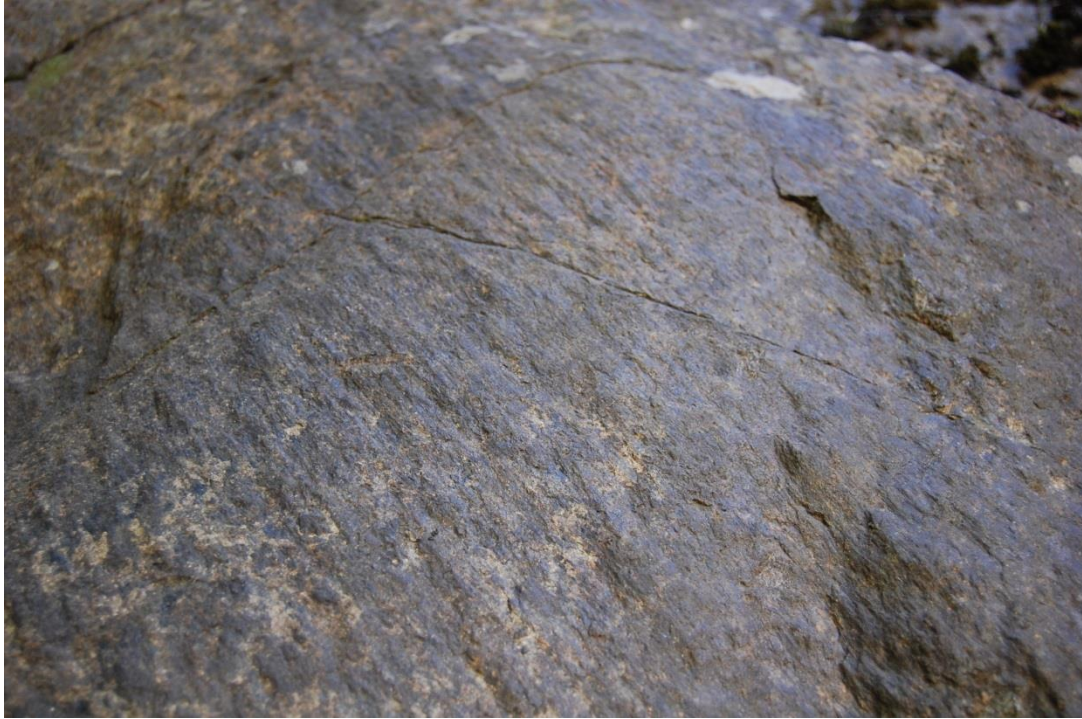
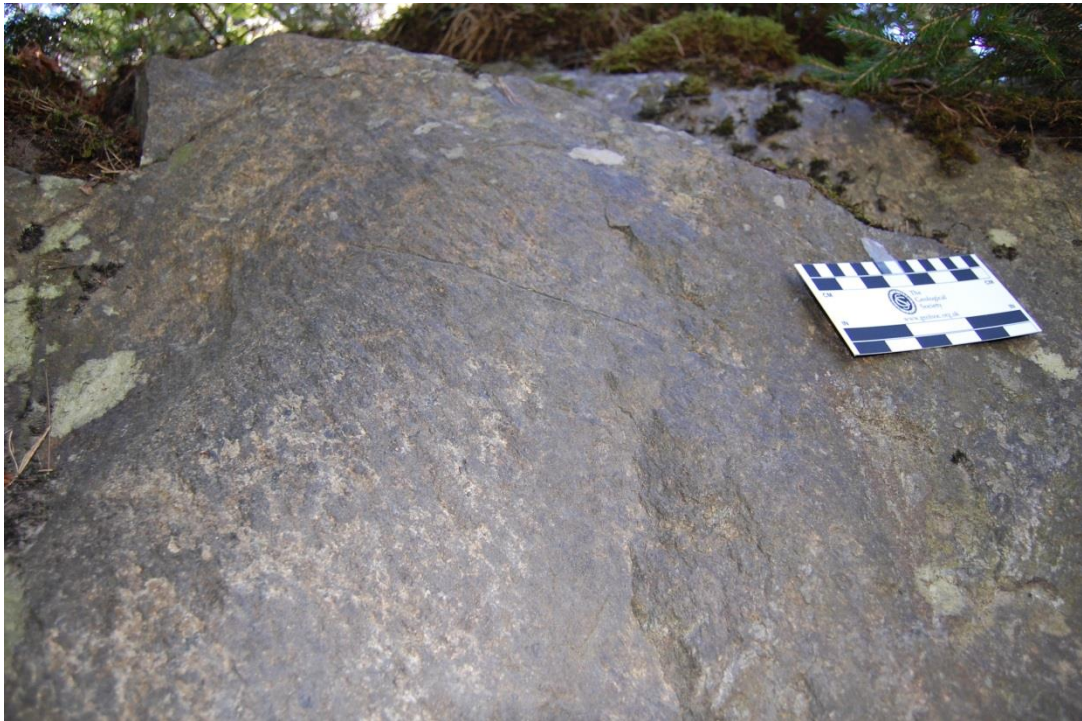
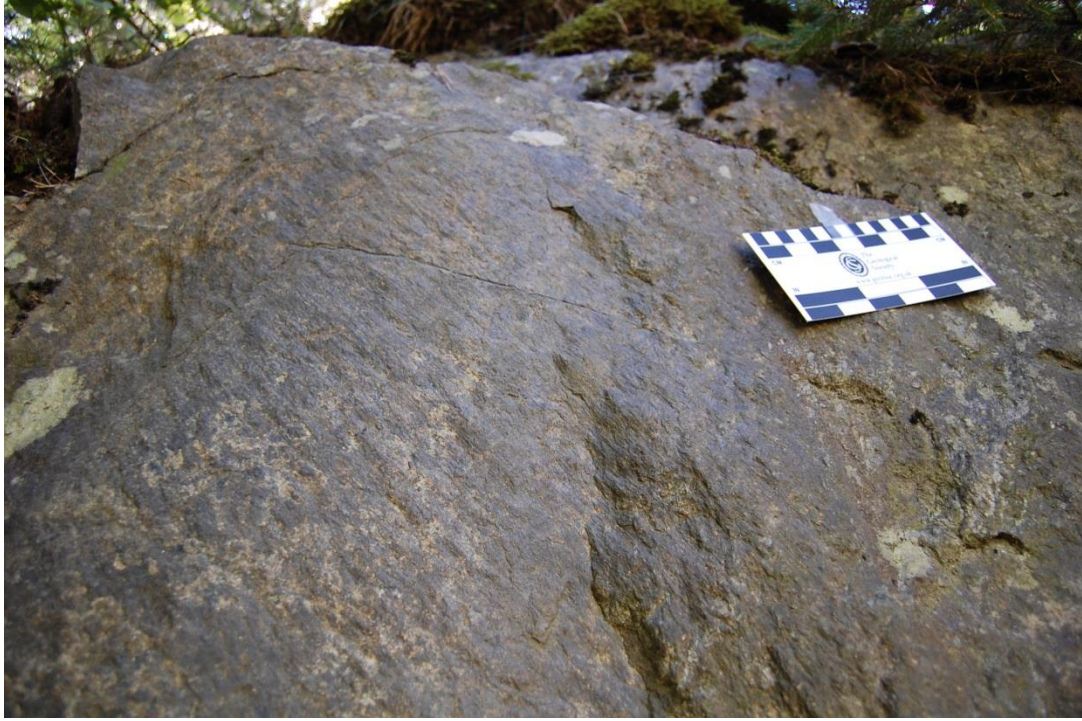
Conf. Level (C, P, S, X):	D	Outcrop at roadside
Weight factor (0 - 9,9):	1	
Activ. Type (1-3):	2	
Striae Intensity (0-4):	2

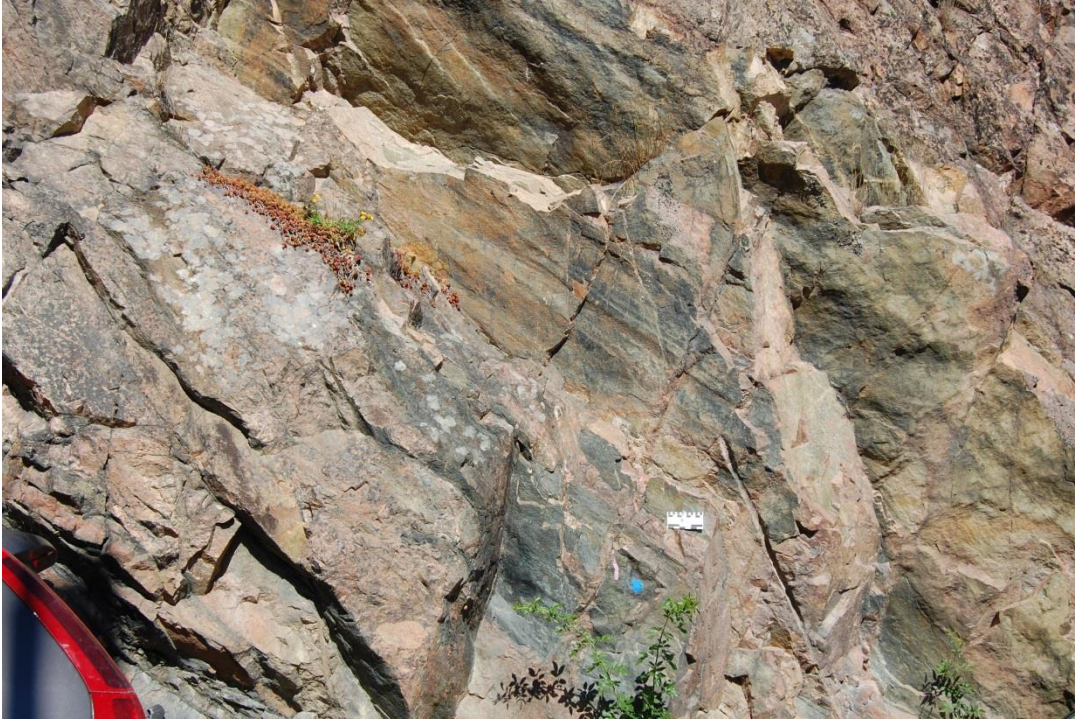
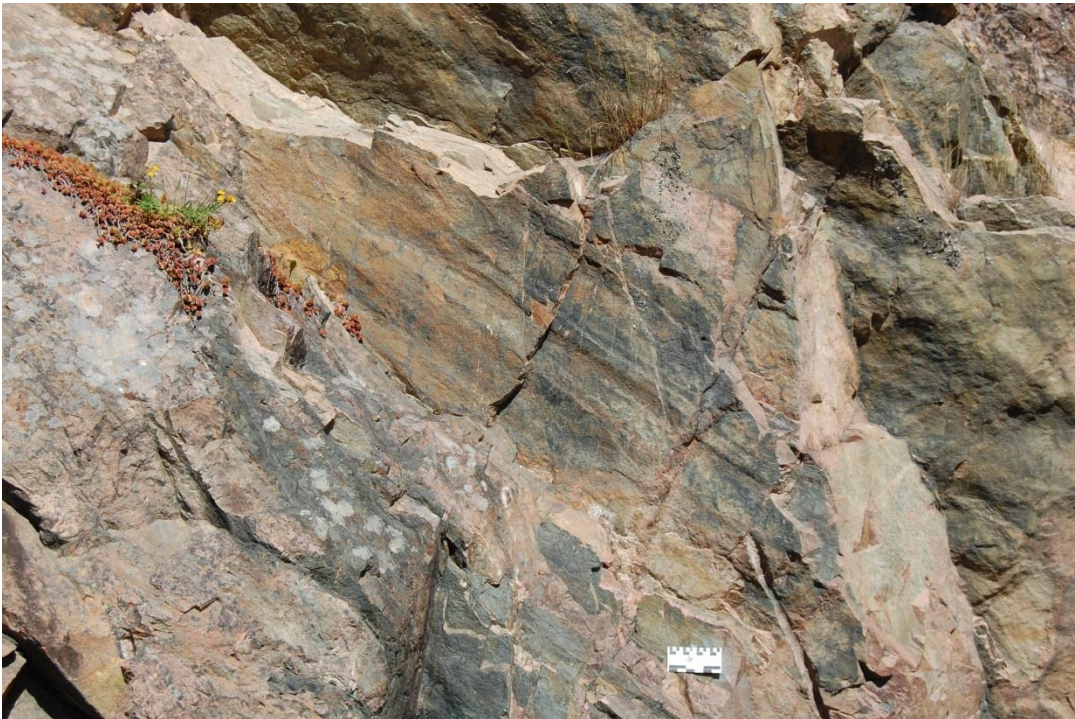
02005

Rock type:	Gnejs
Fracture ID:	005
Location:	
Fracture plane type:	1
Fracture strike:	320
Fracture dip:	75
Rake of slip line:	40

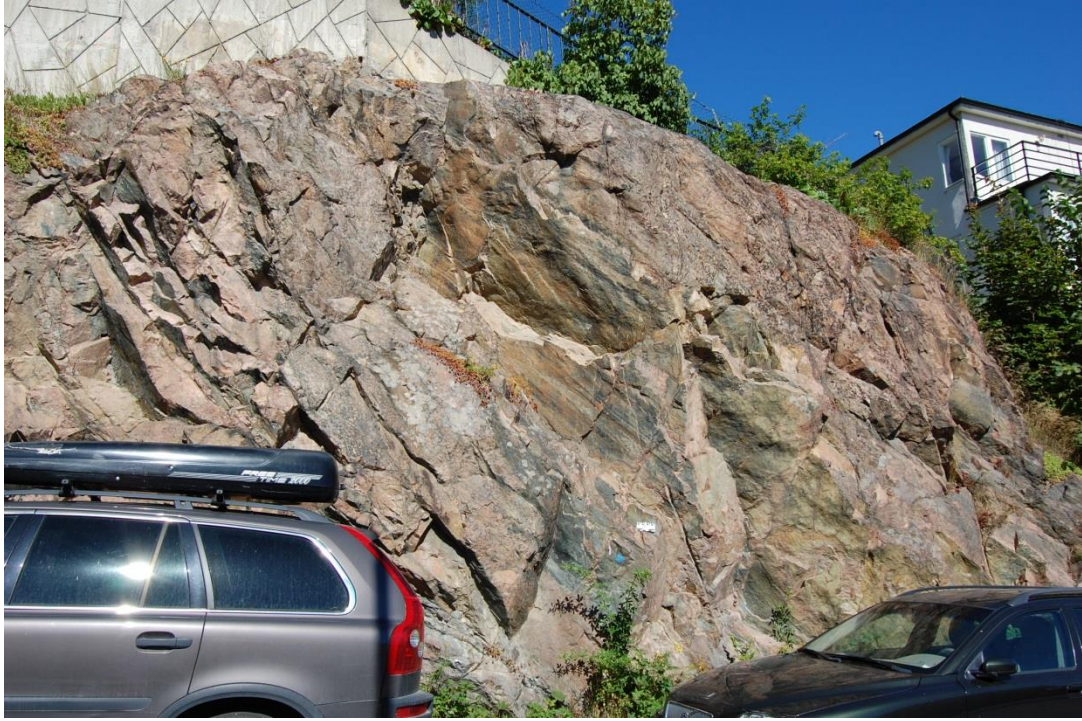
Conf. Level (C, P, S, X):	P	
Weight factor (0 - 9,9):	2	
Activ. Type (1-3):	2	
Striae Intensity (0-4):	2
