Karteringsblad för sprickor med rörelseindikationer

Project:	BeFo 369		
Site ID:	Hasselby (01)	Site name:	Hasselby
Geologist (s):	Ann & Yanling	Field date:	2015 08

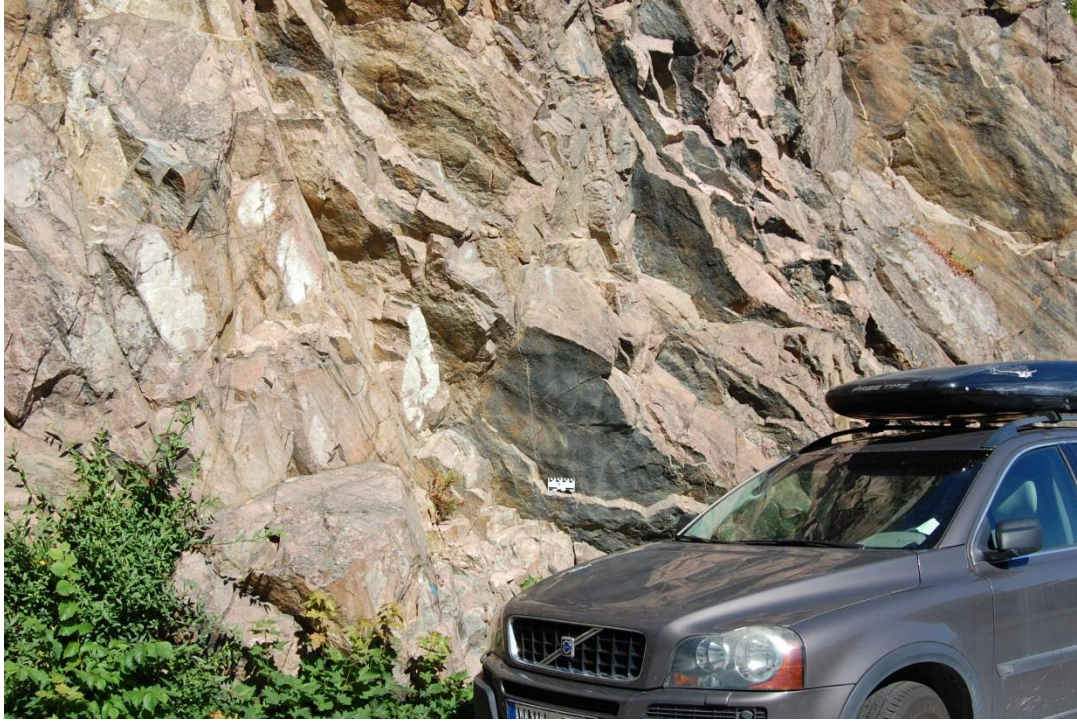
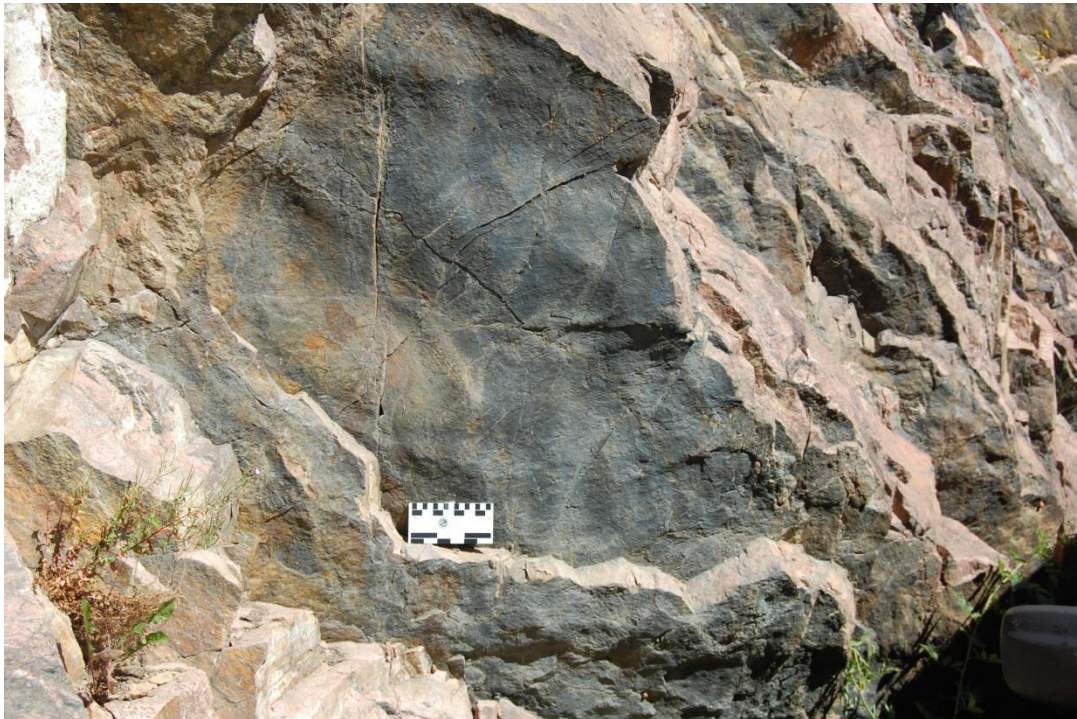
02006

Rock type:	Gnejs
Fracture ID:	006
Location:	
Fracture plane type:	1
Fracture strike:	330
Fracture dip:	70
Rake of slip line:	0

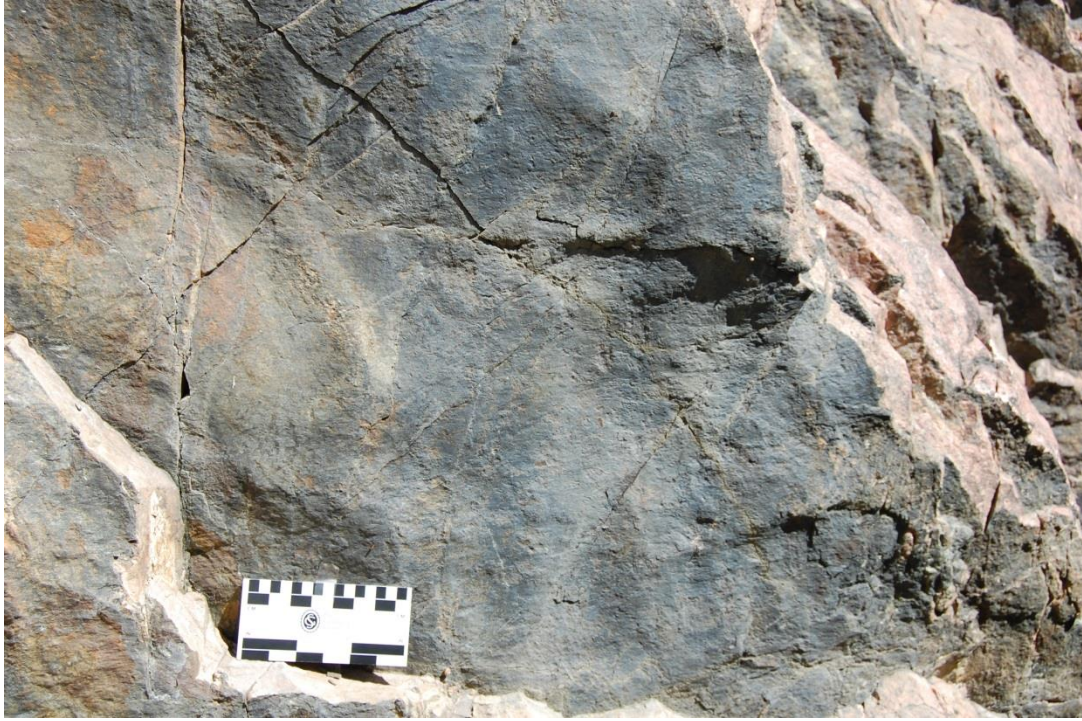
Conf. Level (C, P, S, X):	P	
Weight factor (0 - 9,9):	2	
Activ. Type (1-3):	2	
Striae Intensity (0-4):	2

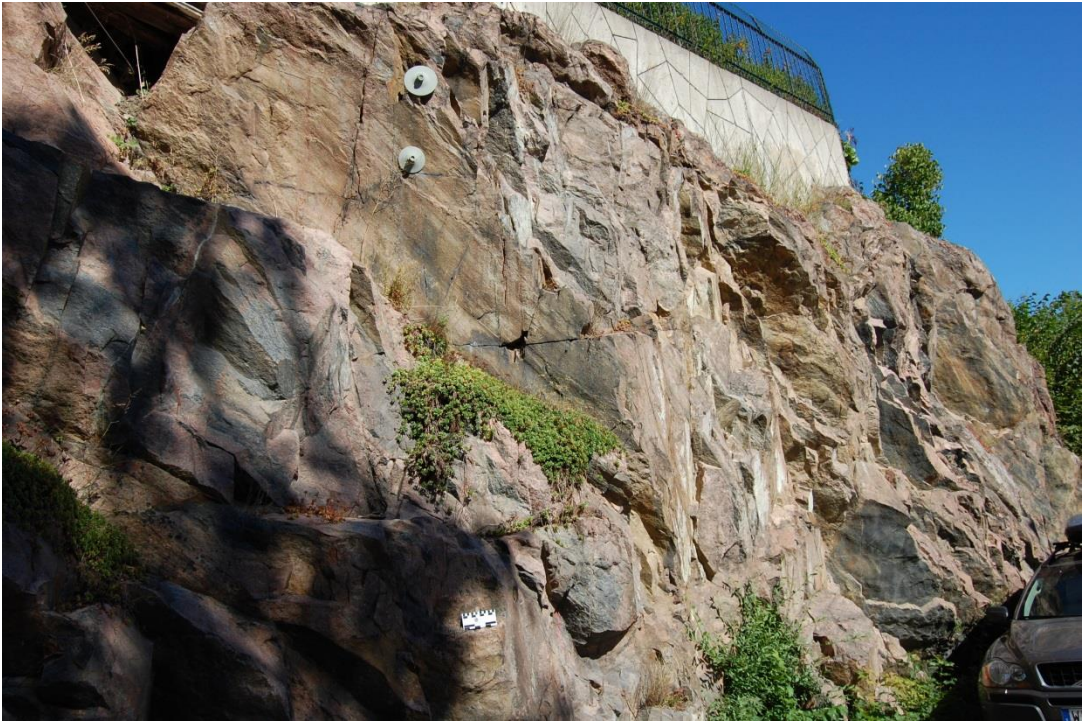
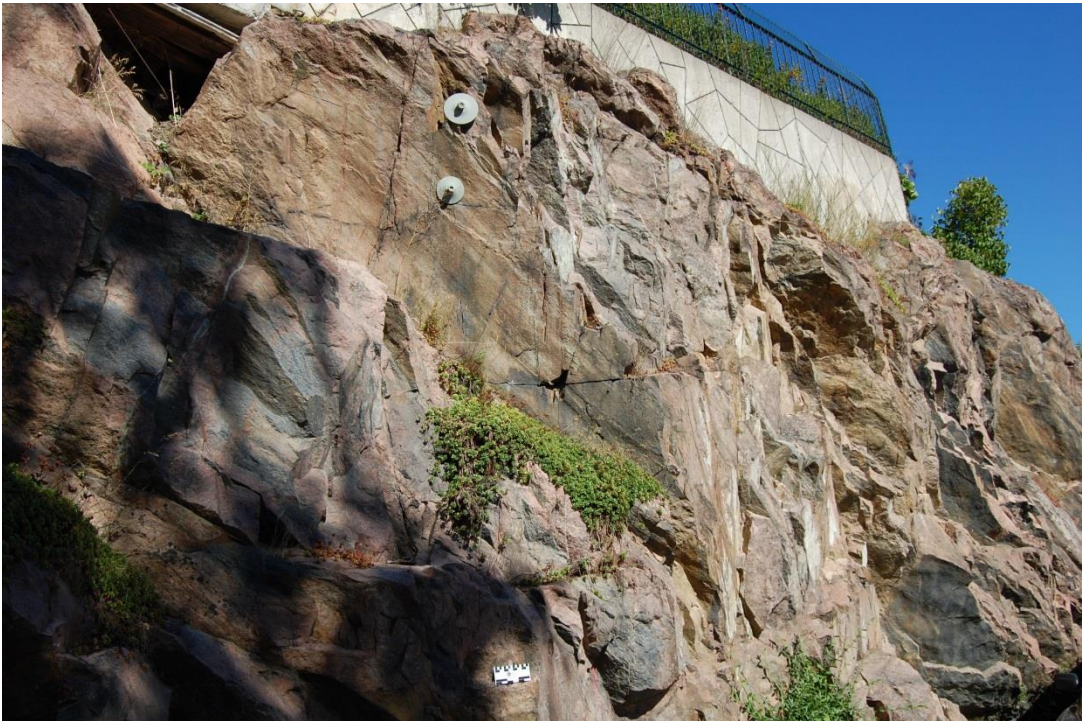
02007

Rock type:	Gnejs
Fracture ID:	007
Location:	
Fracture plane type:	1
Fracture strike:	345
Fracture dip:	70
Rake of slip line:	45

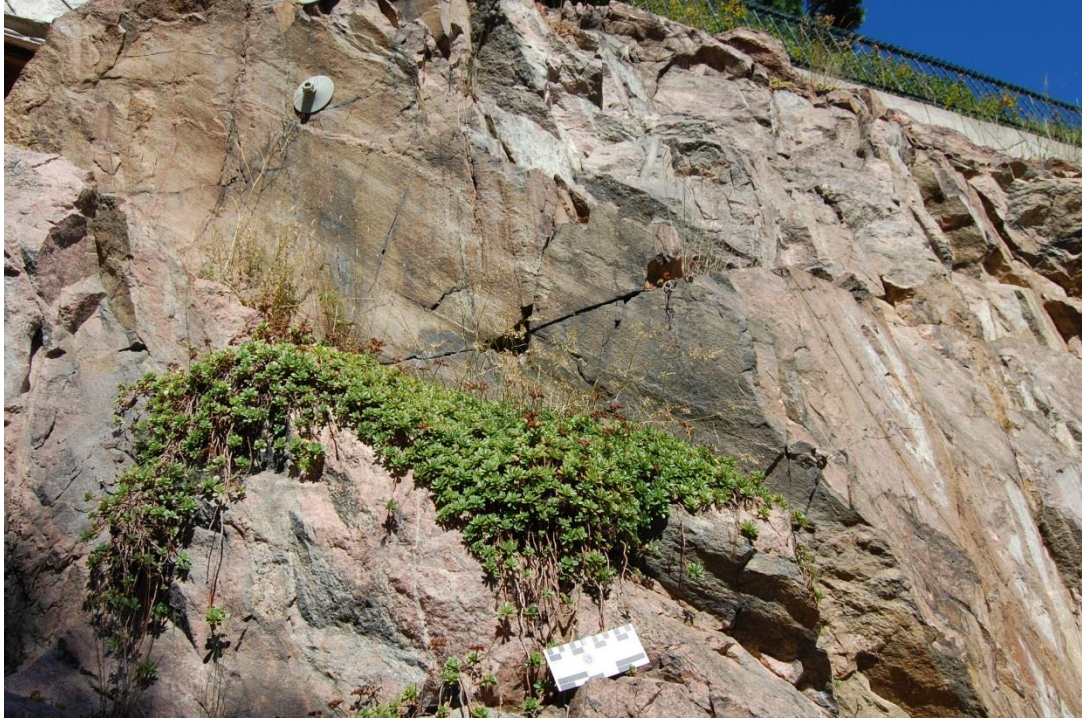
Conf. Level (C, P, S, X):	X	
Weight factor (0 - 9,9):	2	
Activ. Type (1-3):	2	
Striae Intensity (0-4):	2

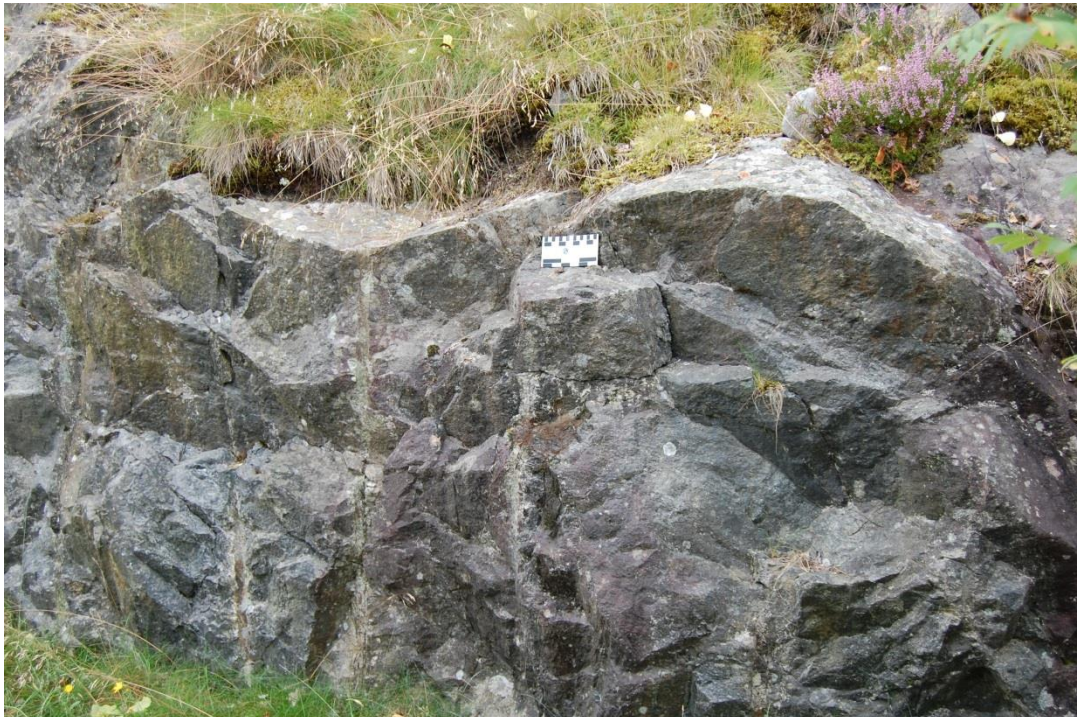
03001

Rock type:	Gnejs
Fracture ID:	0301
Location:	
Fracture plane type:	
Fracture strike:	60
Fracture dip:	70
Rake of slip line:	+160° -20° -160° -20

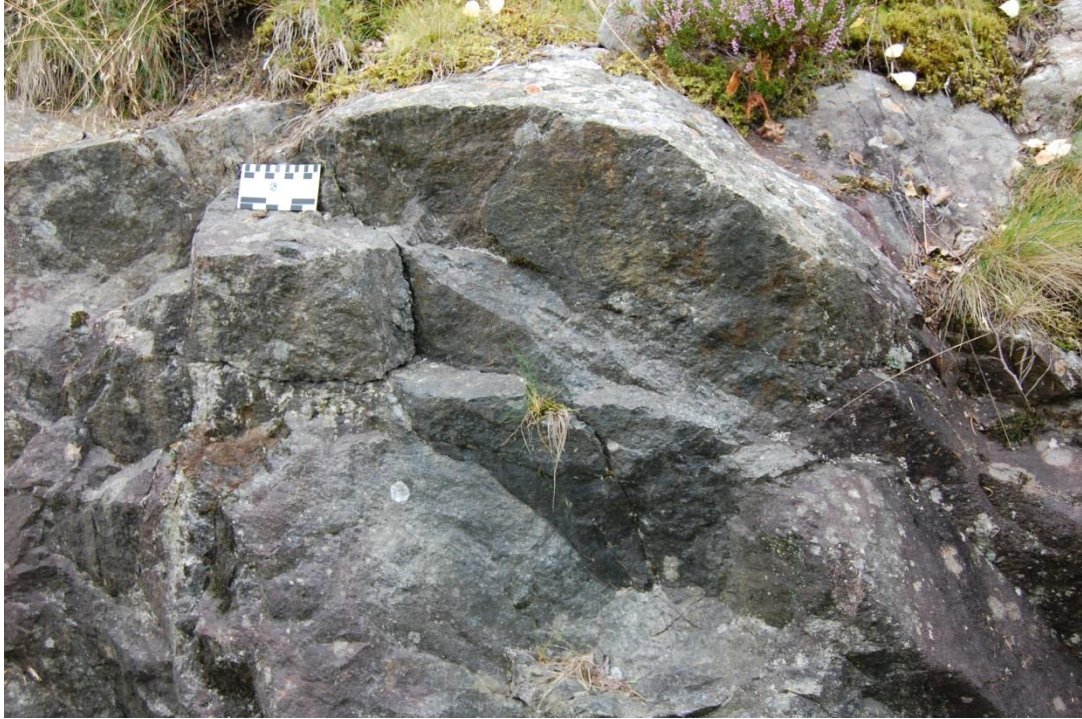
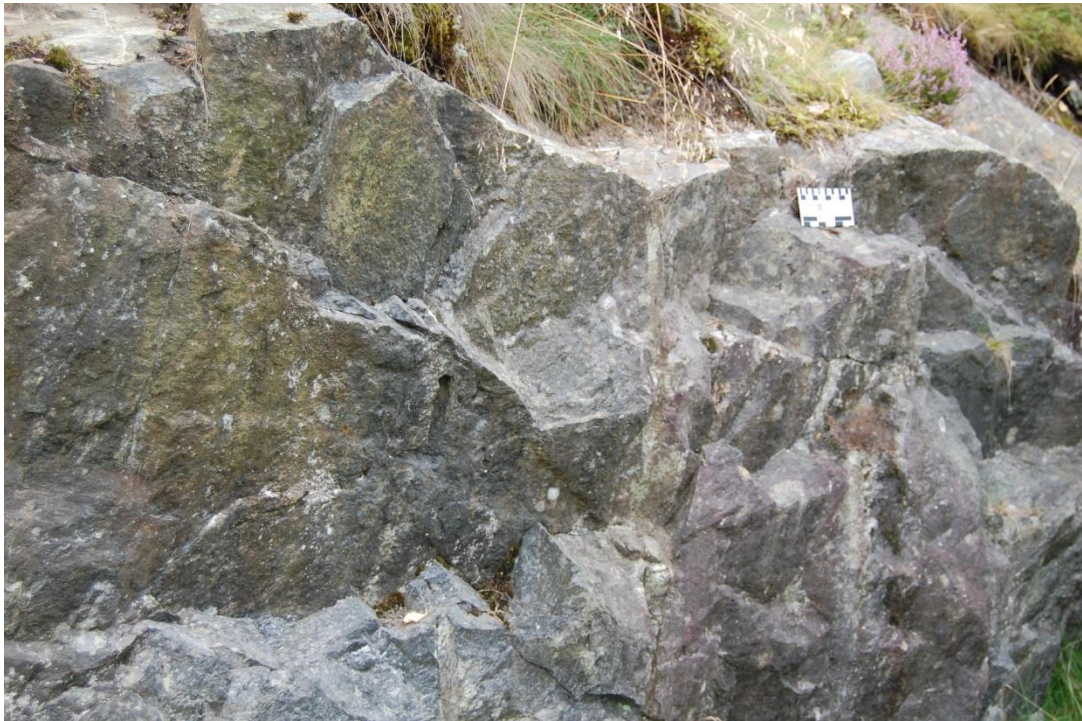
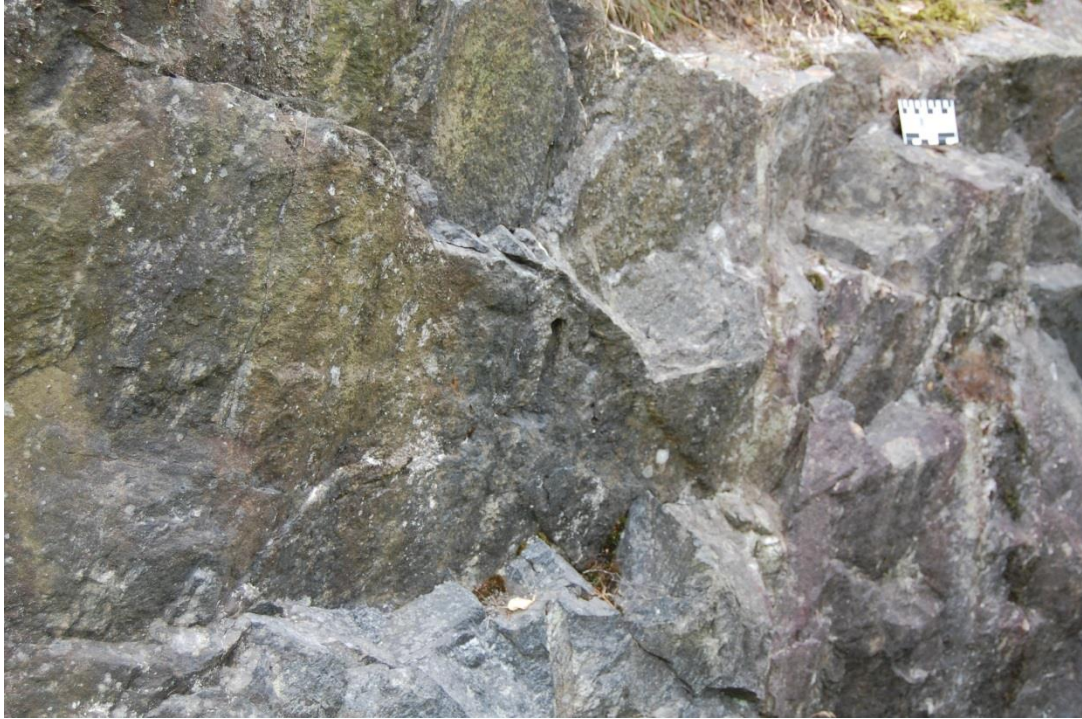
Conf. Level (C, P, S, X):	P	
Weight factor (0 - 9,9):	0.5	
Activ. Type (1-3):		
Striae Intensity (0-4):

Enl. ytan på det undre blocket (som här är borta)

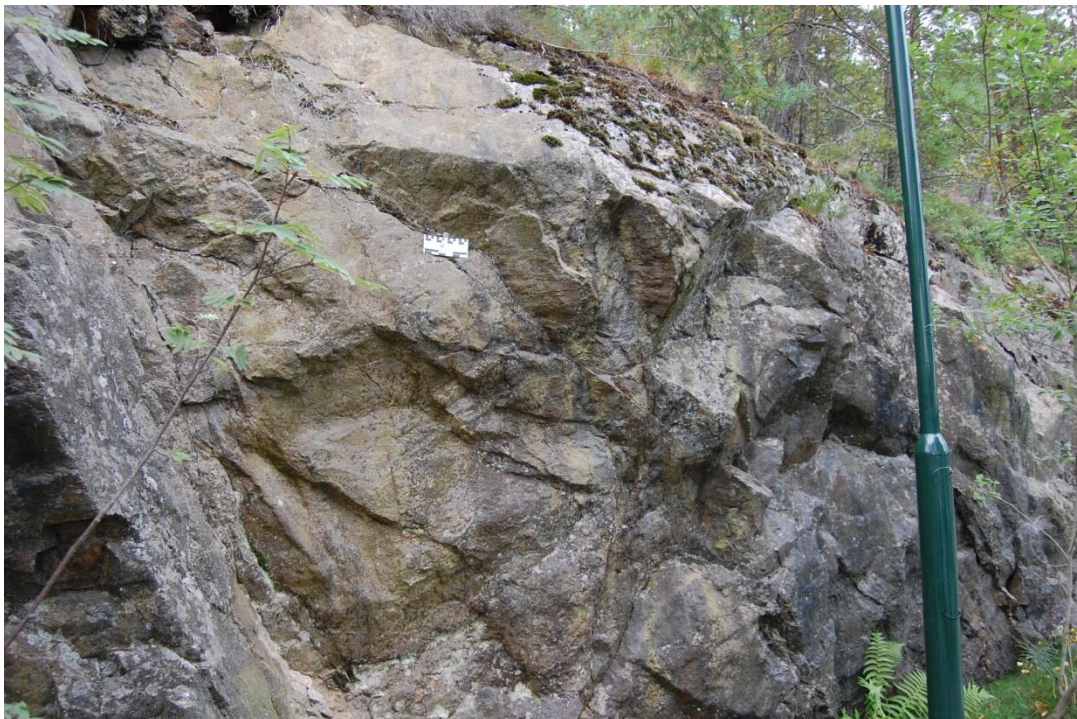
03002

Rock type:	Gneiss
Fracture ID:	0302
Location:	
Fracture plane type:	
Fracture strike:	80
Fracture dip:	70
Rake of slip line:	-005

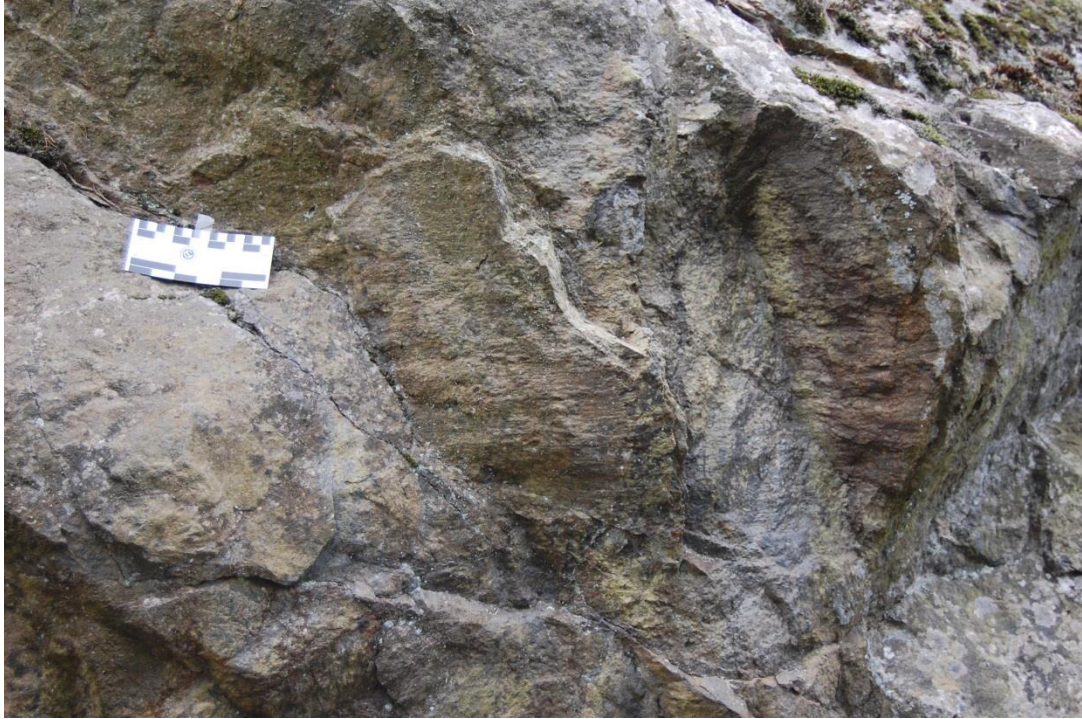
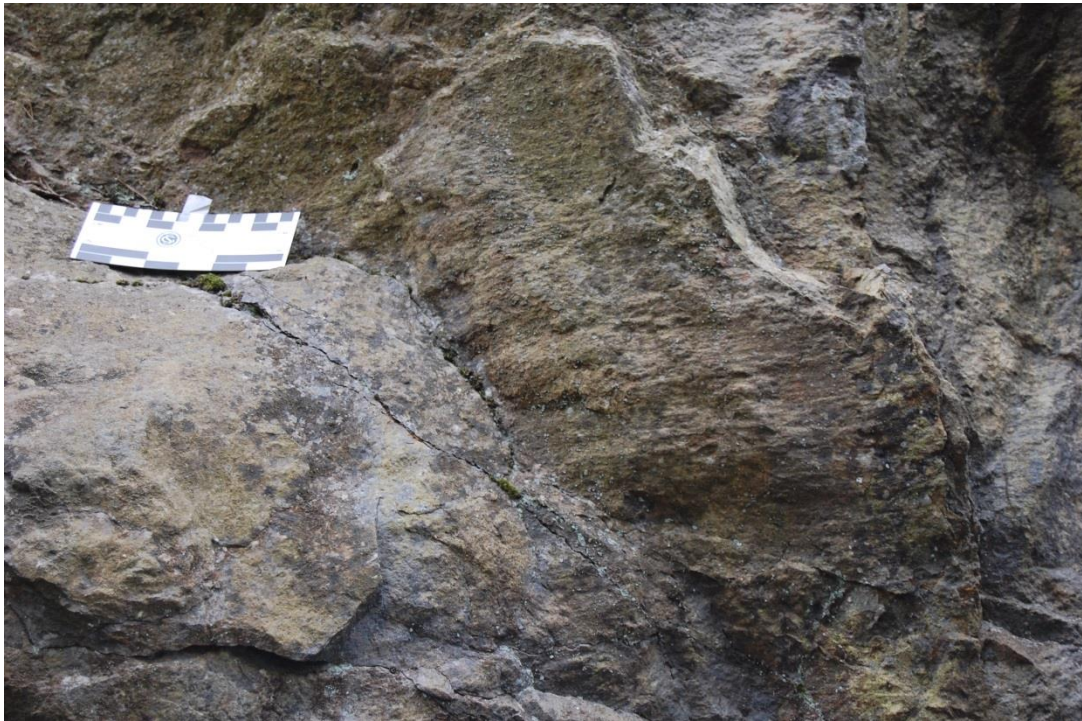
Conf. Level (C, P, S, X):	P	
Weight factor (0 - 9,9):		
Activ. Type (1-3):		
Striae Intensity (0-4):

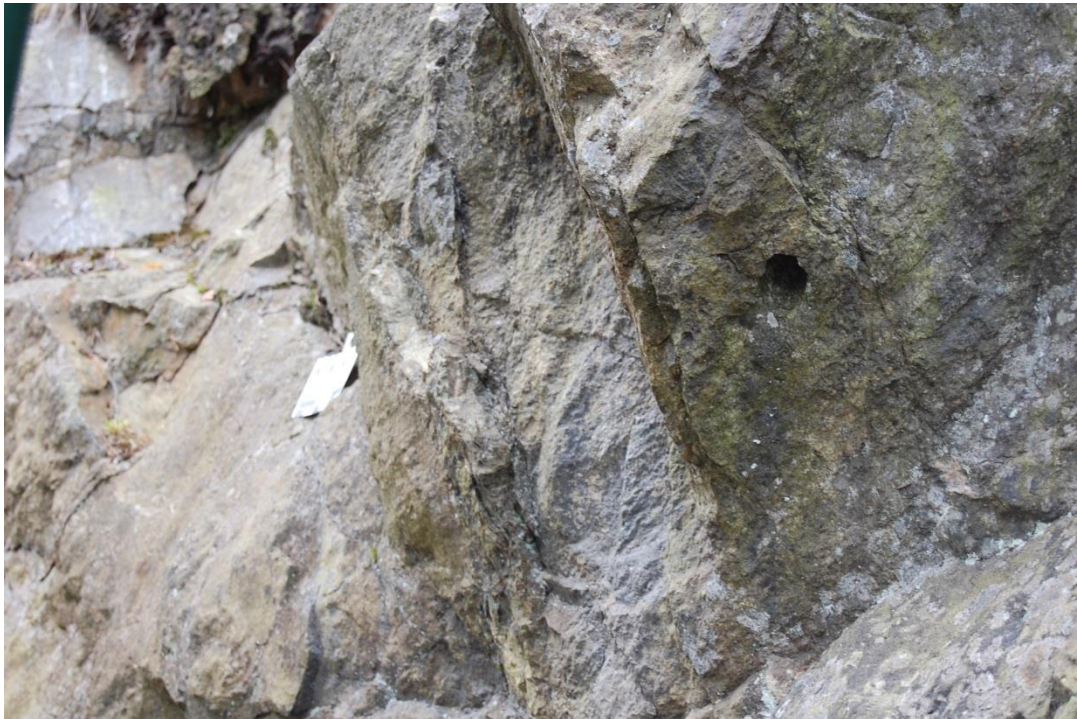
03003

Rock type:	
Fracture ID:	Q303
Location:	
Fracture plane type:	
Fracture strike:	80°
Fracture dip:	80°
Rake of slip line:	-100

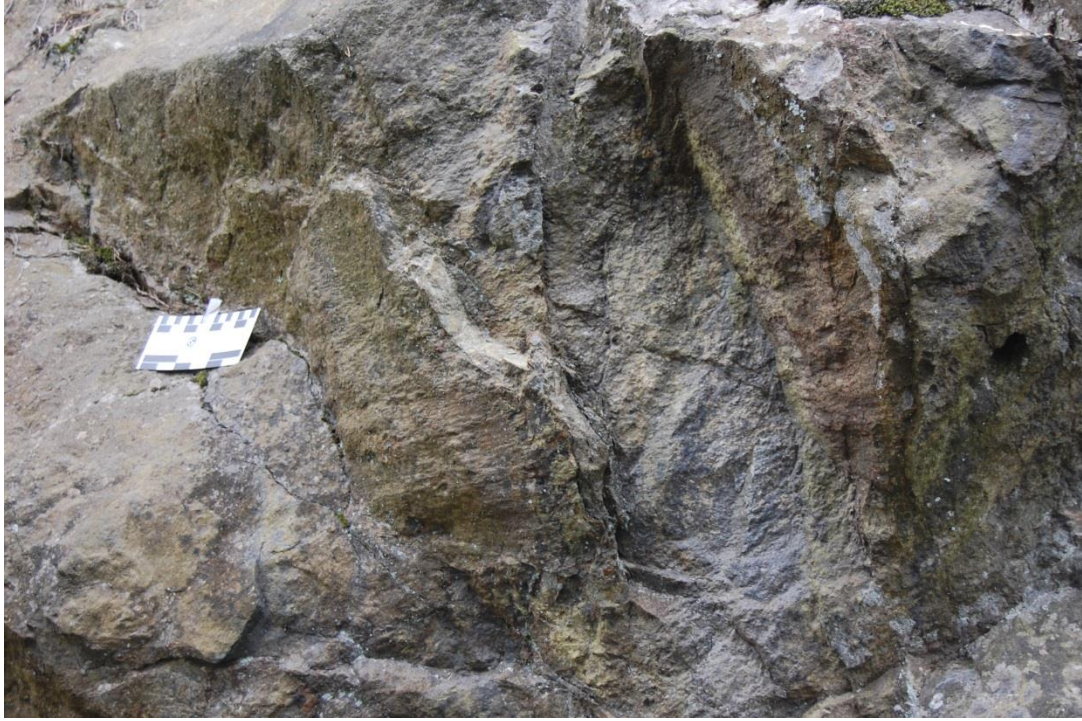
Conf. Level (C, P, S, X):		Ytan har kvarts
Weight factor (0 - 9,9):		
Activ. Type (1-3):		
Striae Intensity (0-4):

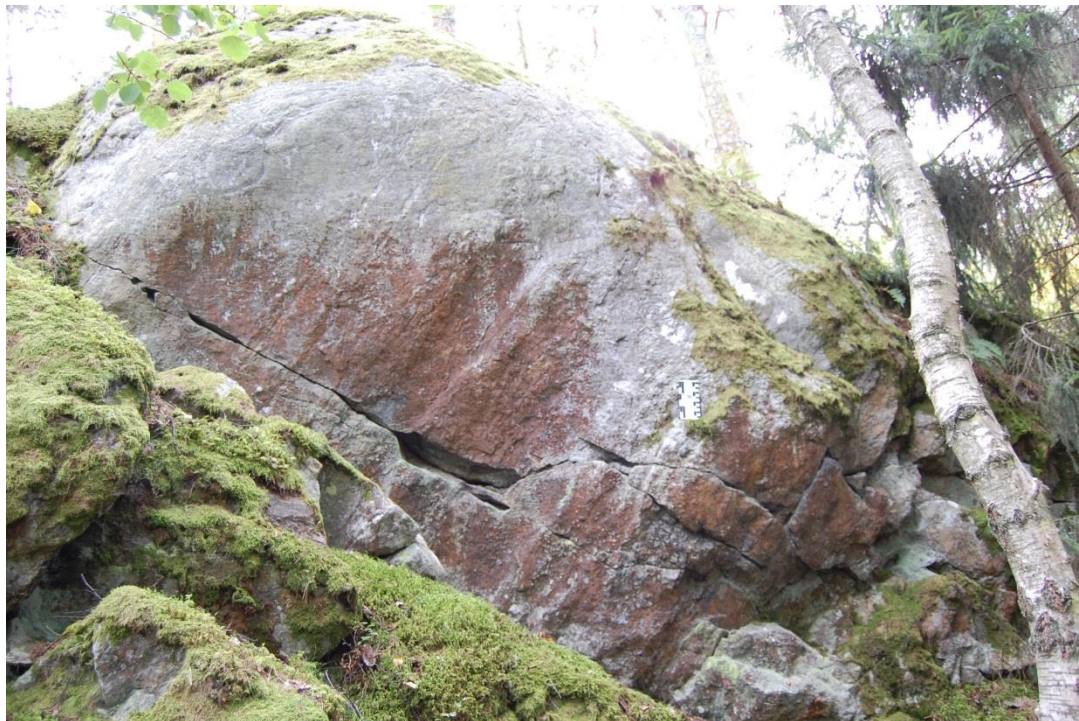
03004

Rock type:	Gnejs m pegm-del
Fracture ID:	0304
Location:	
Fracture plane type:	
Fracture strike:	45°
Fracture dip:	75°
Rake of slip line:	+120

Conf. Level (C, P, S, X):	P	Grooves
Weight factor (0 - 9,9):		
Activ. Type (1-3):		
Striae Intensity (0-4):

3st tydliga grooves

60°
revers dextral

Enl. ytan som visas på undre blocket

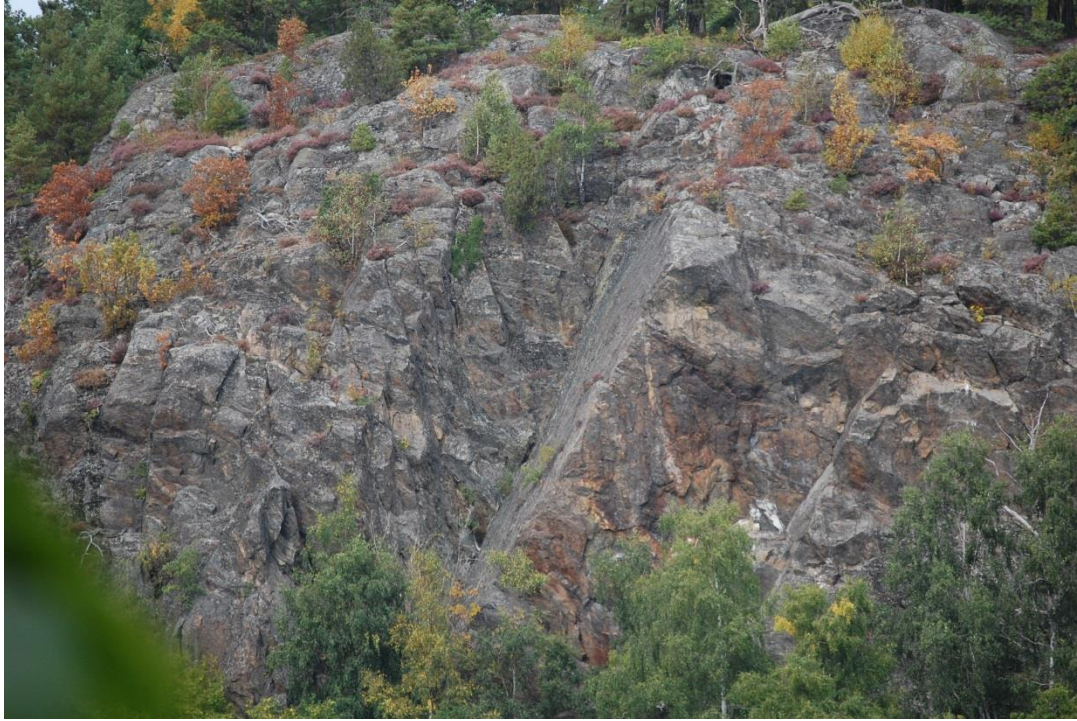
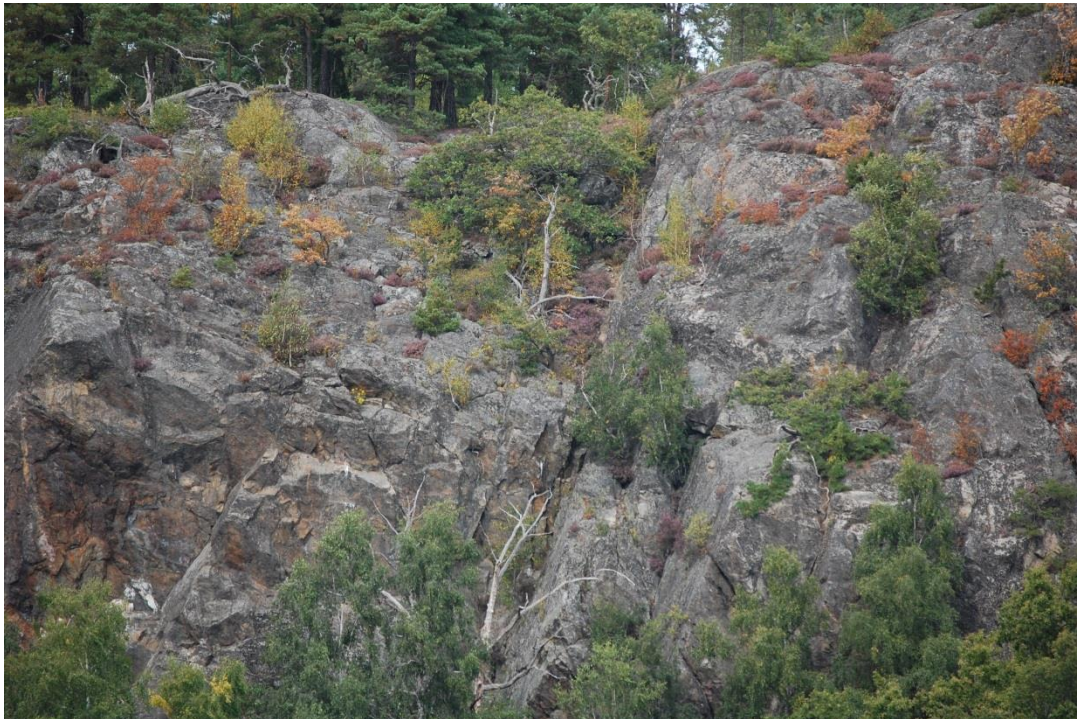
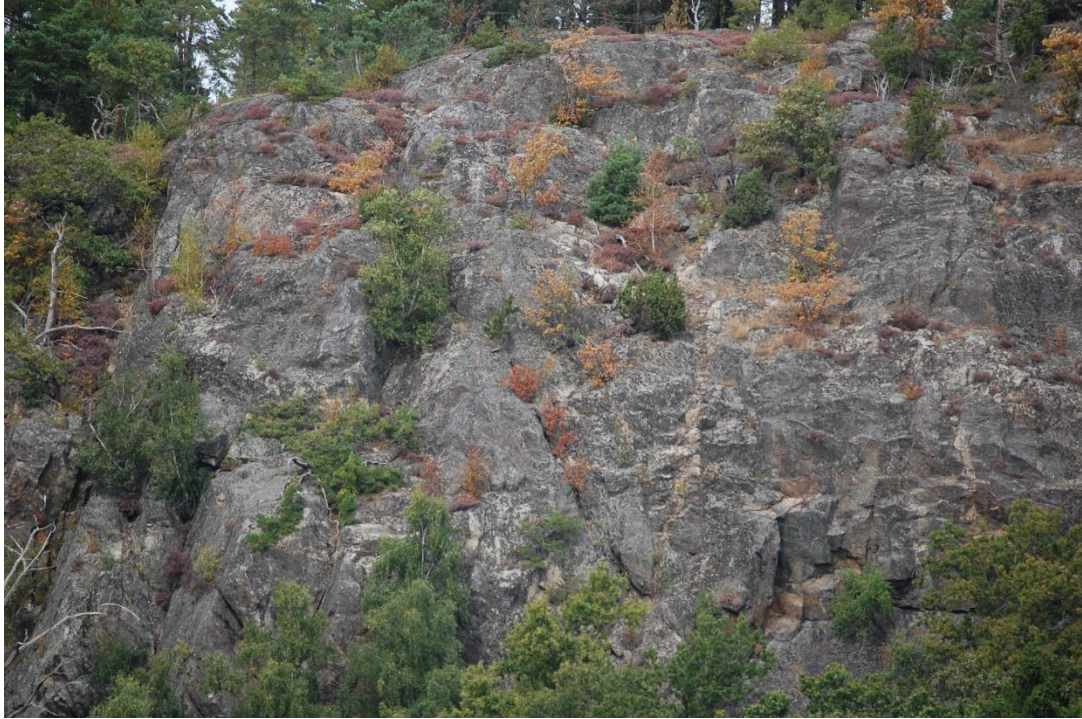
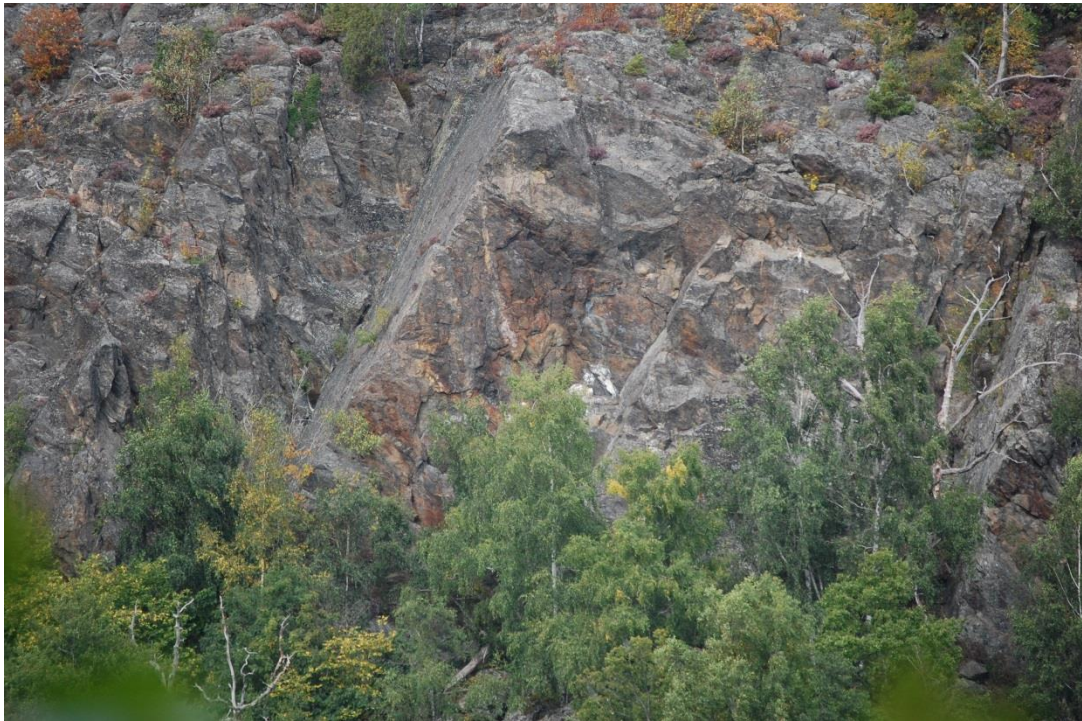
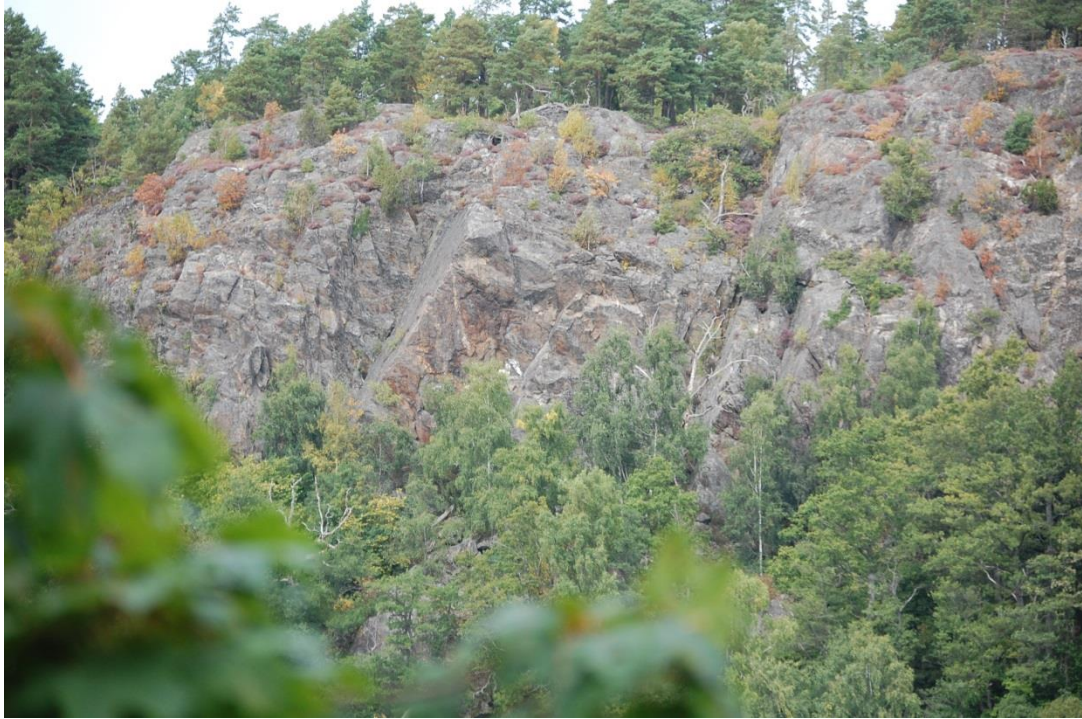
03005

Rock type:	Gnejs
Fracture ID:	0305
Location:	
Fracture plane type:	
Fracture strike:	130°
Fracture dip:	60°
Rake of slip line:

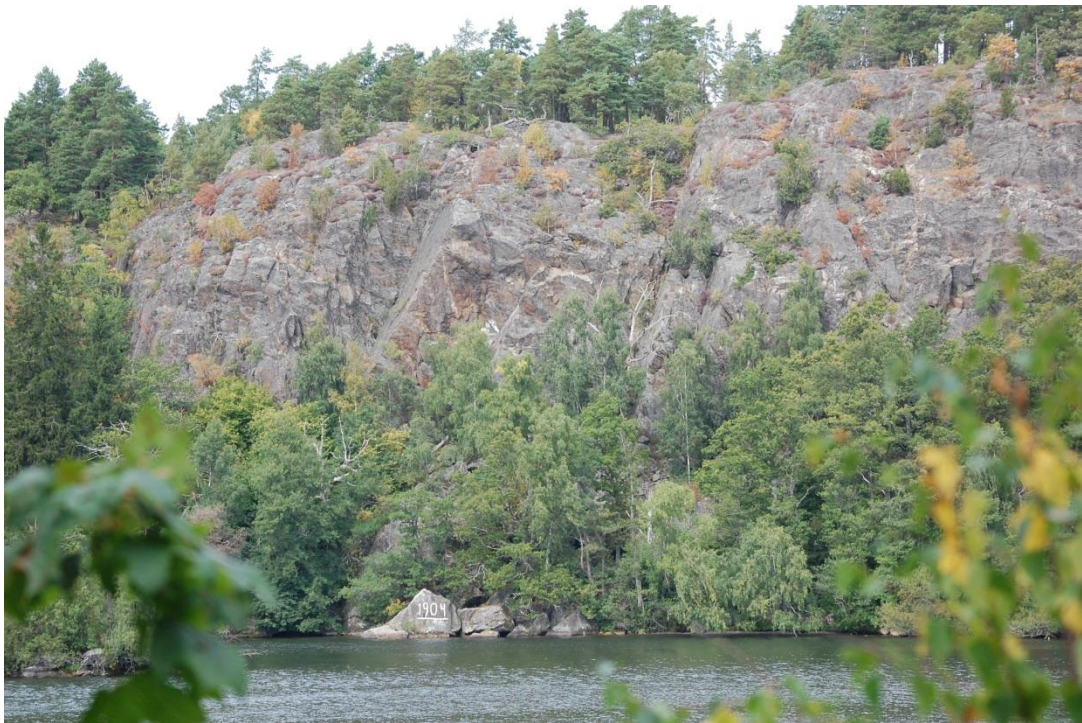
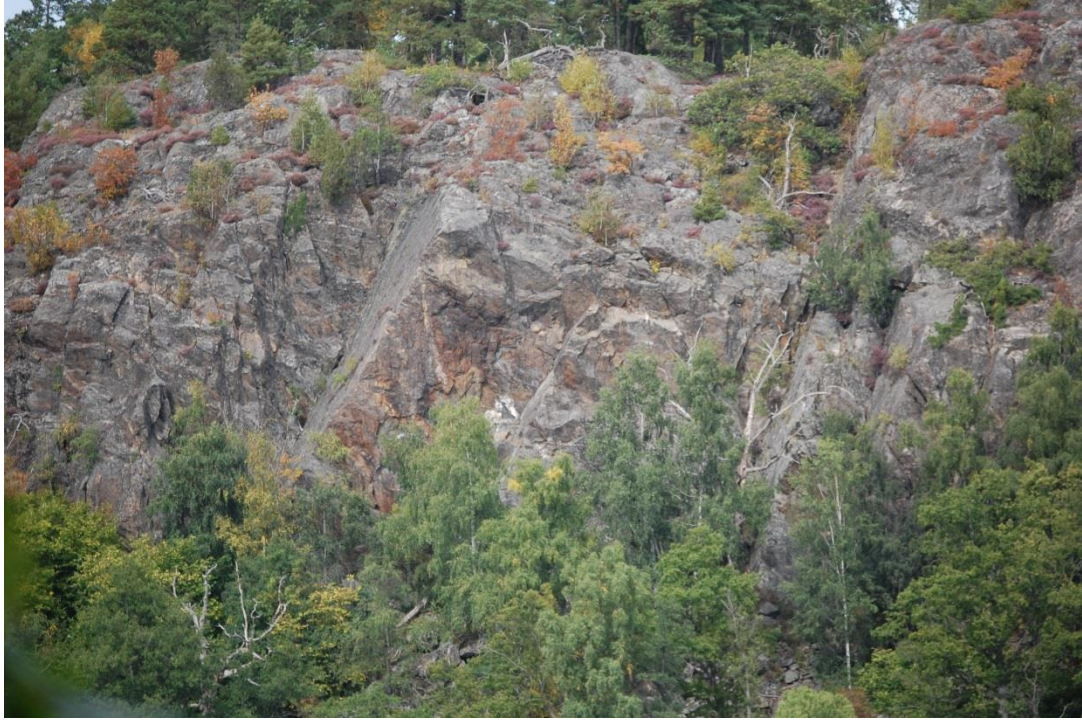
Conf. Level (C, P, S, X):		Stor yta på Kungshatt
Weight factor (0 - 9,9):		
Activ. Type (1-3):		
Striae Intensity (0-4):

Kilbildning
~~kan vara~~
 normalt
 i ortostad

gång som inte rört sig

Ingen striering går att mäta

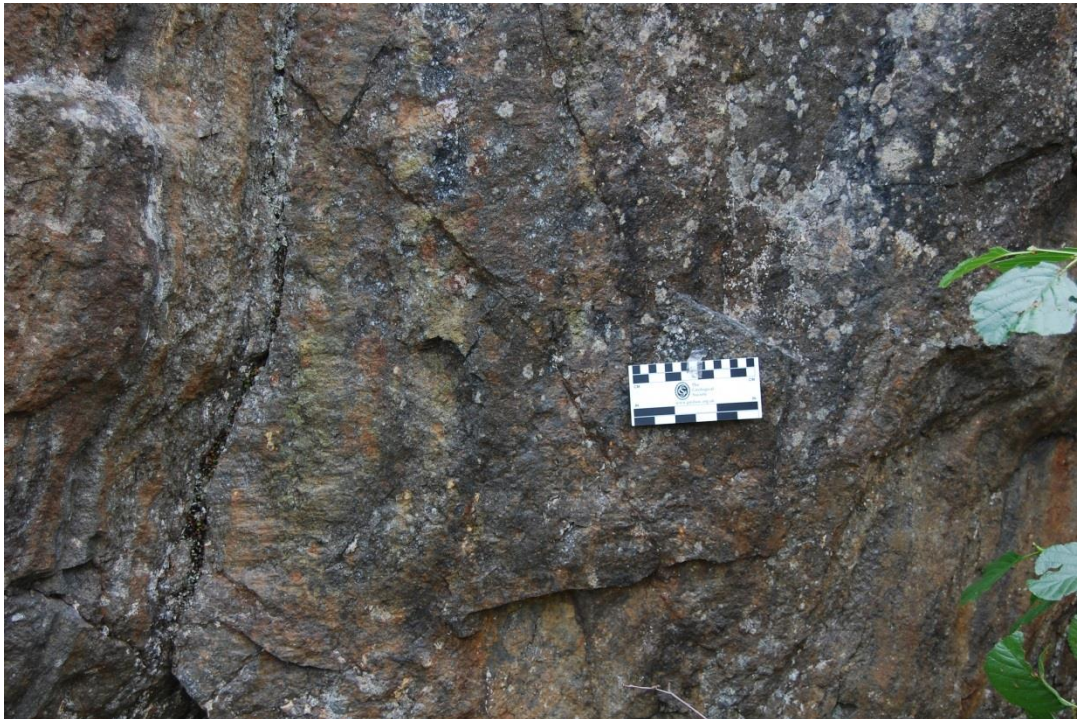
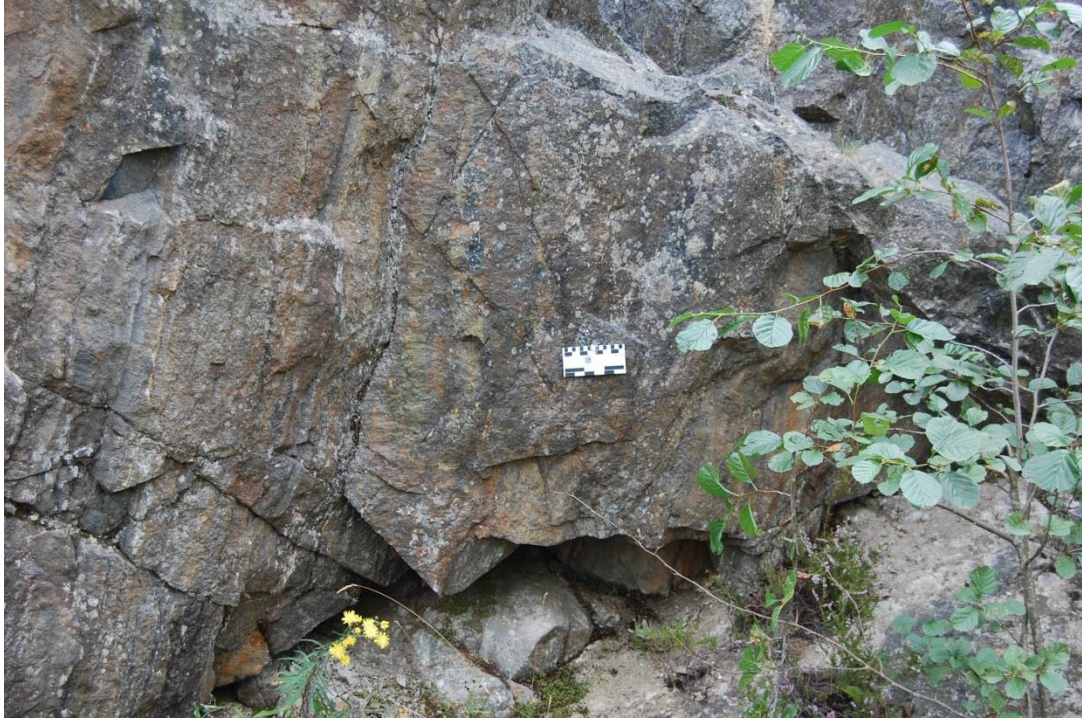
03006

Rock type:	Gnejs
Fracture ID:	0306
Location:	
Fracture plane type:	
Fracture strike:	50°
Fracture dip:	90°
Rake of slip line:

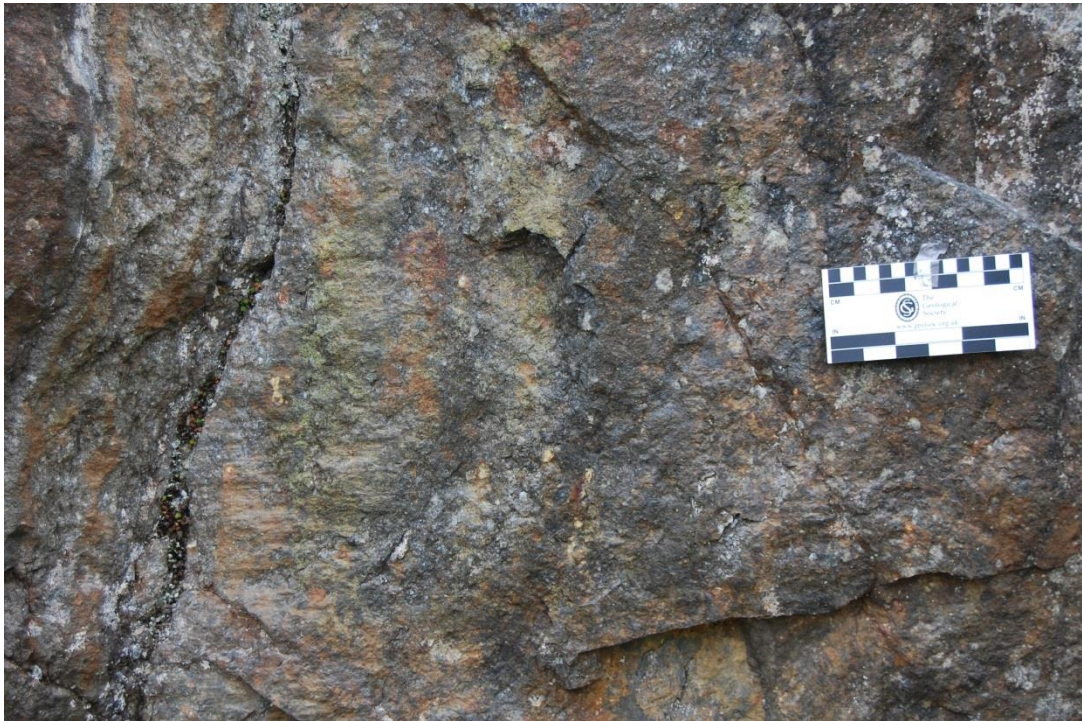
Conf. Level (C, P, S, X):	P	Horisontell rörelse på vertikalyta
Weight factor (0 - 9,9):		
Activ. Type (1-3):		
Striae Intensity (0-4):

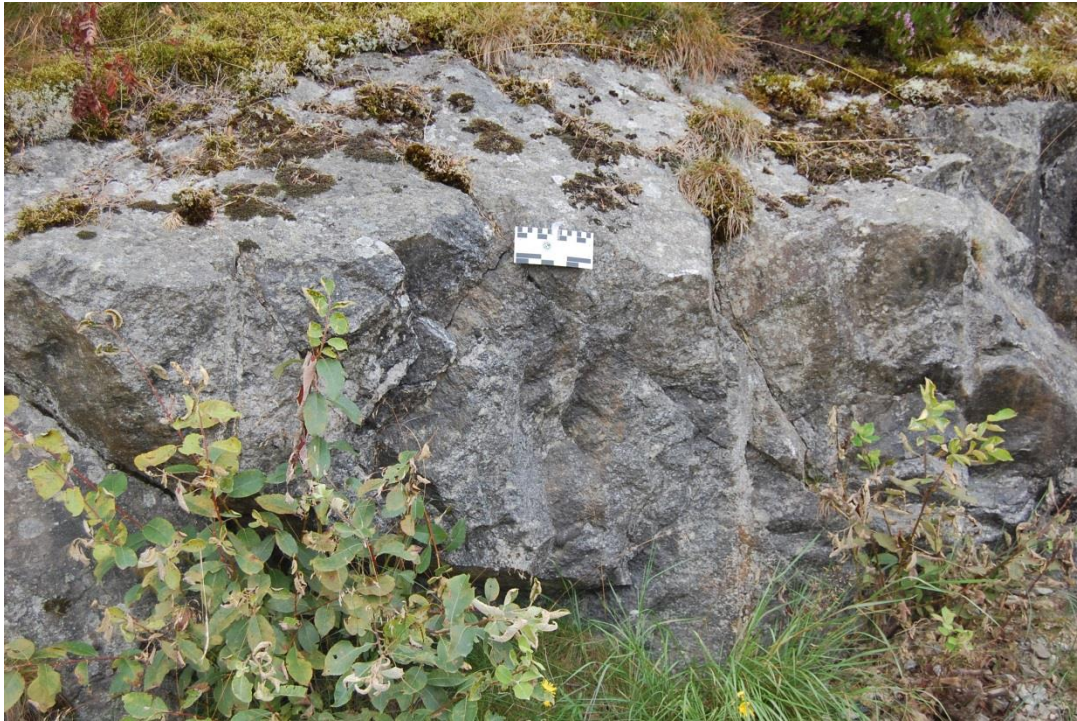
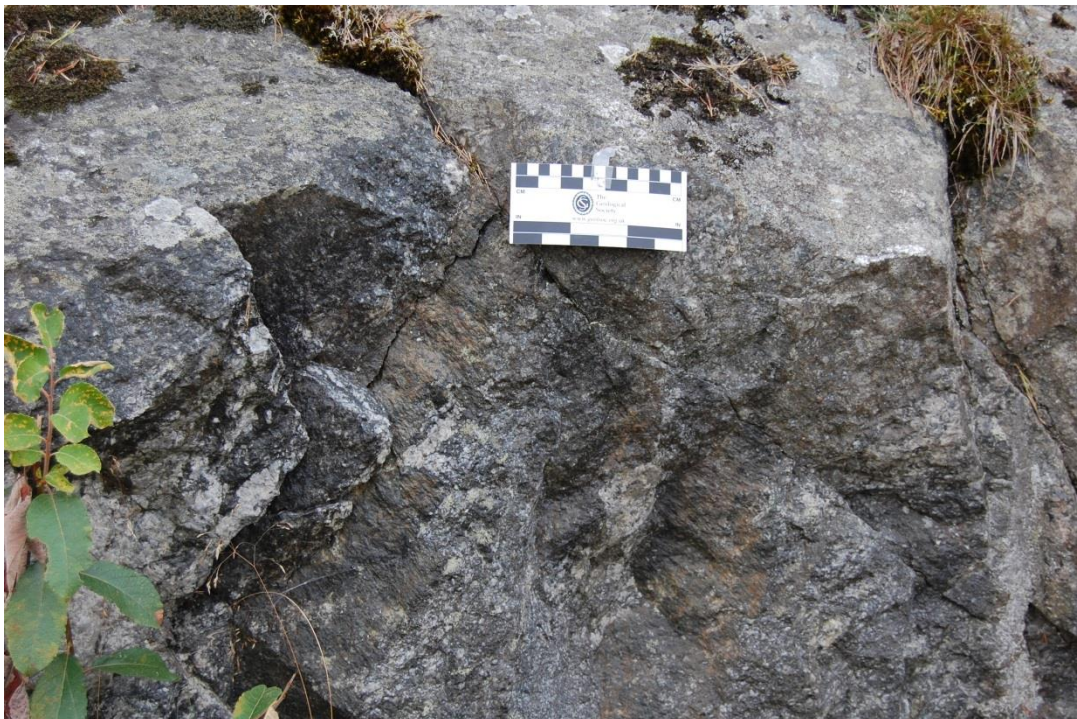
03007

Rock type:	
Fracture ID:	0307
Location:	
Fracture plane type:	
Fracture strike:	260
Fracture dip:	80°
Rake of slip line:

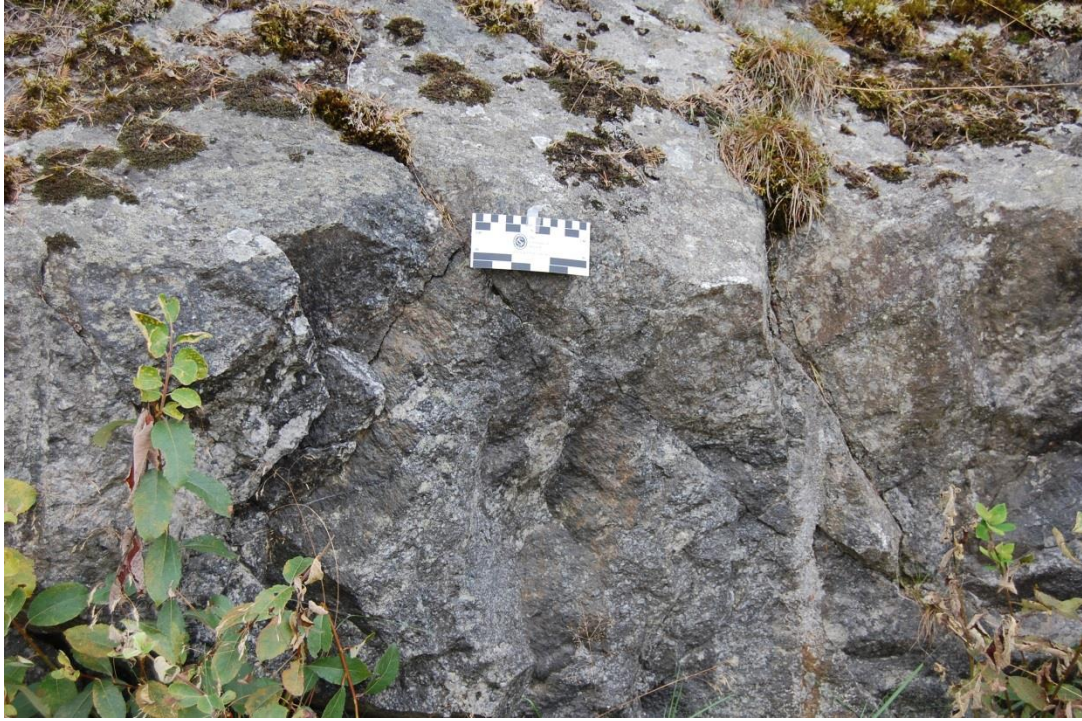
Conf. Level (C, P, S, X):	P	Tydlig yta två stycken
Weight factor (0 - 9,9):		
Activ. Type (1-3):		
Striae Intensity (0-4):
