Karteringsblad för sprickor med rörelseindikationer

Project:	BeFo 369		
Site ID:	Hasselby (01)	Site name:	Hasselby
Geologist (s):	Ann & Yanling	Field date:	2015 08

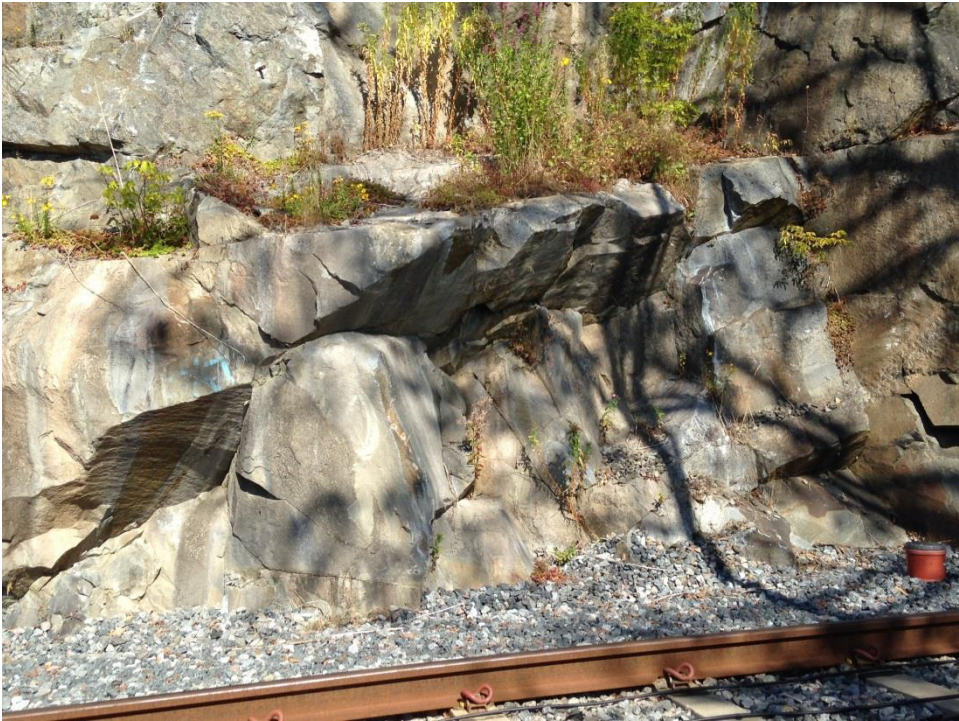
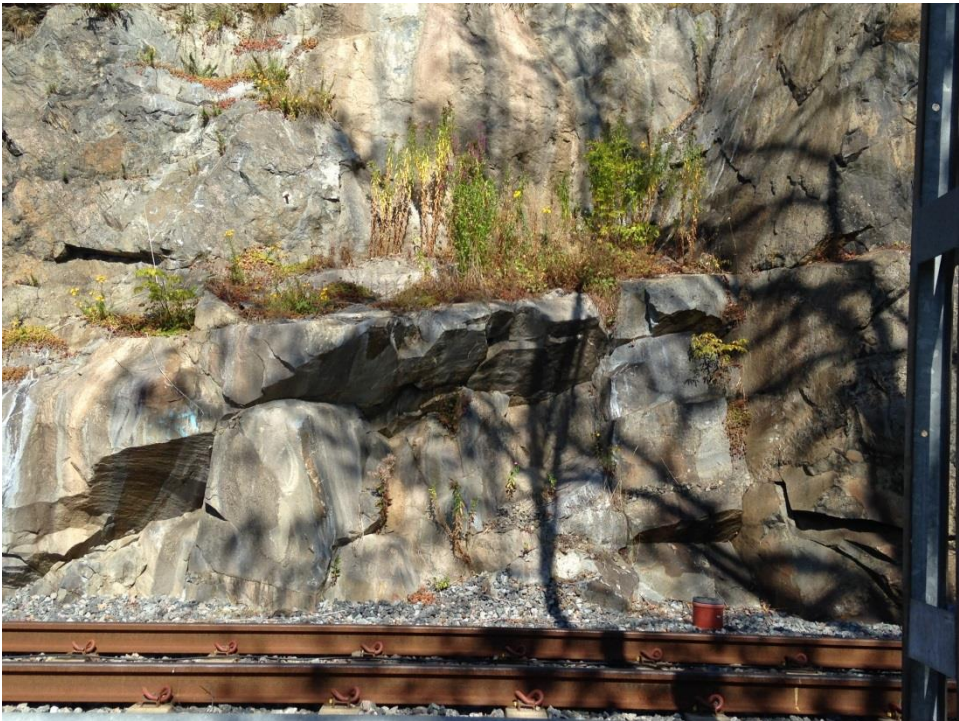
Rock type:	Gnejs
Fracture ID:	07001
Location:	Lidingö Y
Fracture plane type:	linear stria
Fracture strike:	272
Fracture dip:	40
Rake of slip line:

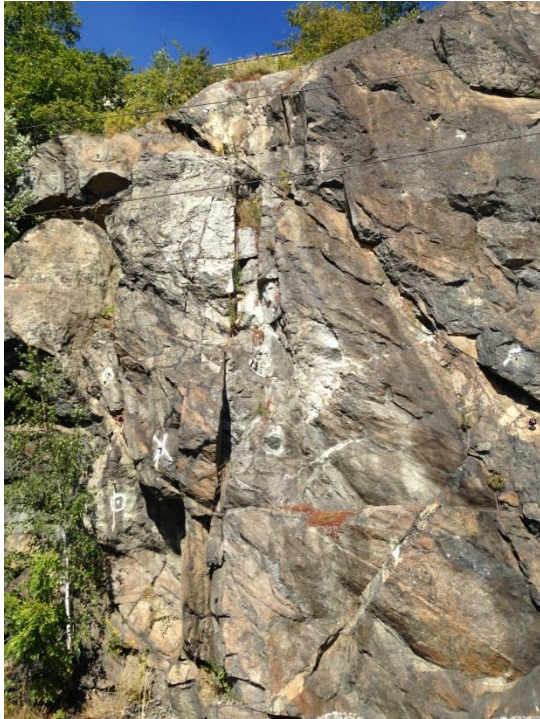
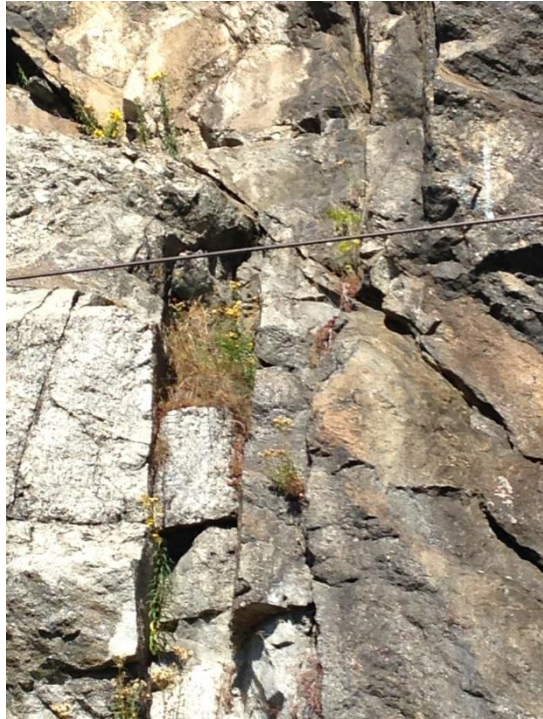
07002

Rock type:	Gnejs
Fracture ID:	002
Location:	Lidingö ✓
Fracture plane type:	Fault
Fracture strike:	0°
Fracture dip:	46
Rake of slip line:	—

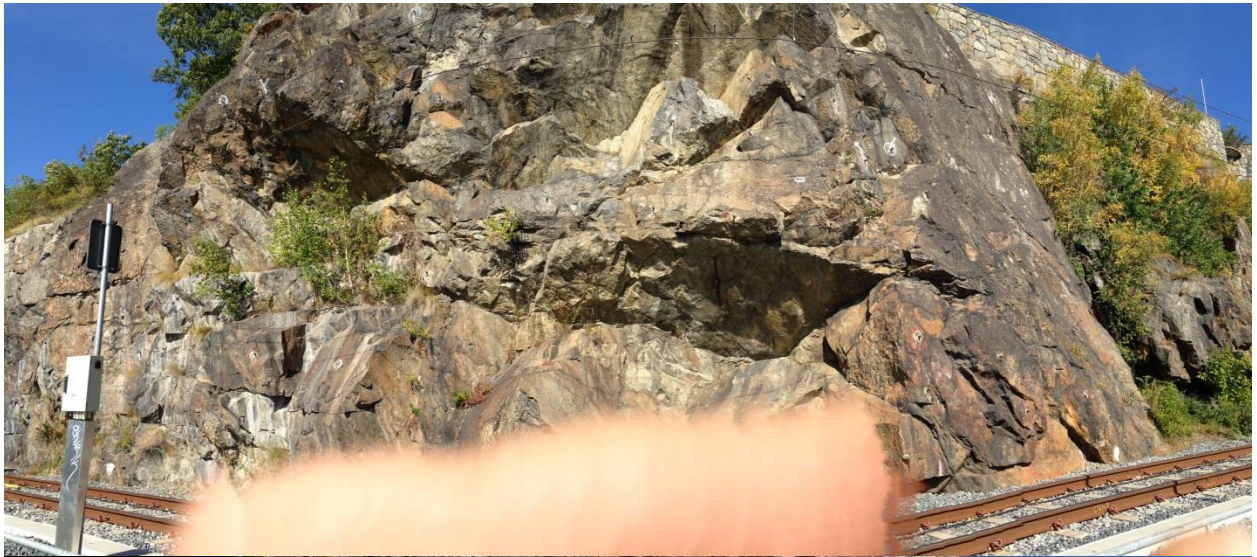
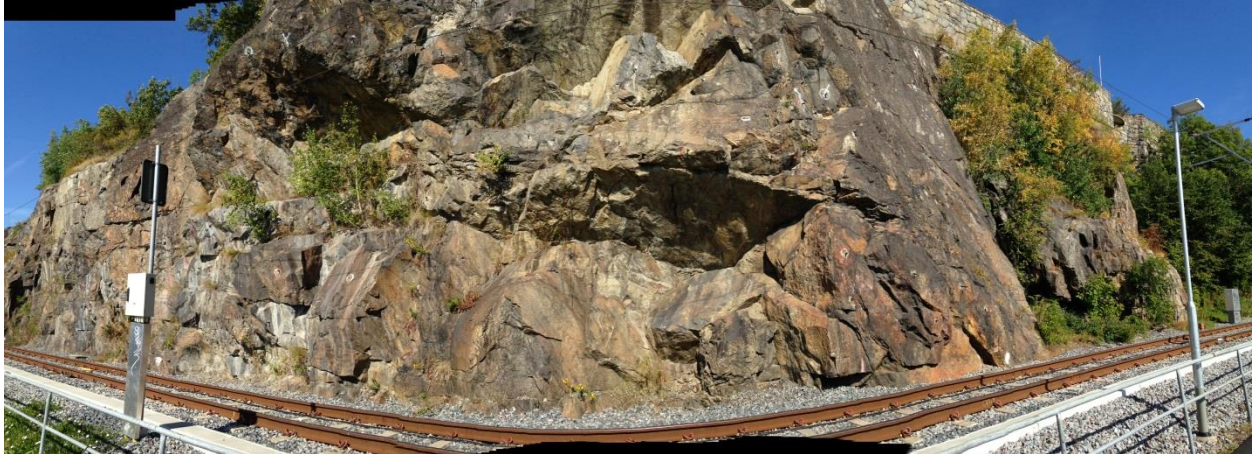
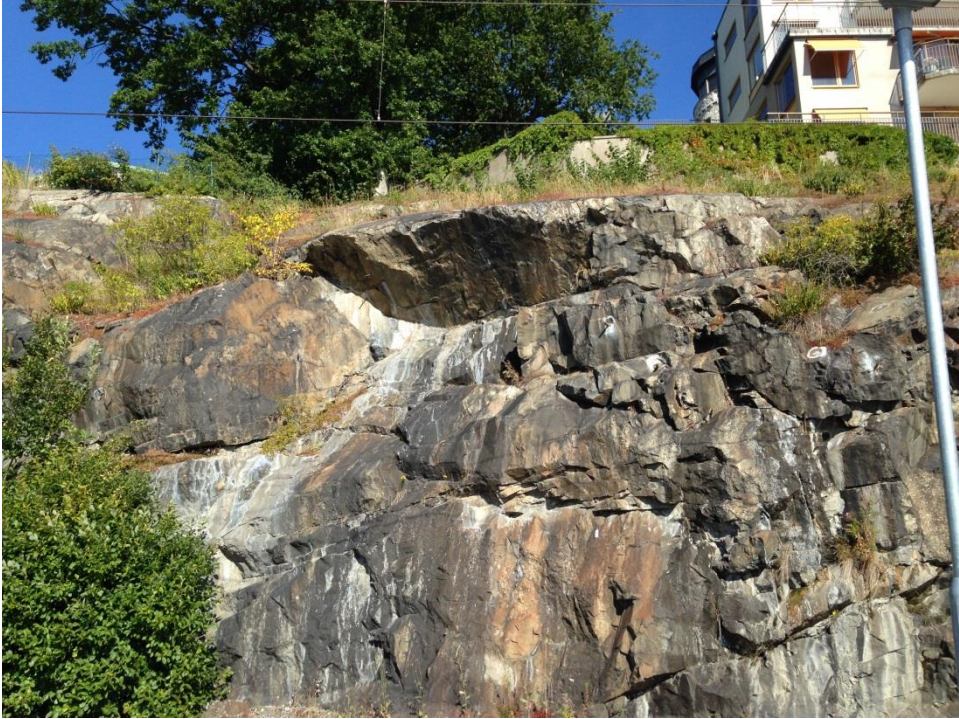
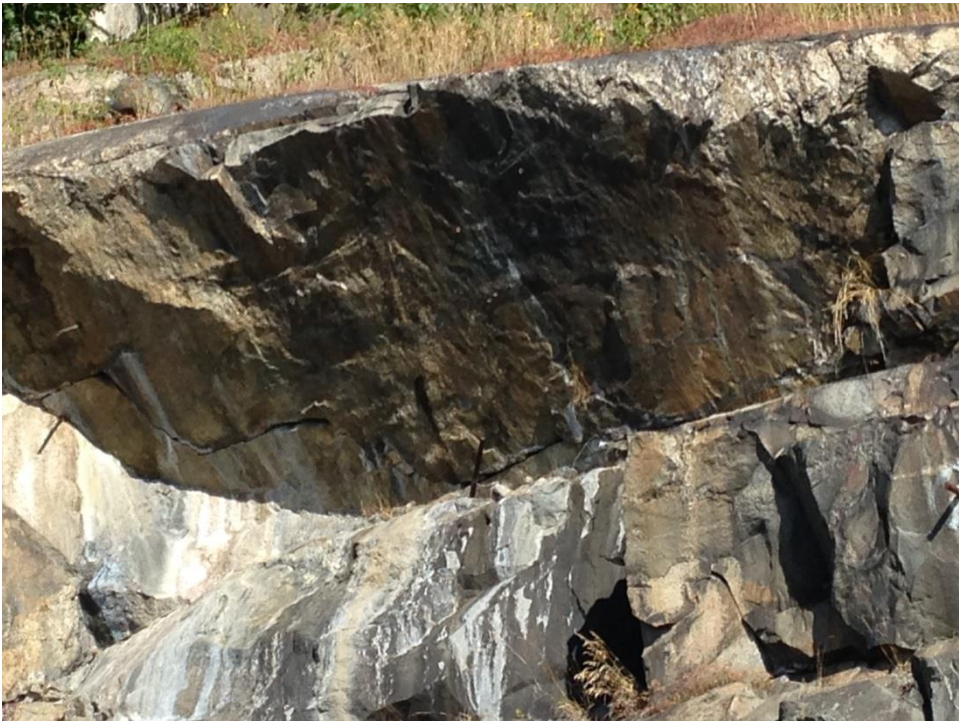
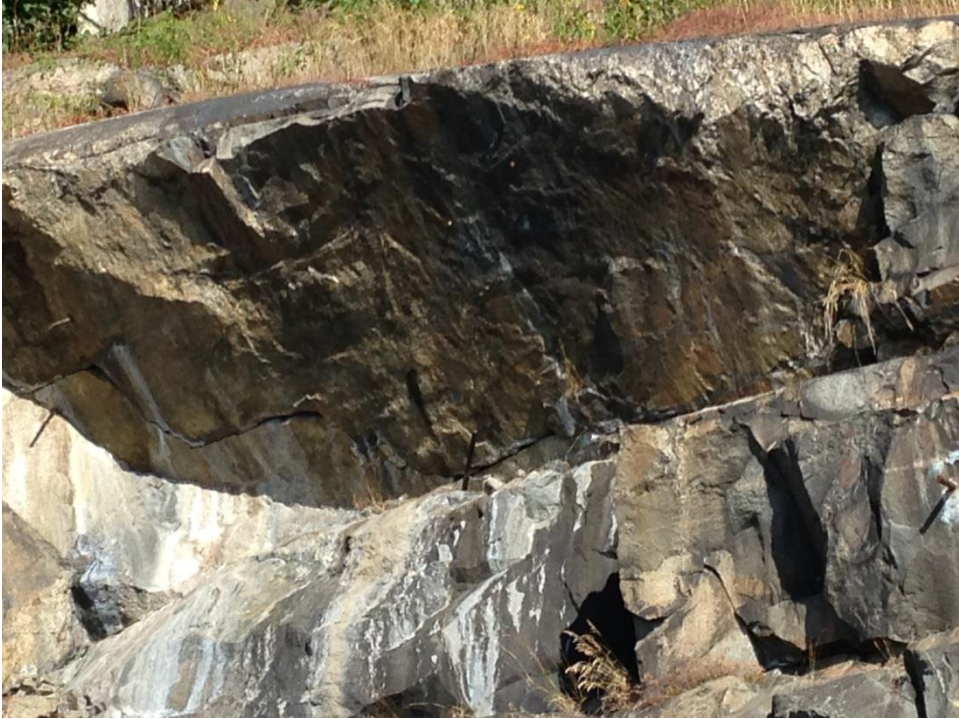
07003

Rock type:	Granit
Fracture ID:	003
Location:	Lidingsö ✓
Fracture plane type:	
Fracture strike:	0
Fracture dip:	59°
Rake of slip line:	90

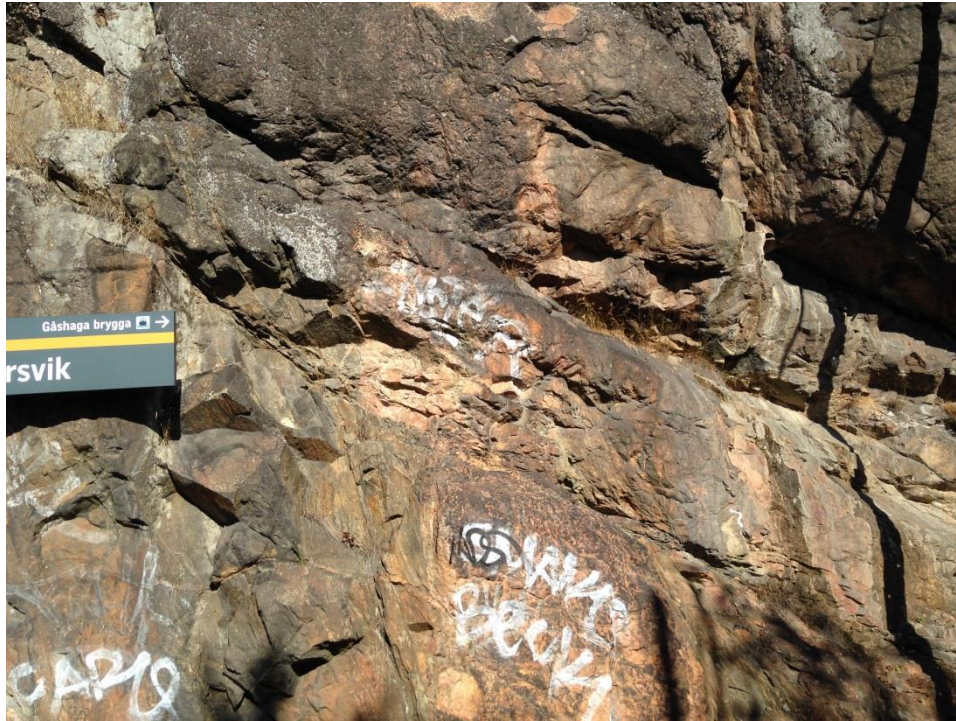
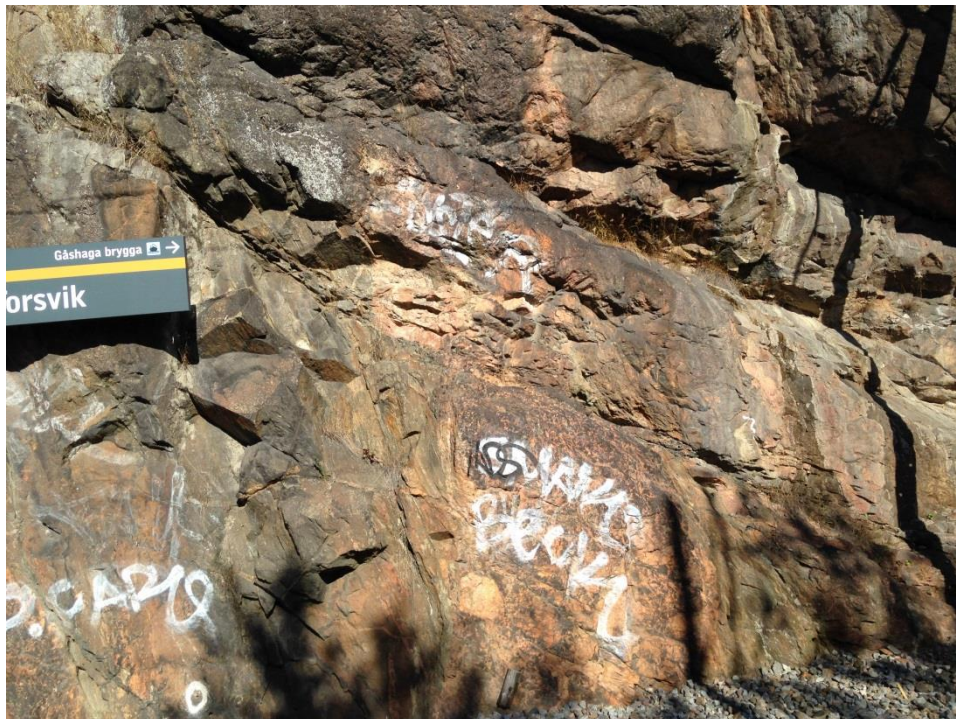
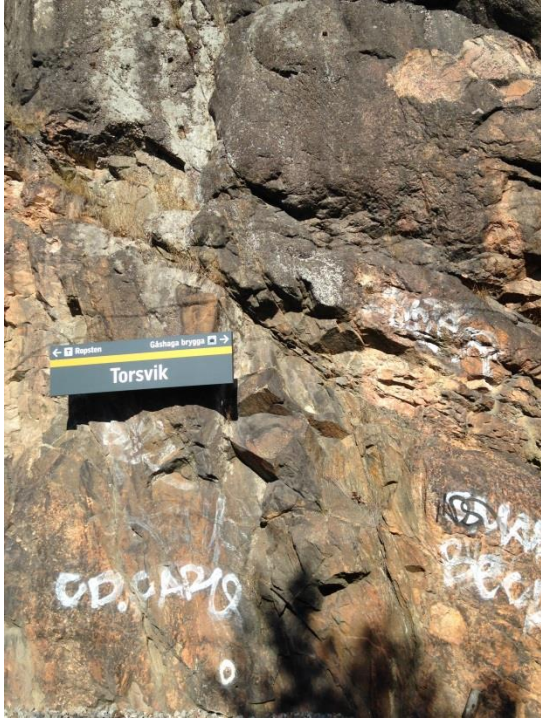
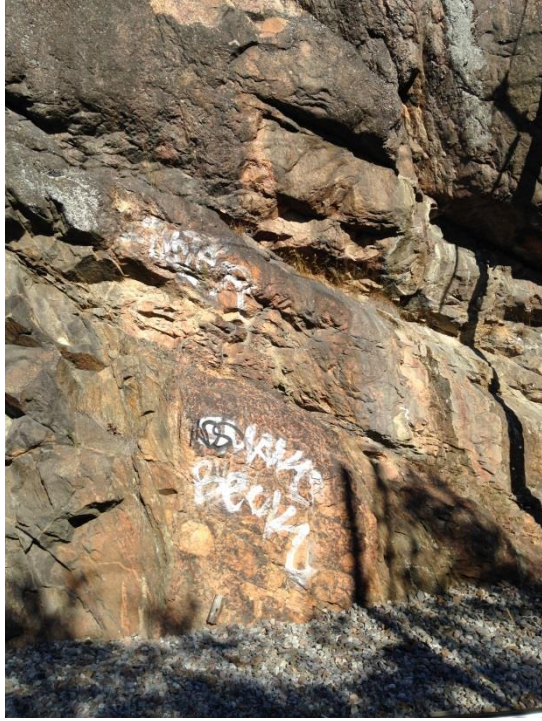
07004

Rock type:	rosa granitisk grejs
Fracture ID:	004
Location:	Lidingö V
Fracture plane type:	
Fracture strike:	20
Fracture dip:	30
Rake of slip line:

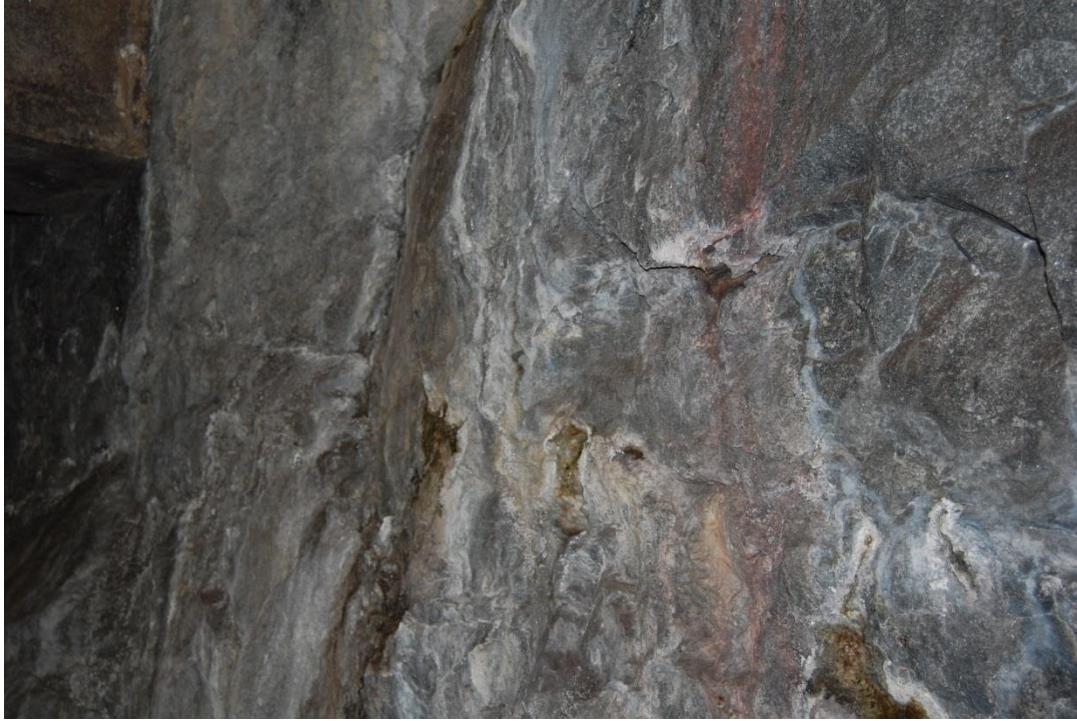
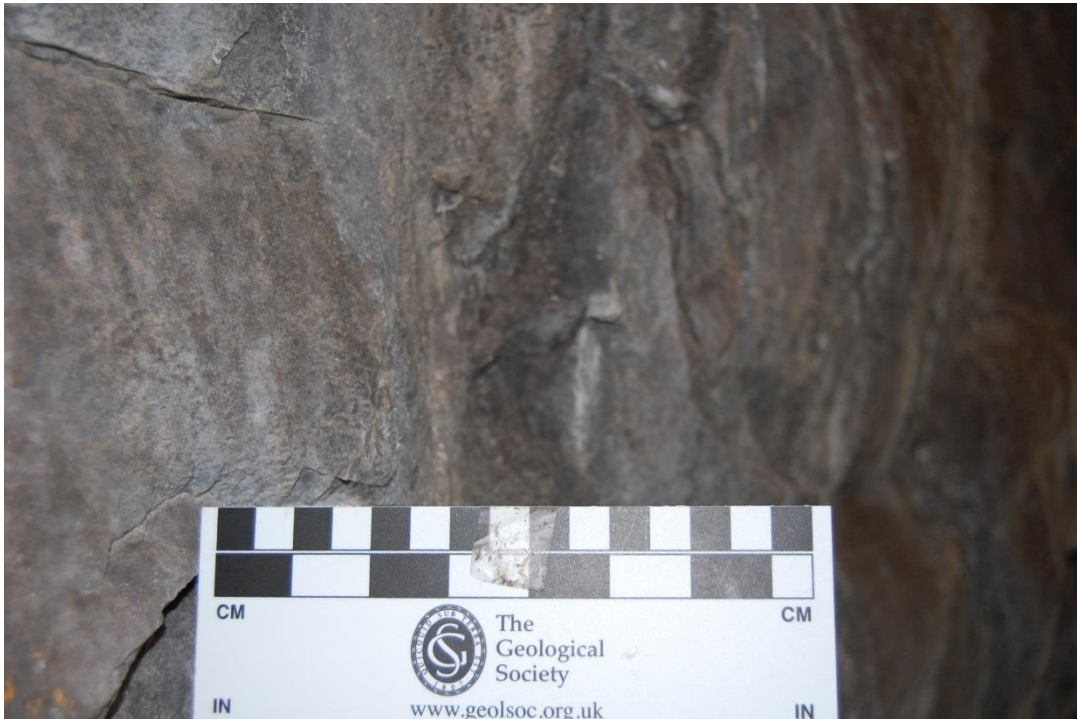
Rock type:	Gnejs
Fracture ID:	09001
Location:	
Fracture plane type:	1
Fracture strike:	22 22
Fracture dip:	70
Rake of slip line:	horizontal horizontal (01)

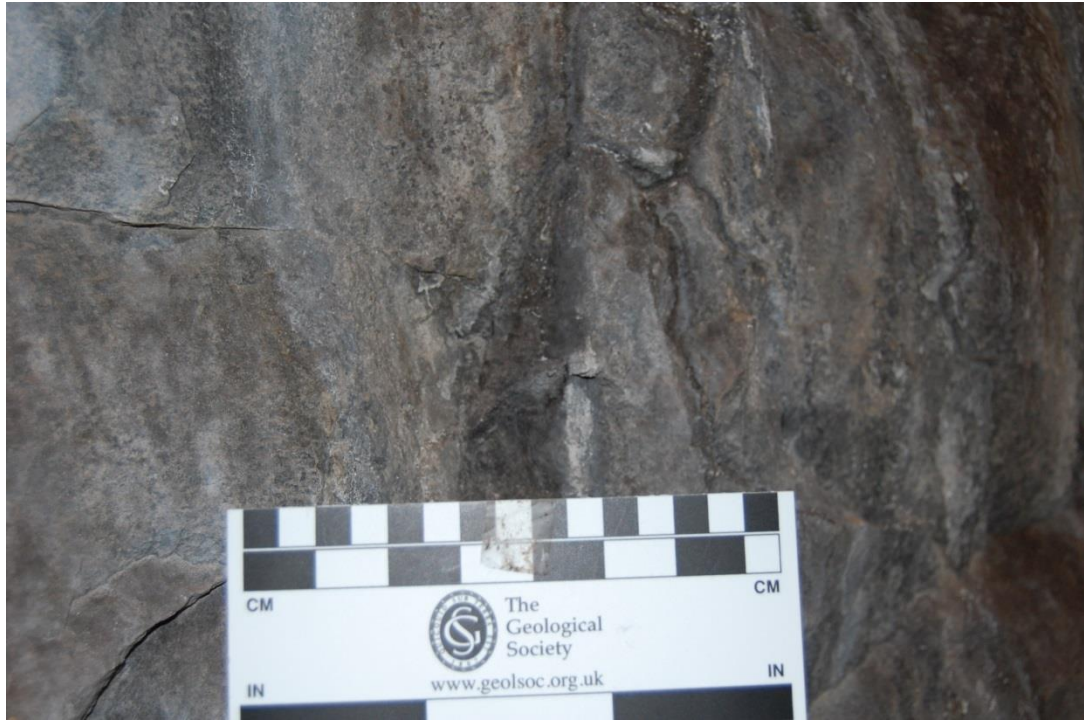
Conf. Level (C, P, S, X):	S (X)	Very small surface
Weight factor (0 - 9,9):	1	
Activ. Type (1-3):	2	
Striae Intensity (0-4):	2

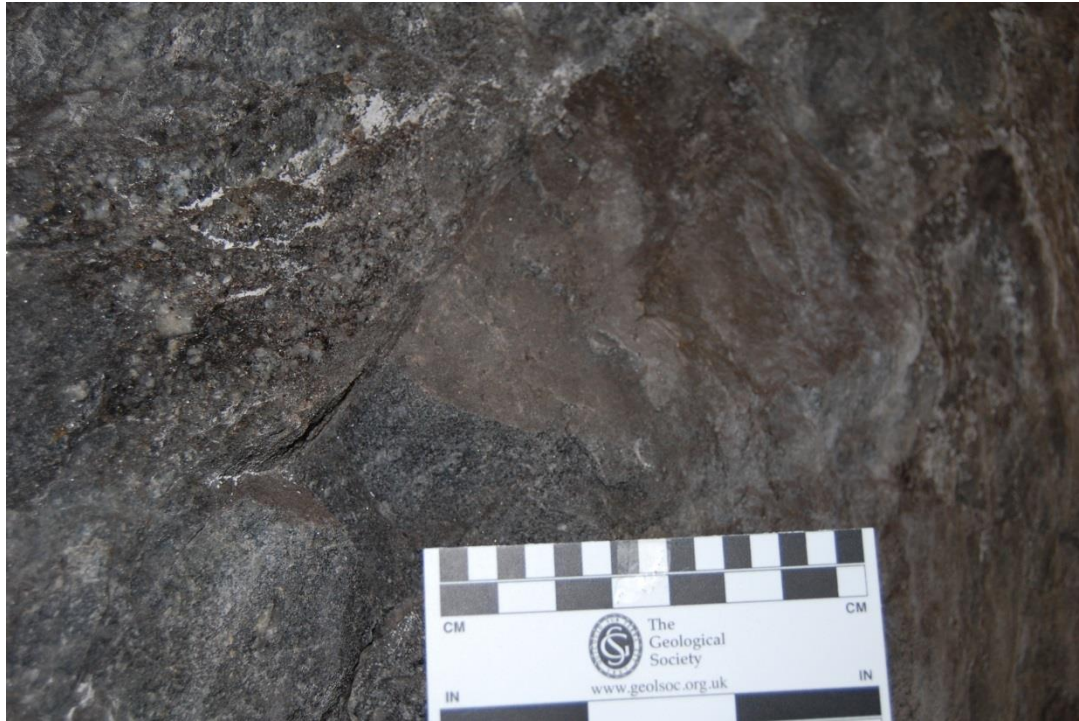
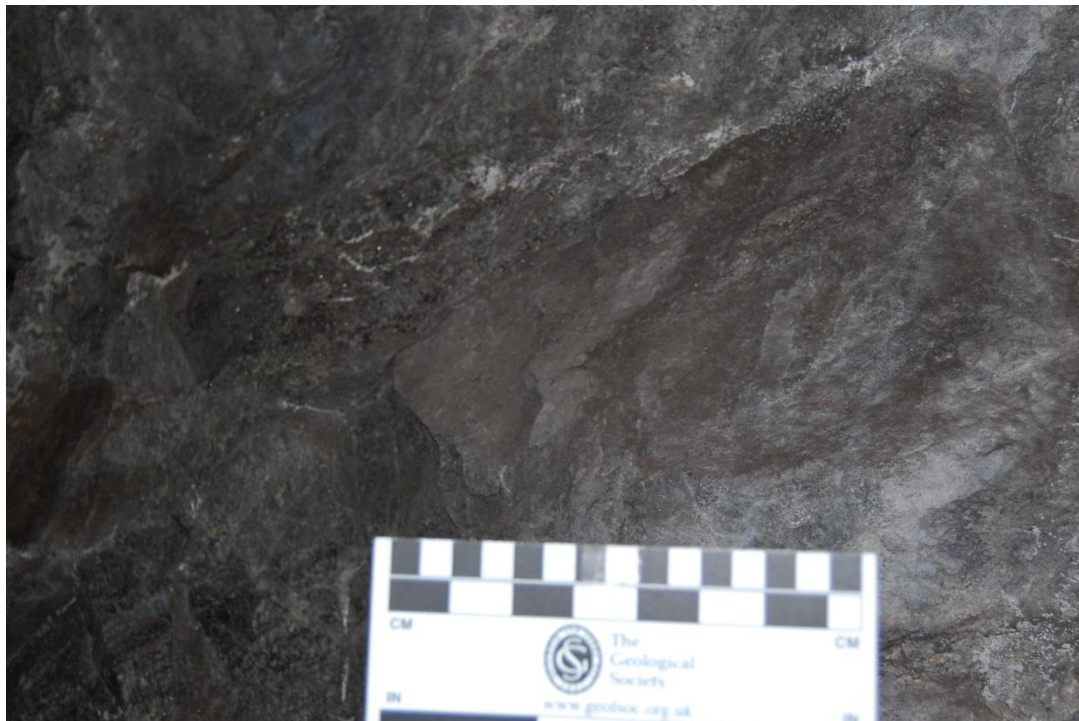
09002

Rock type:	GNEjs
Fracture ID:	D9802
Location:	
Fracture plane type:	1
Fracture strike:	288
Fracture dip:	62
Rake of slip line:	084/35

Conf. Level (C, P, S, X):	S (X)	Väldigt osäker
Weight factor (0 - 9,9):	1	
Activ. Type (1-3):	2	
Striae Intensity (0-4):

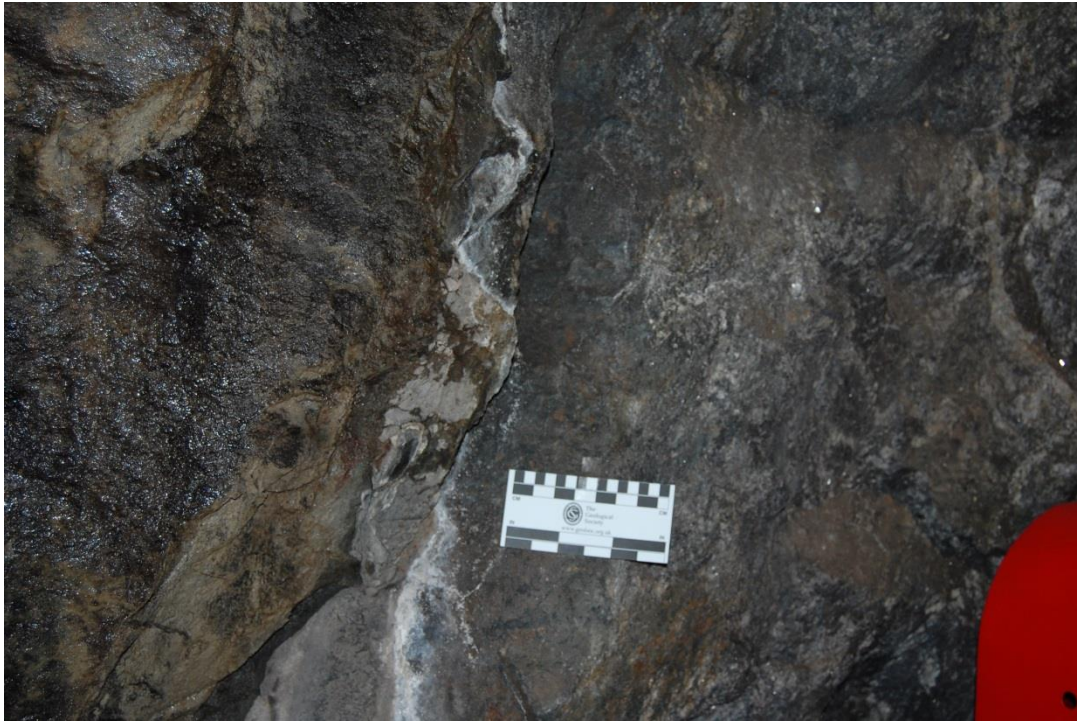
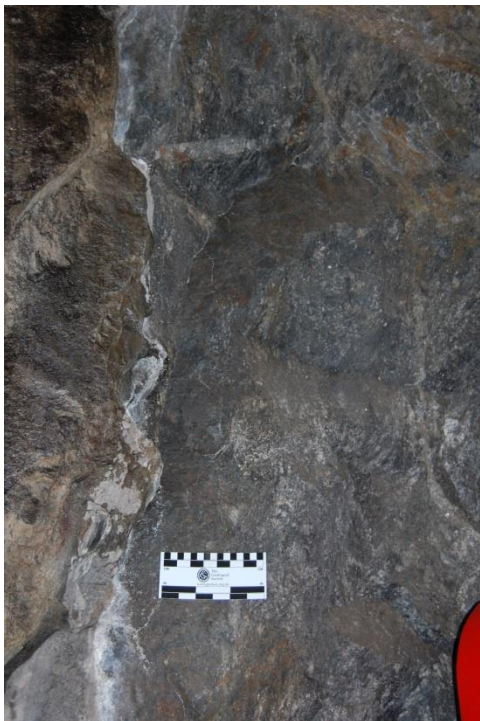
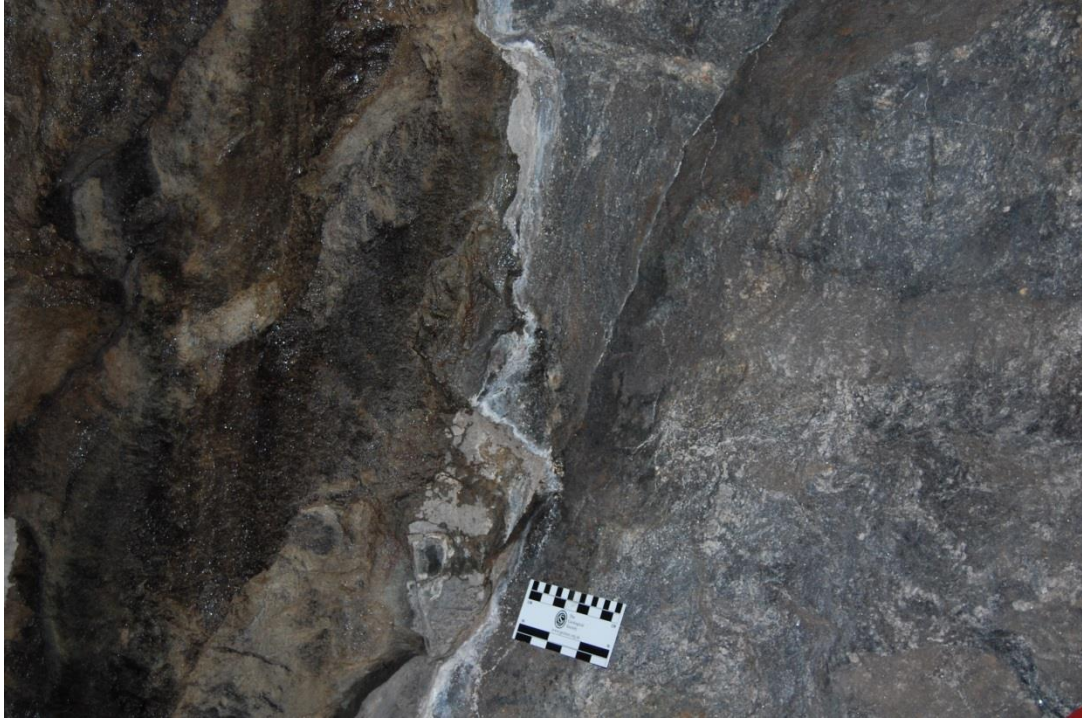
09003

Rock type:	Gneis
Fracture ID:	09-03
Location:	
Fracture plane type:	
Fracture strike:	0°
Fracture dip:	70°
Rake of slip line:	0°

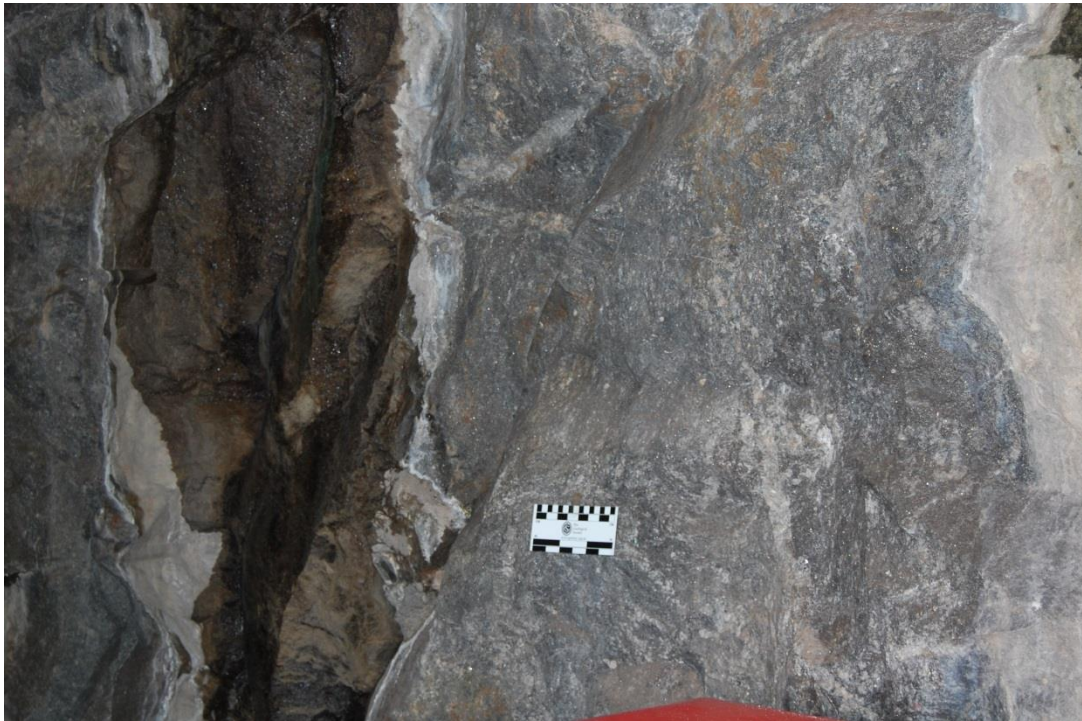
Conf. Level (C, P, S, X):	C	Sinistral
Weight factor (0 - 9,9):		
Activ. Type (1-3):		
Striae Intensity (0-4):

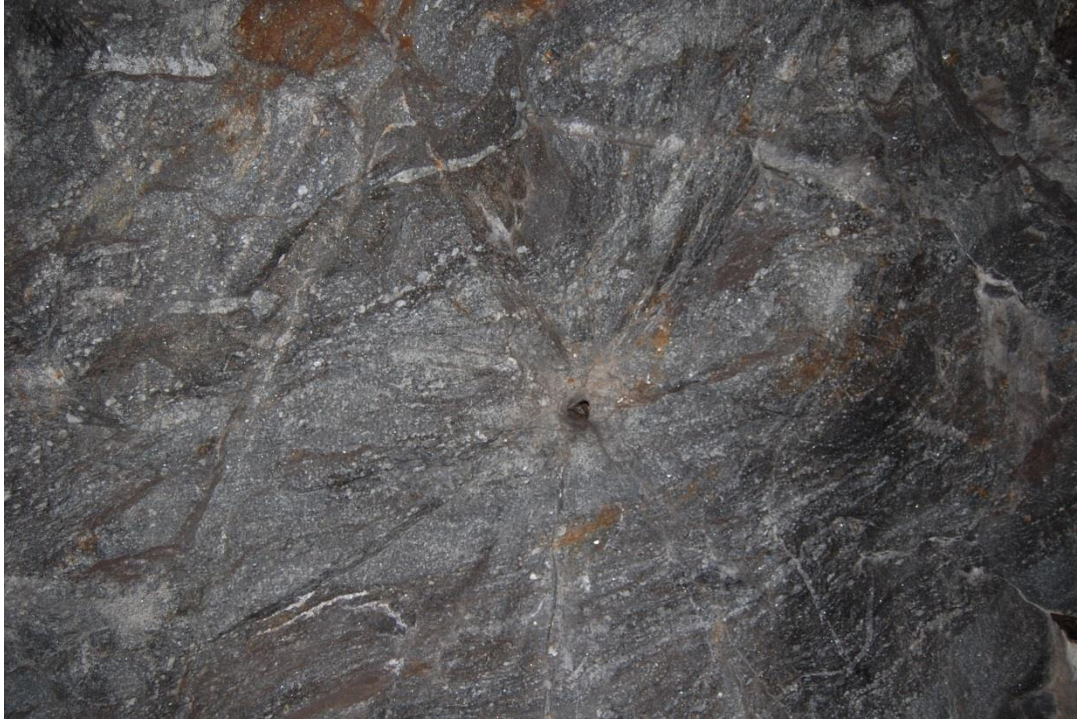
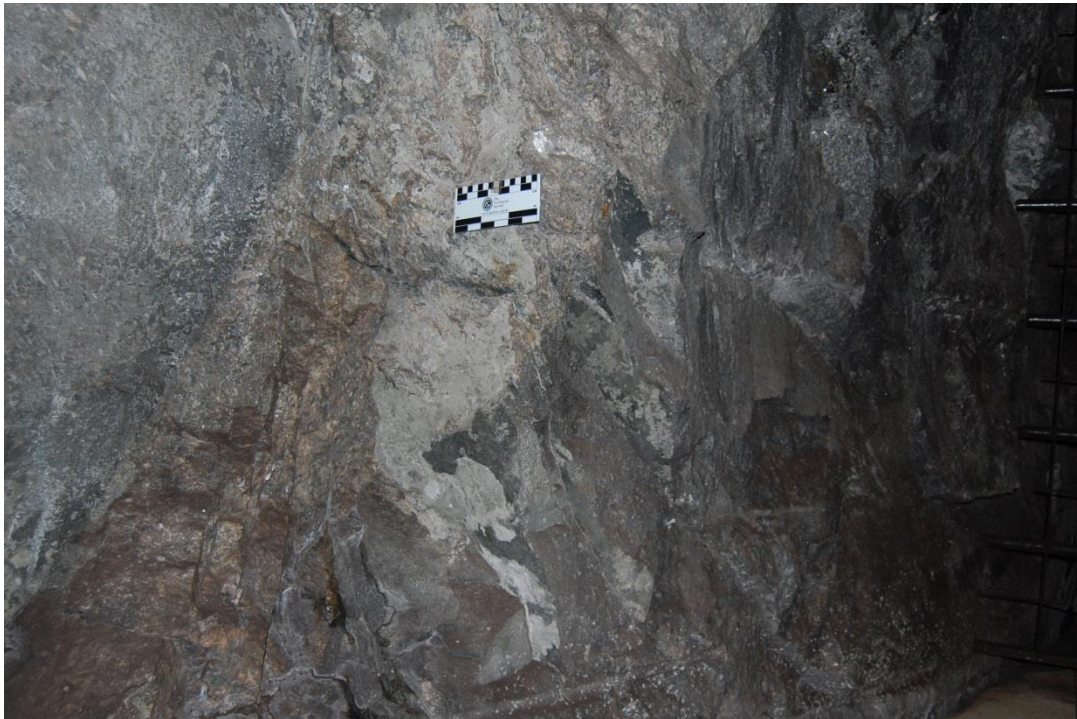
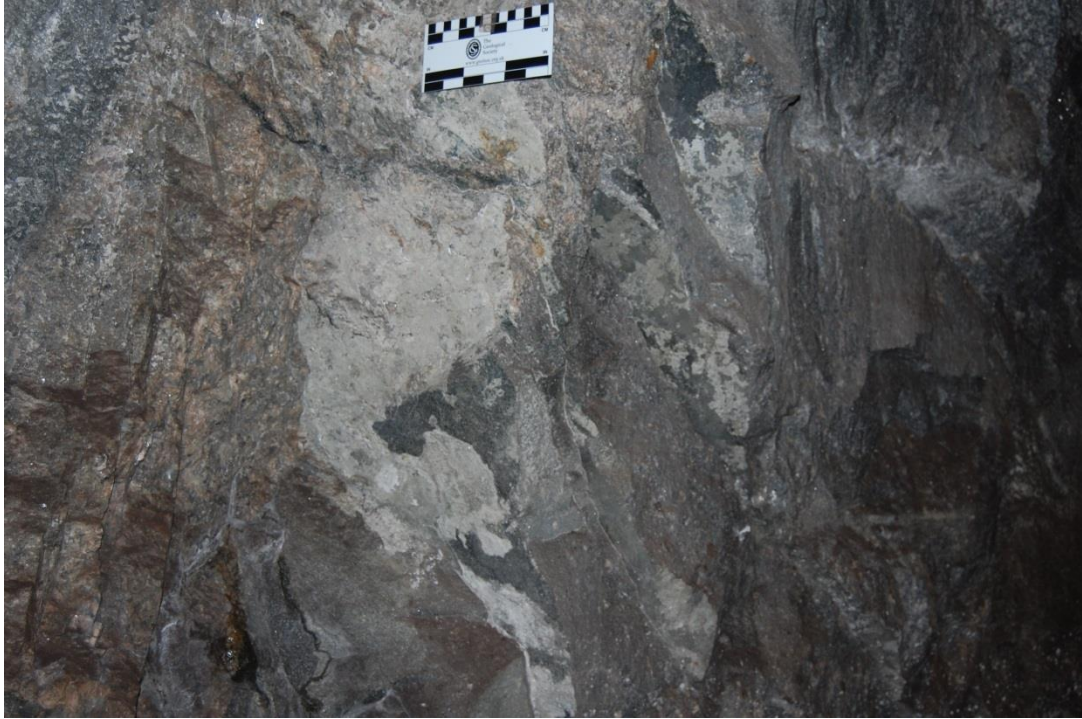
09004

Rock type:	Gnejs + pegmatit
Fracture ID:	04
Location:	NV änden av grottan
Fracture plane type:	
Fracture strike:	320
Fracture dip:	56
Rake of slip line:

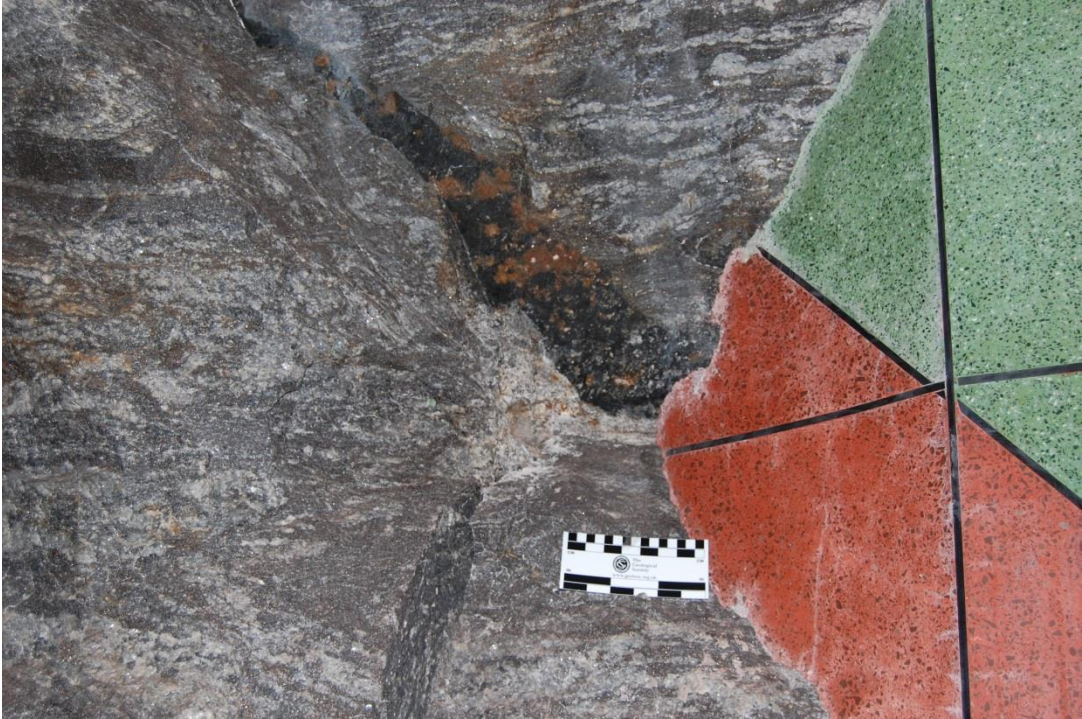
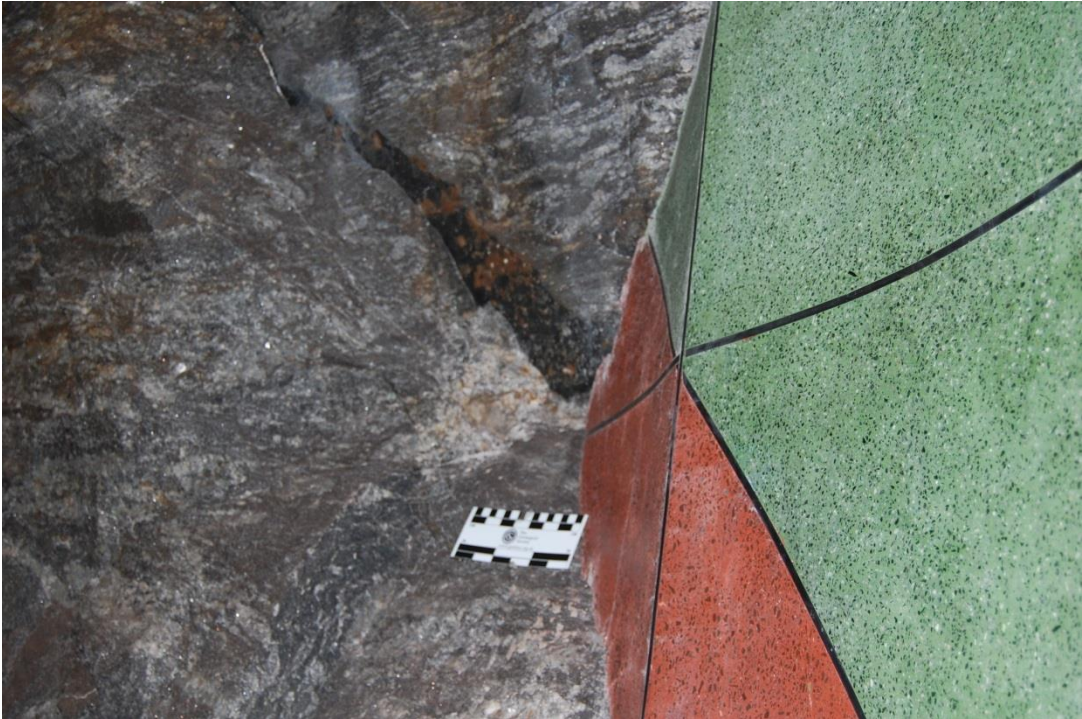
09005

Rock type:	Gnejs
Fracture ID:	05
Location:	
Fracture plane type:	1
Fracture strike:	310
Fracture dip:	55
Rake of slip line:	45 30

Conf. Level (C, P, S, X):	P	Sprickemin. hematit ?
Weight factor (0 - 9,9):		
Activ. Type (1-3):		
Striae Intensity (0-4):

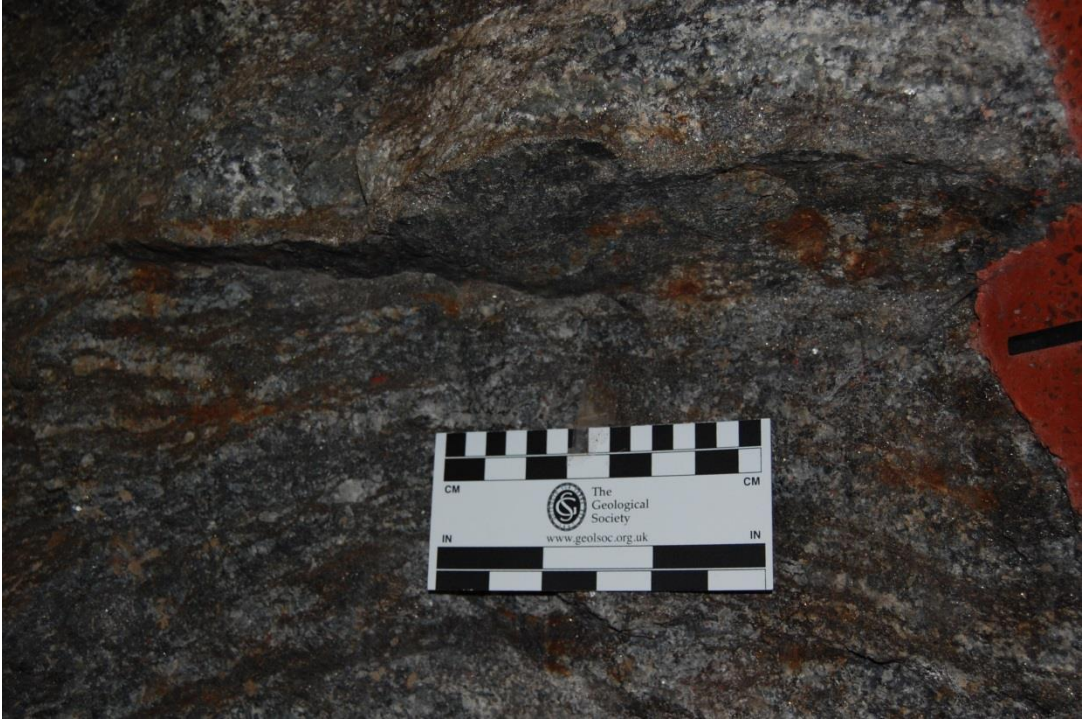
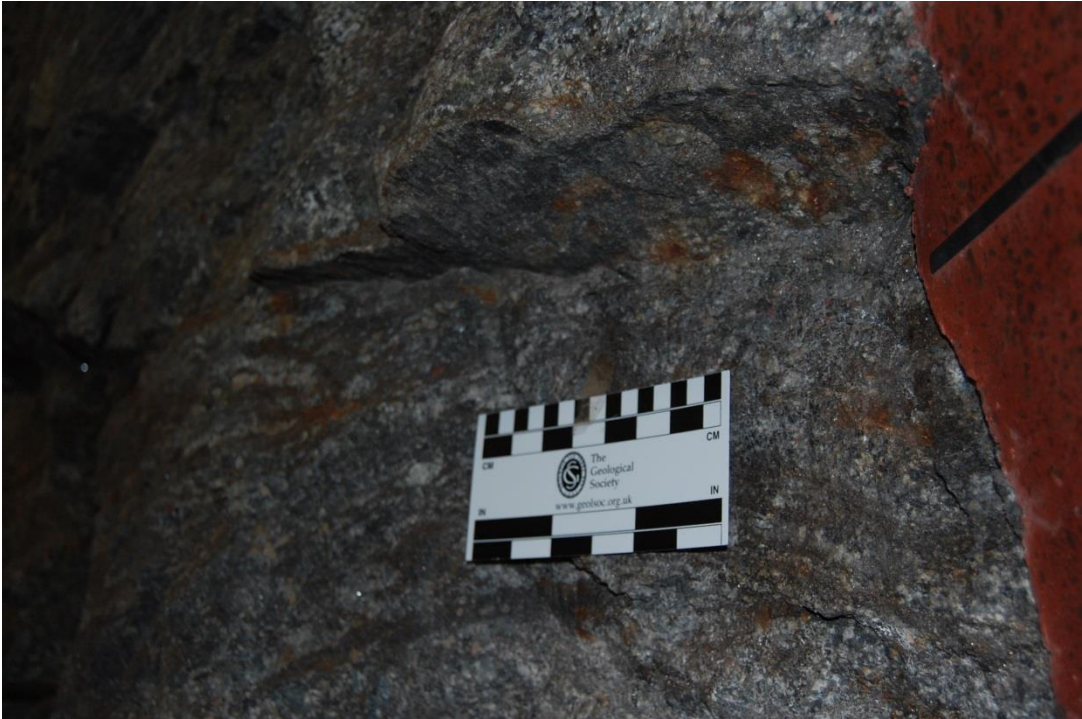
09006

Rock type:	Gnejs
Fracture ID:	06
Location:	
Fracture plane type:	1
Fracture strike:	350
Fracture dip:	25
Rake of slip line:	77/25 bakåt \Rightarrow 101/25

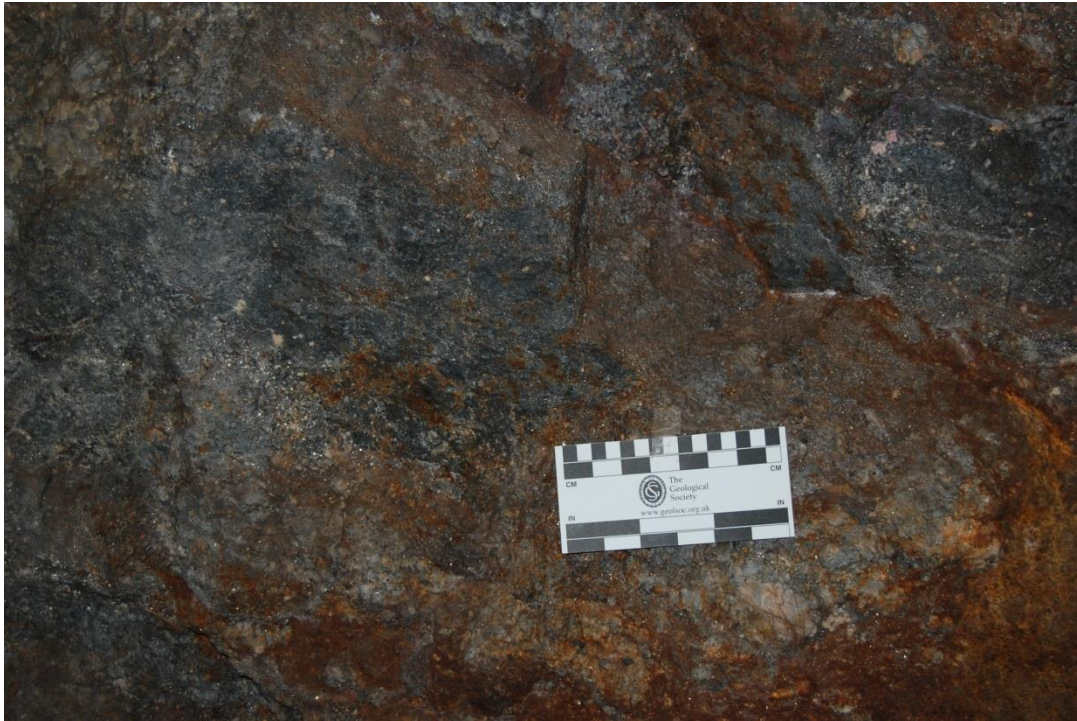
09007

Rock type:	Pegmatit i Gnejs
Fracture ID:	07
Location:	
Fracture plane type:	1
Fracture strike:	290
Fracture dip:	70
Rake of slip line:	0

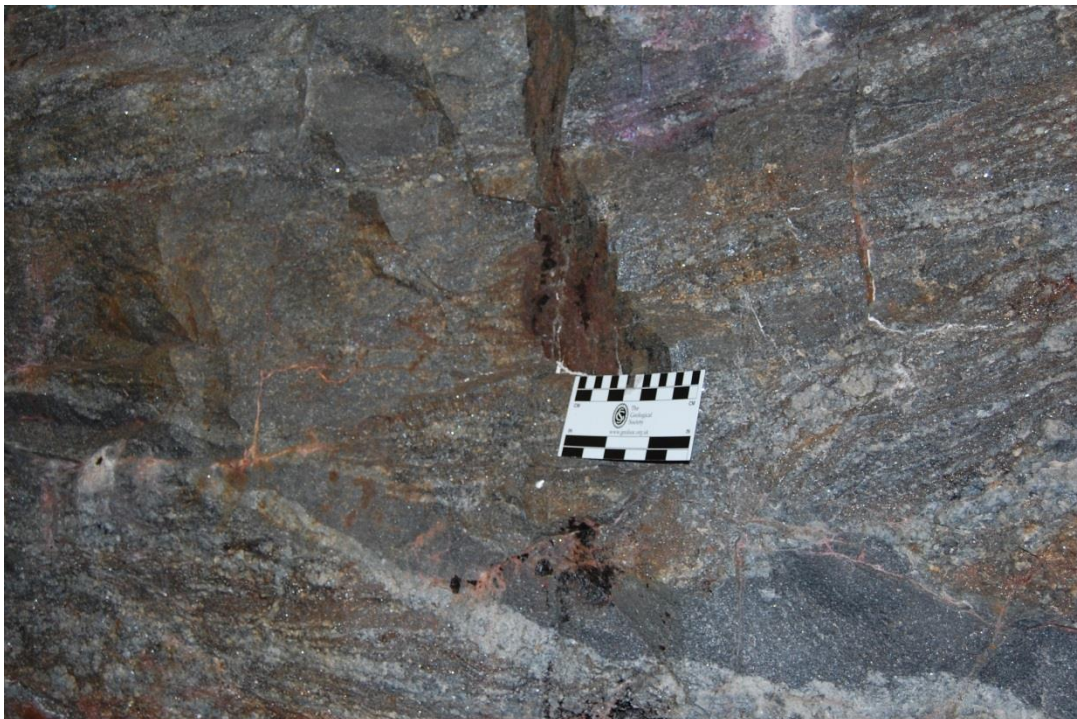
09009

Rock type:	Gnejs
Fracture ID:	009
Location:	
Fracture plane type:	1
Fracture strike:	320
Fracture dip:	65-70
Rake of slip line:	0°

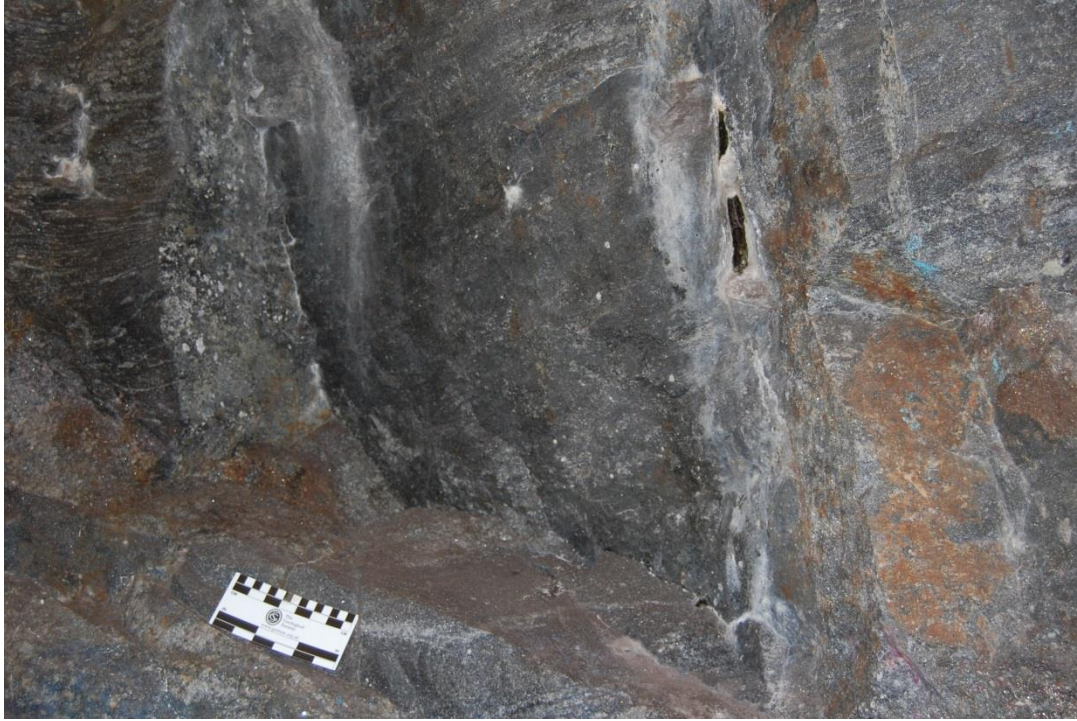
09010

Rock type:	Gnejs
Fracture ID:	010
Location:	
Fracture plane type:	1
Fracture strike:	120
Fracture dip:	24
Rake of slip line:	-105
