Karteringsblad för sprickor med rörelseindikationer

Project:	BeFo 369		
Site ID:	Hasselby (01)	Site name:	Hasselby
Geologist (s):	Ann & Yanling	Field date:	2015 08

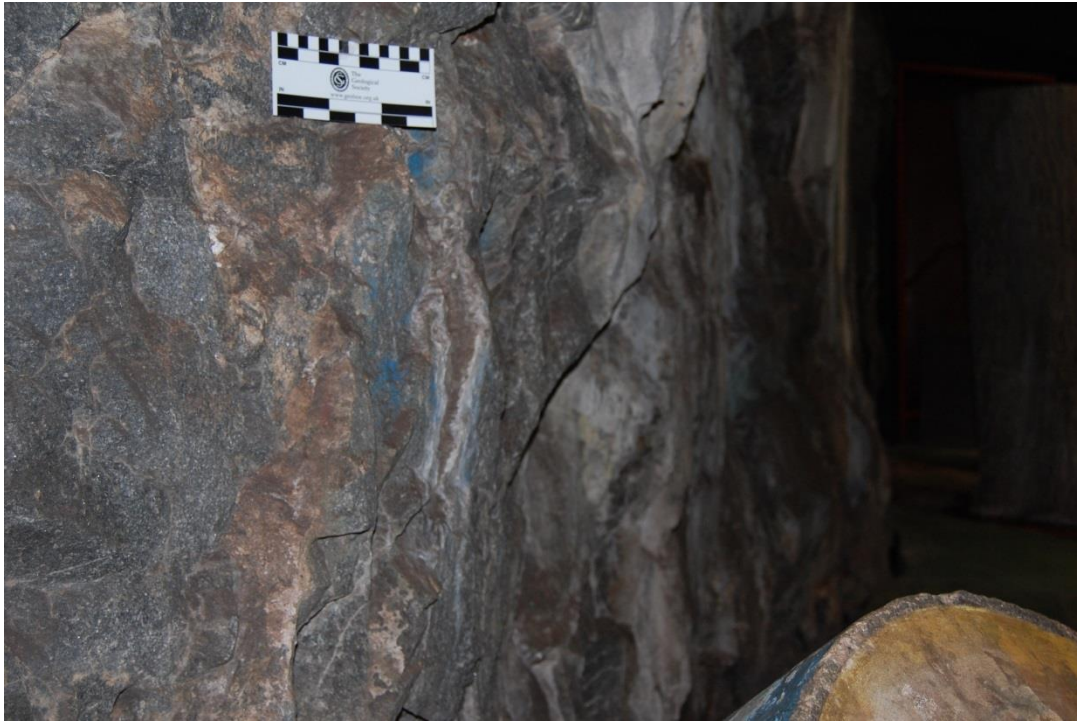
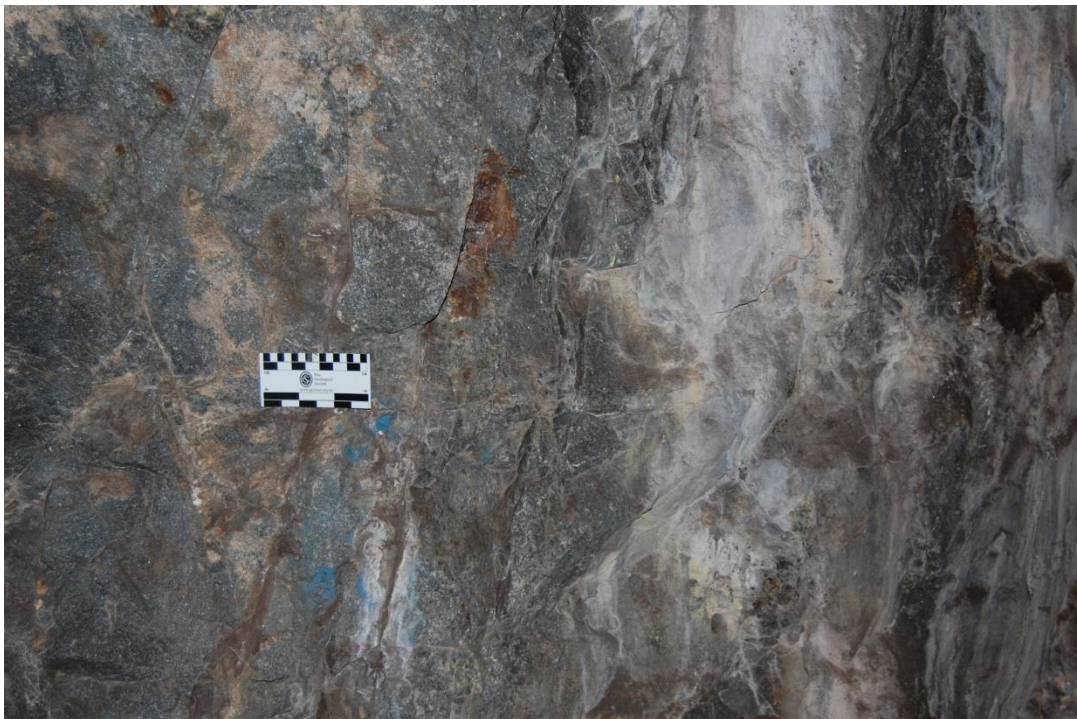
09011

Rock type:	Gnejs
Fracture ID:	011
Location:	
Fracture plane type:	1
Fracture strike:	280
Fracture dip:	75
Rake of slip line:	10

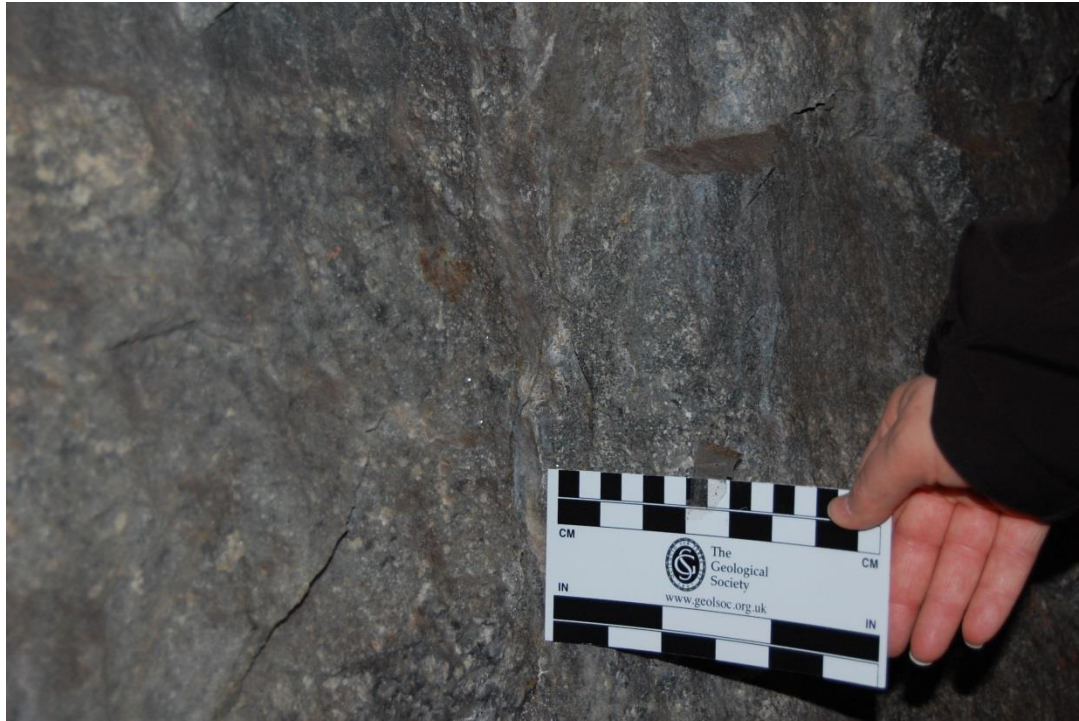
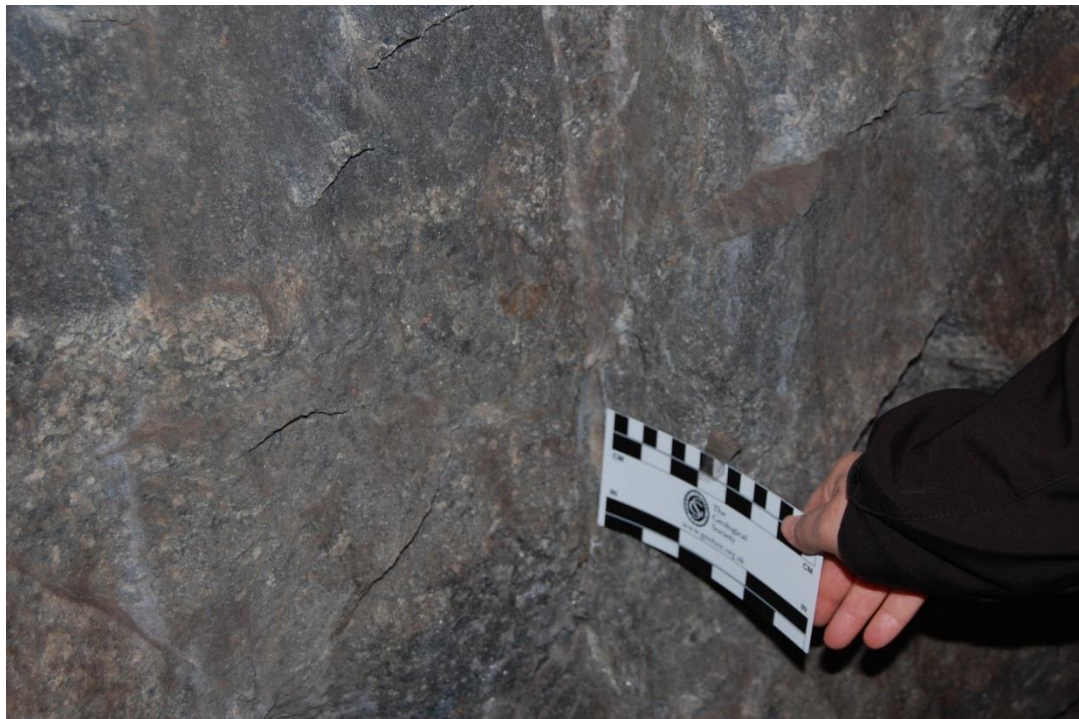
09012

Rock type:	Gnejs
Fracture ID:	012
Location:	
Fracture plane type:	1
Fracture strike:	15
Fracture dip:	90
Rake of slip line:	25 / 90

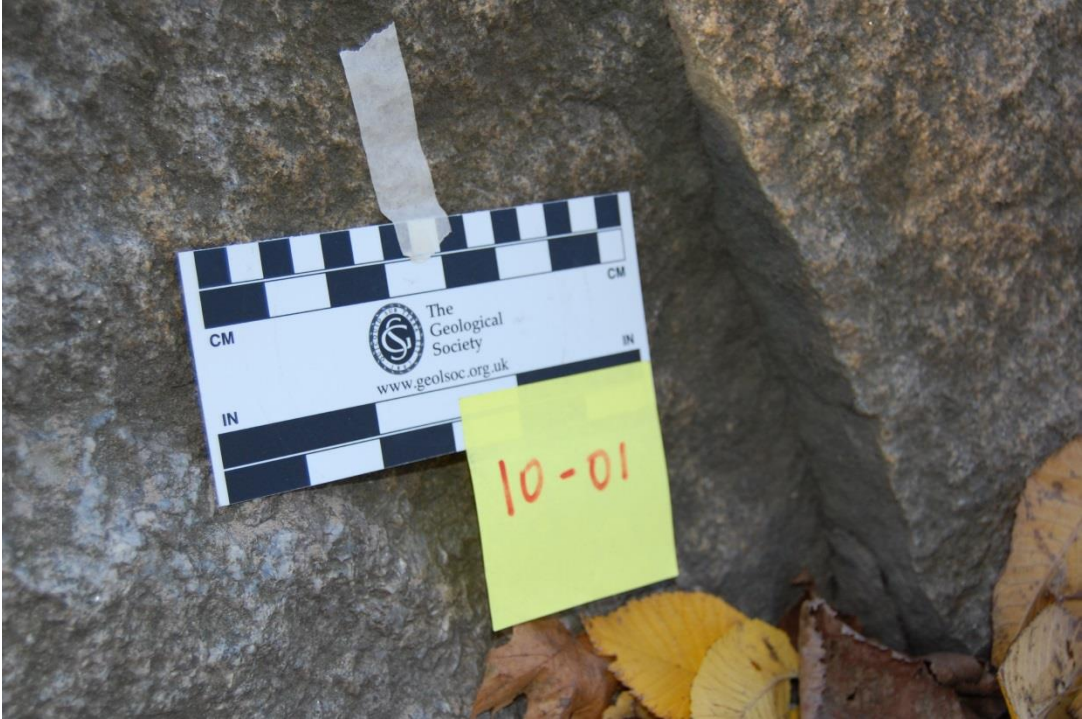
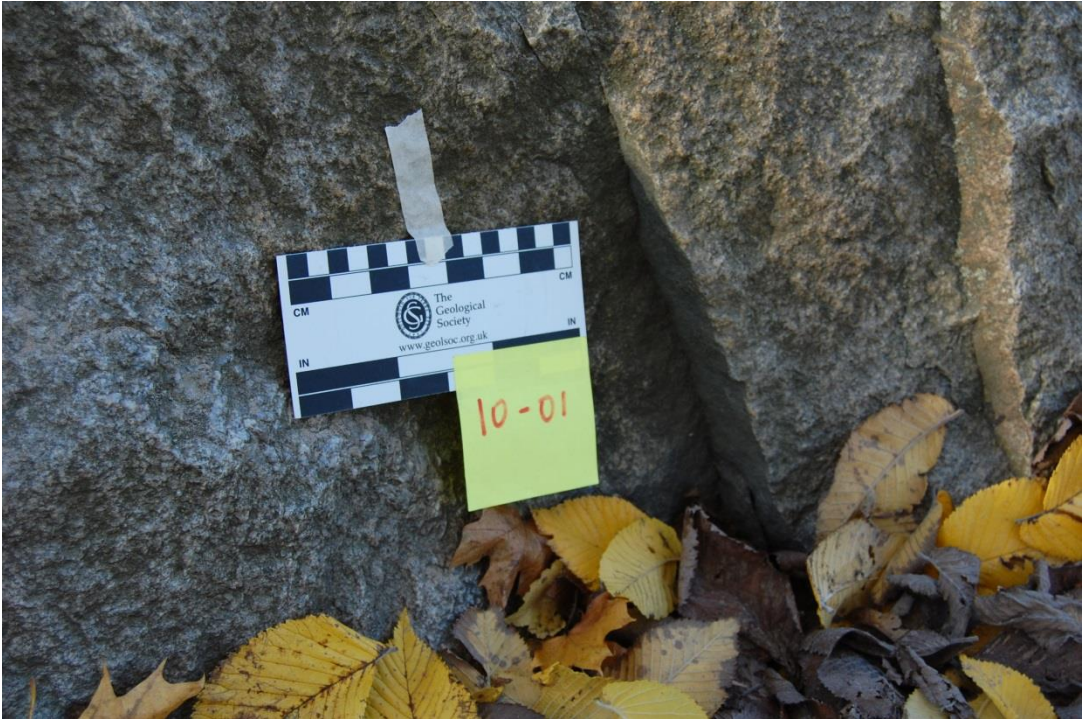
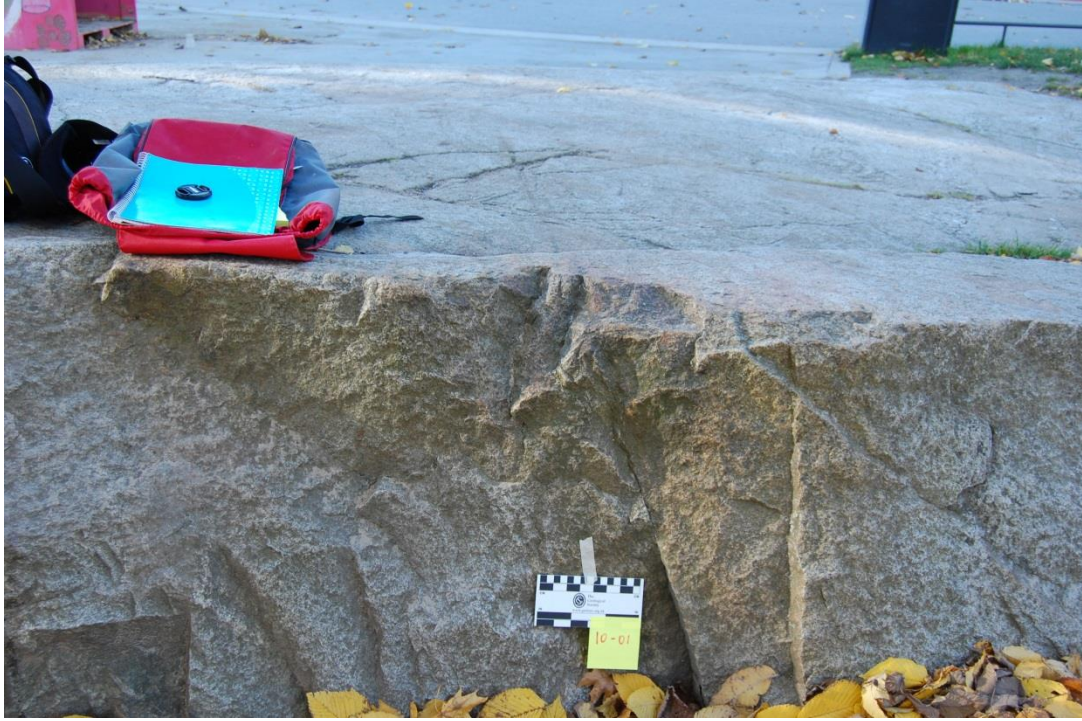
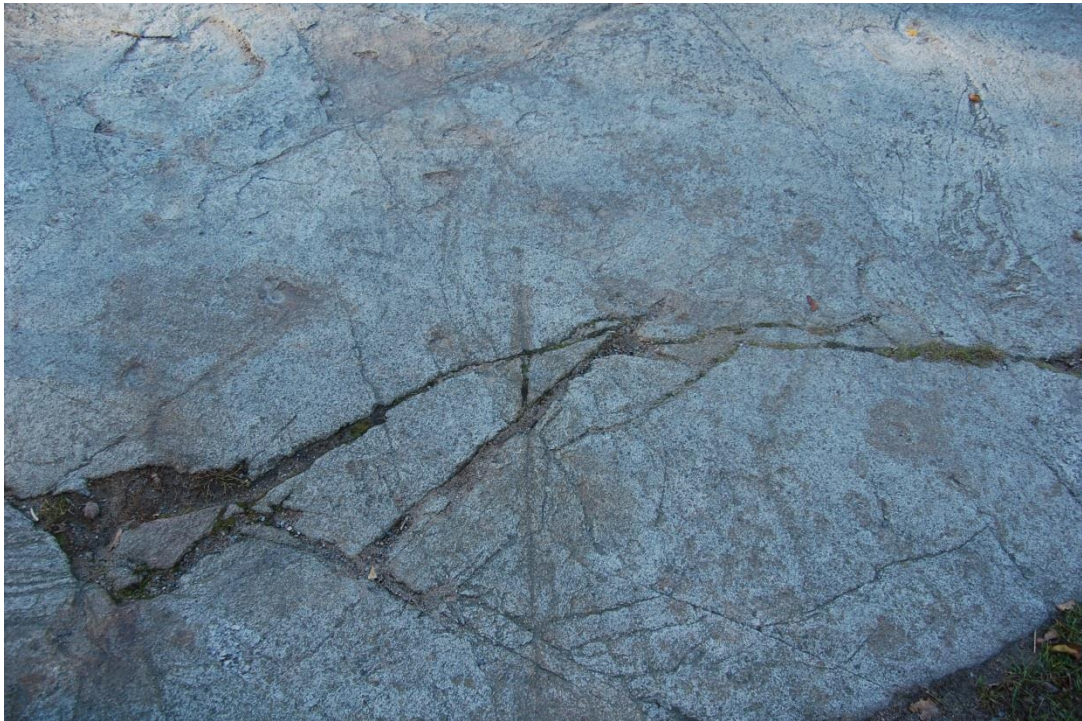
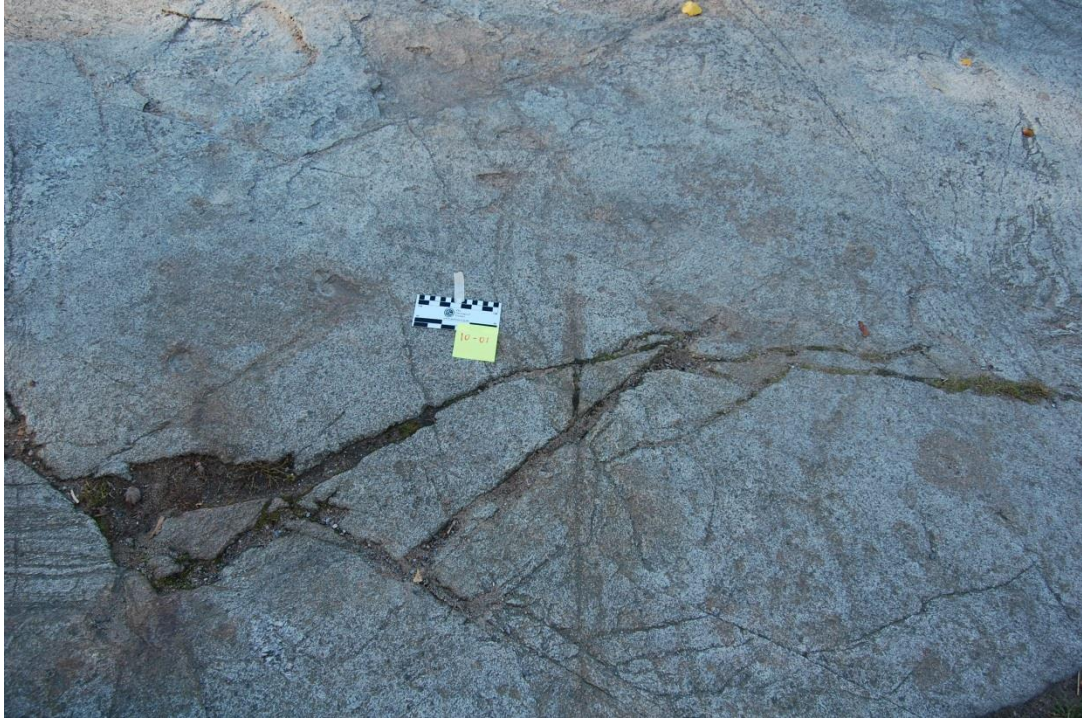
10001

Fracture data	Comments
Rock type:	Vasaparken (mitten)
Fracture ID:	
Location:	
Fracture plane type:	
Fracture strike:	
Fracture dip:	
Rake of slip line:

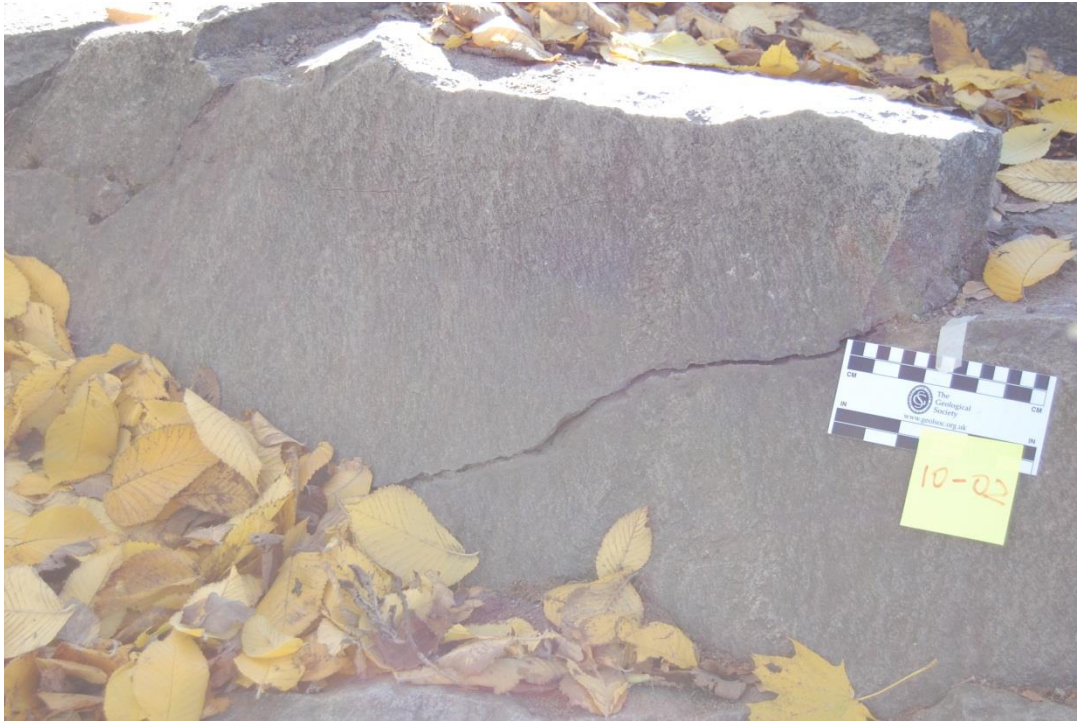
10002

Fracture data	Comments
Rock type:	Vasaparken (mitten)
Fracture ID:	
Location:	
Fracture plane type:	
Fracture strike:	
Fracture dip:	
Rake of slip line:

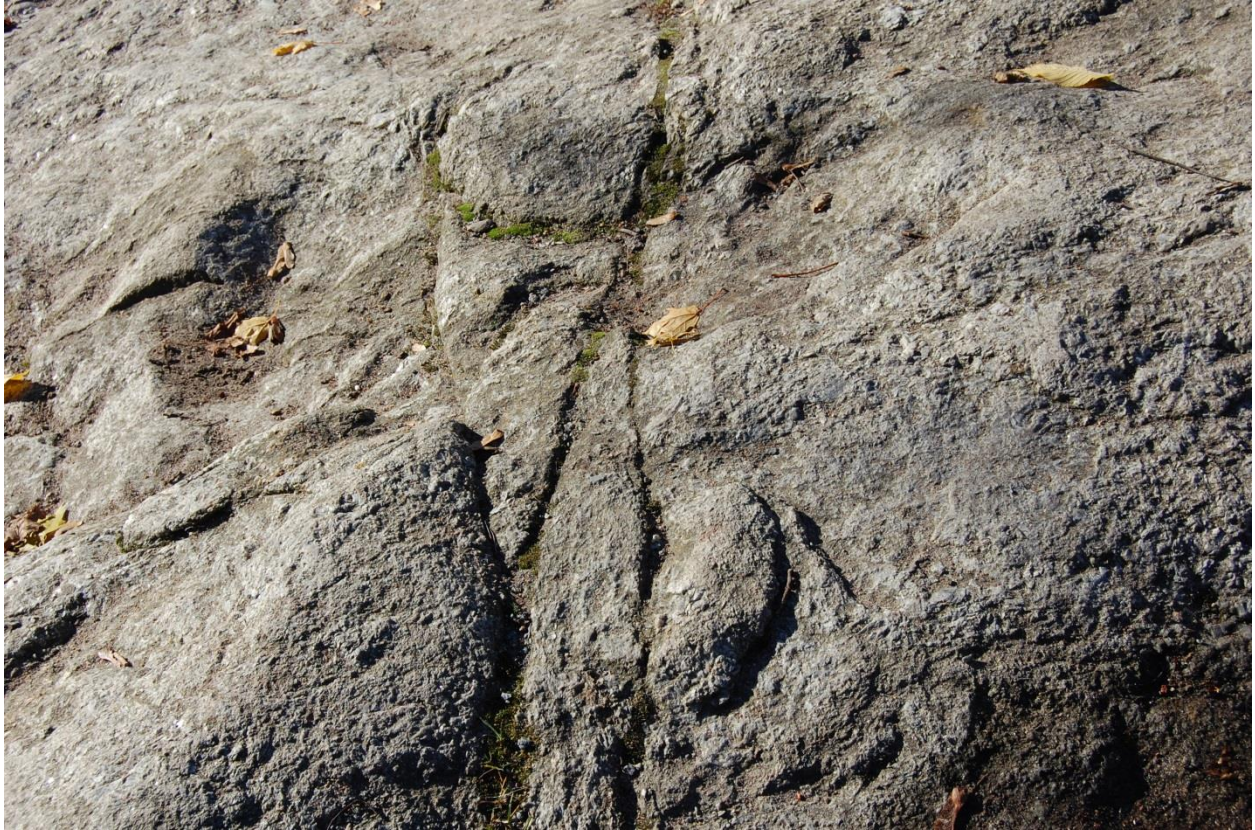
Fracture data		Comments
Rock type:	Gneiss	Ev. Foliationsriktn. flera små ytor <div style="border: 1px solid red; padding: 5px; display: inline-block;">Skärning Torsgatan</div>
Fracture ID:	10003	
Location:		
Fracture plane type:		
Fracture strike:	180	
Fracture dip:	70	
Rake of slip line:	+120

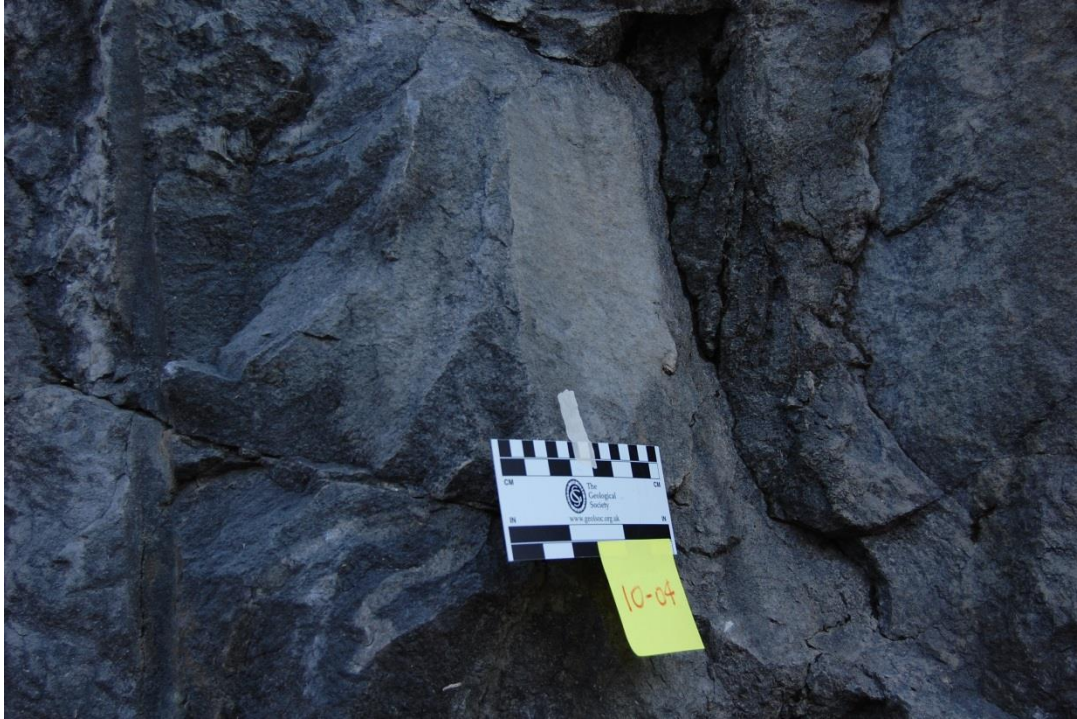
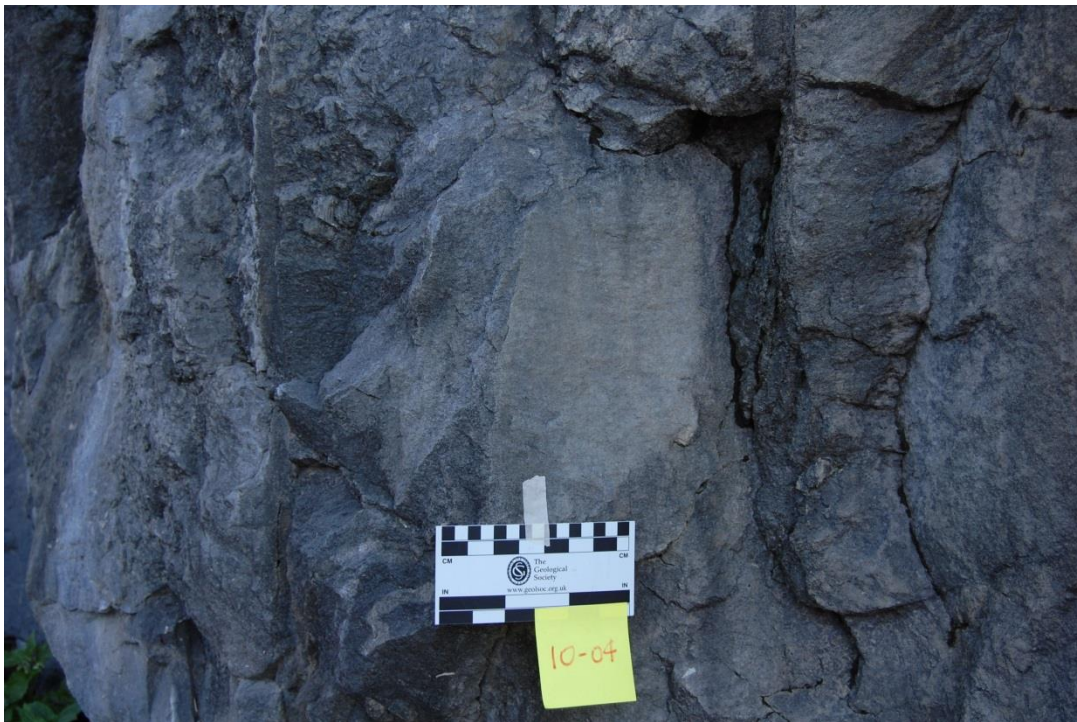
10004

Fracture data	Comments		
Rock type:	Gneiss m	Dextral	
Fracture ID:	004		
Location:			
Fracture plane type:			
Fracture strike:	92		
Fracture dip:	80		
Rake of slip line:	+170

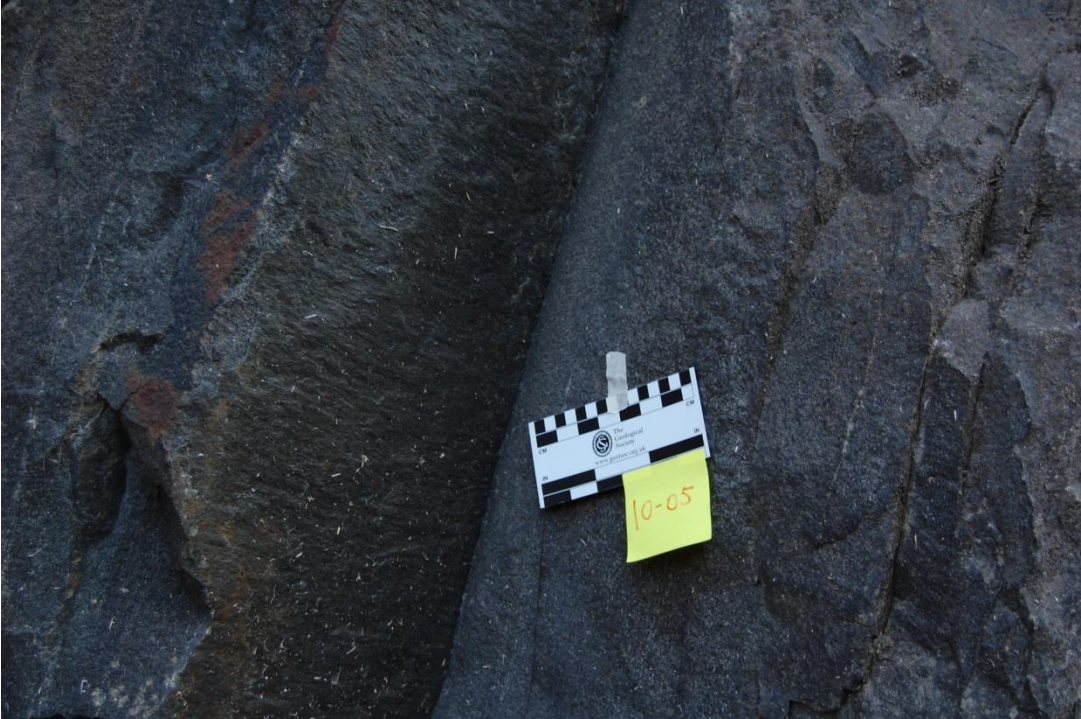
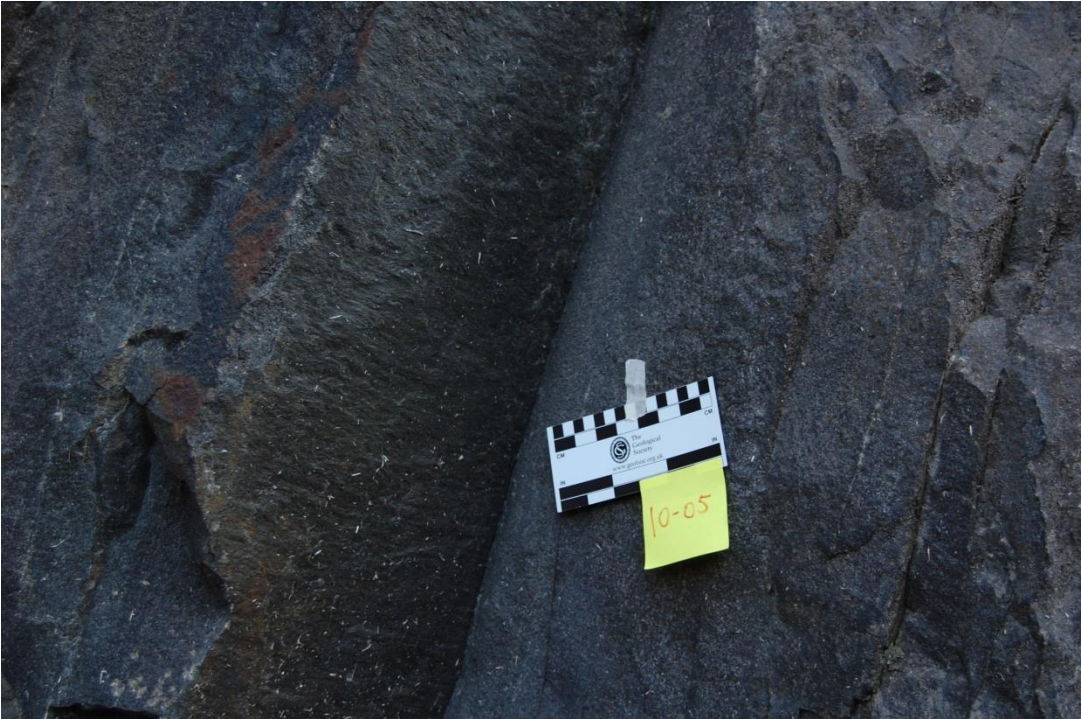
10005

Fracture data	Comments		
Rock type:	Gnejs		
Fracture ID:	005		
Location:			
Fracture plane type:			
Fracture strike:	310		
Fracture dip:	70		
Rake of slip line:	+15

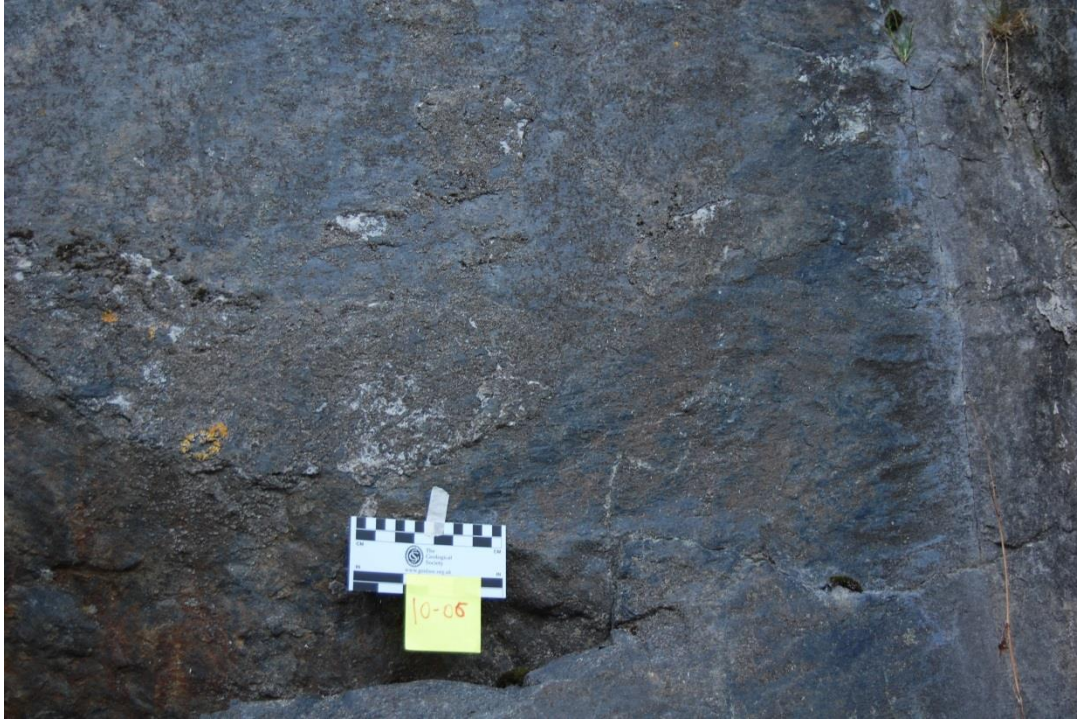
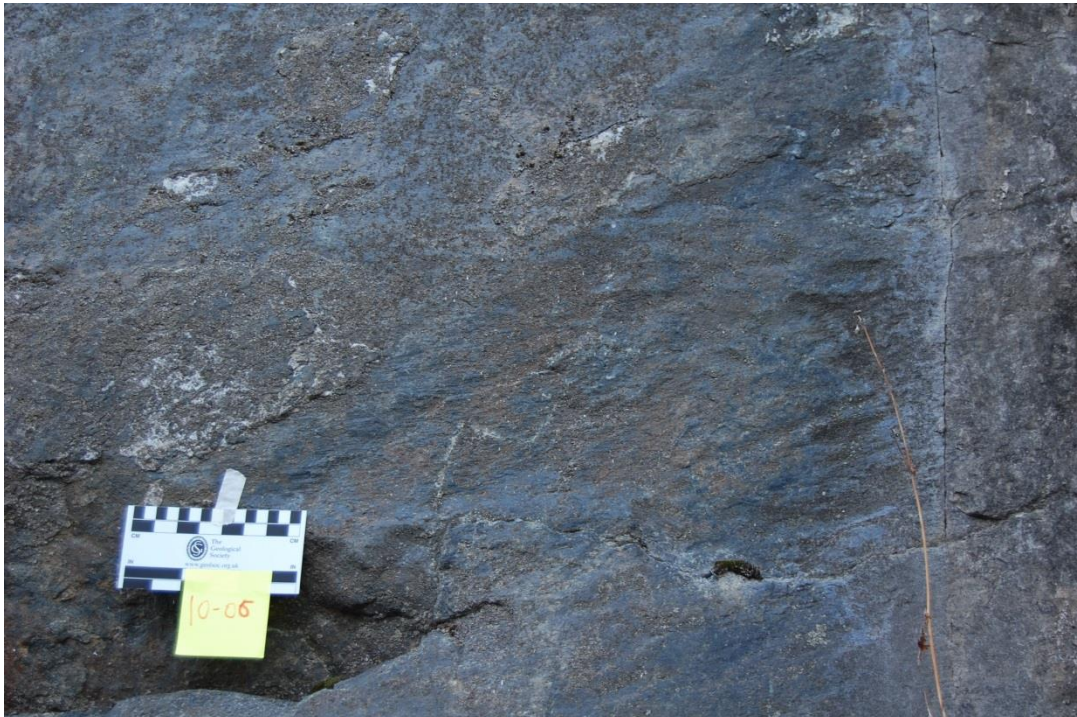
10006

Fracture data		Comments
Rock type:	Gnejs	Kvarts fläckvis striering på sprickytan
Fracture ID:	006	
Location:		
Fracture plane type:		
Fracture strike:	120	
Fracture dip:	80	
Rake of slip line:	-165

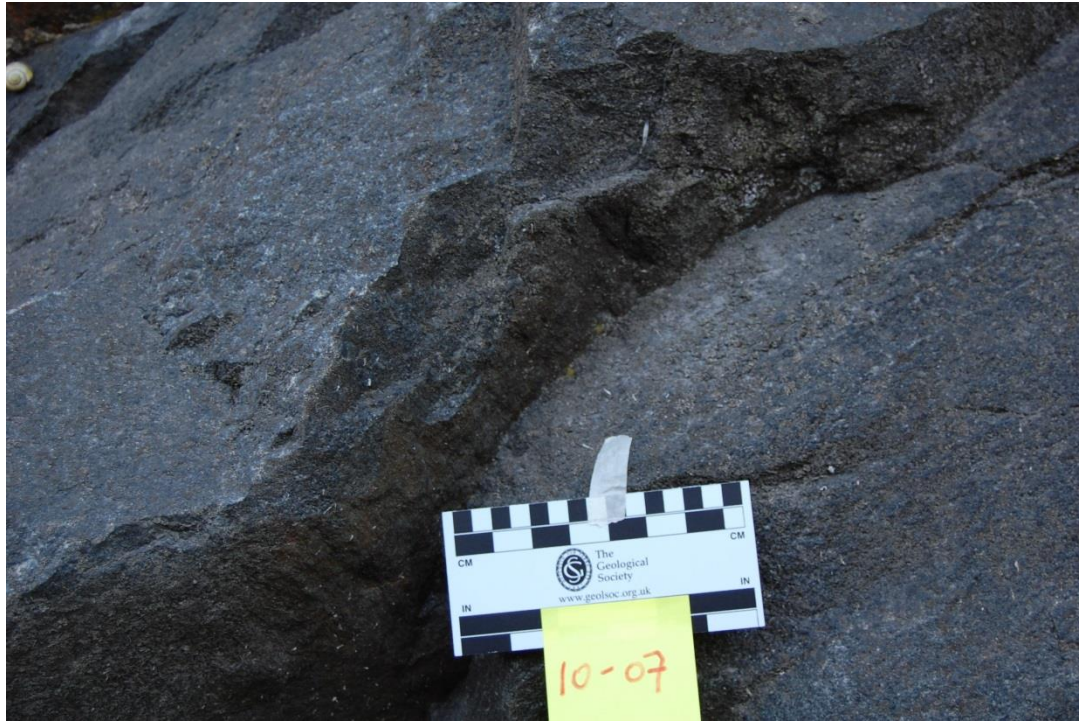
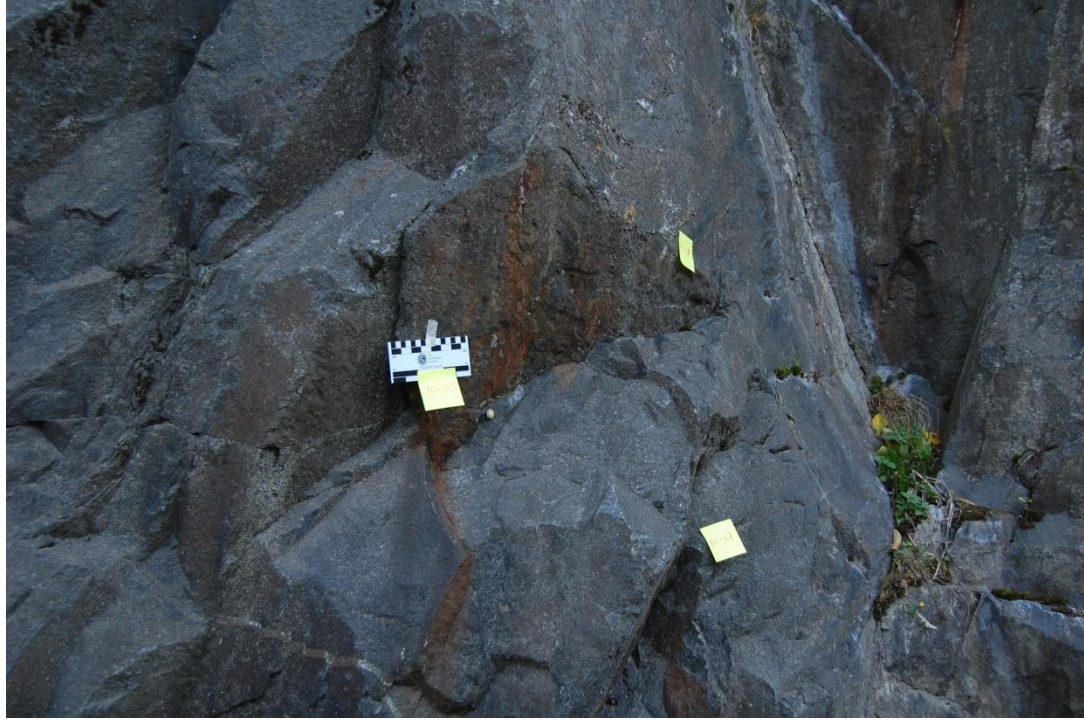
10007

Fracture data	Comments
Rock type:	Gnejs
Fracture ID:	007
Location:	
Fracture plane type:	1
Fracture strike:	272
Fracture dip:	72
Rake of slip line:	+45

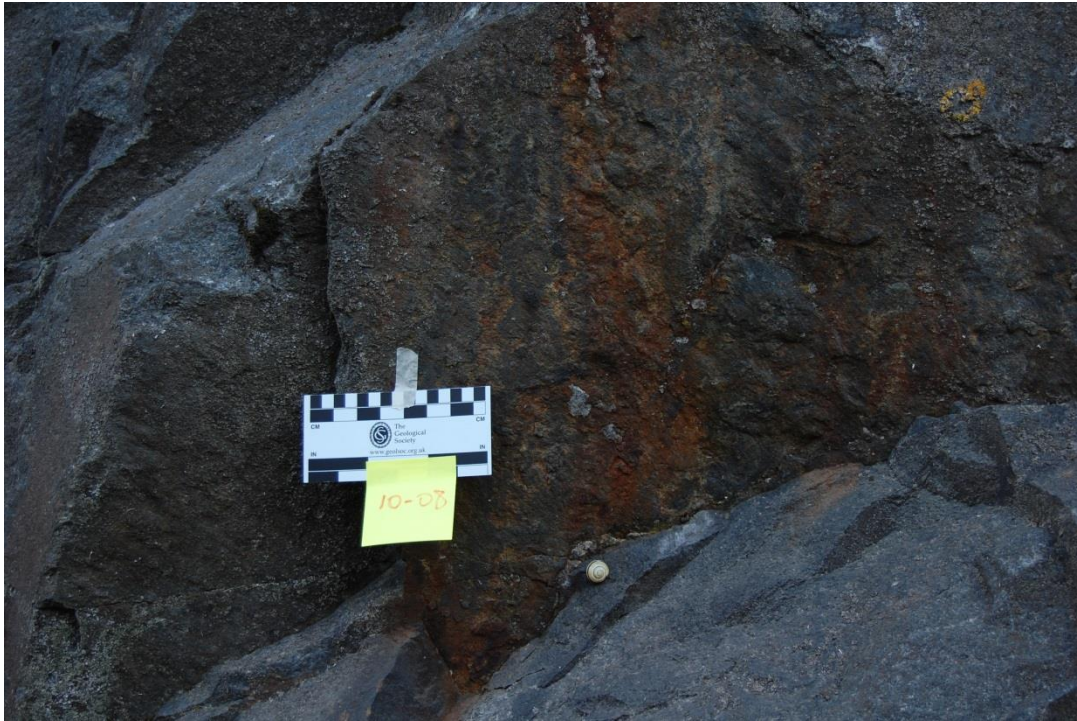
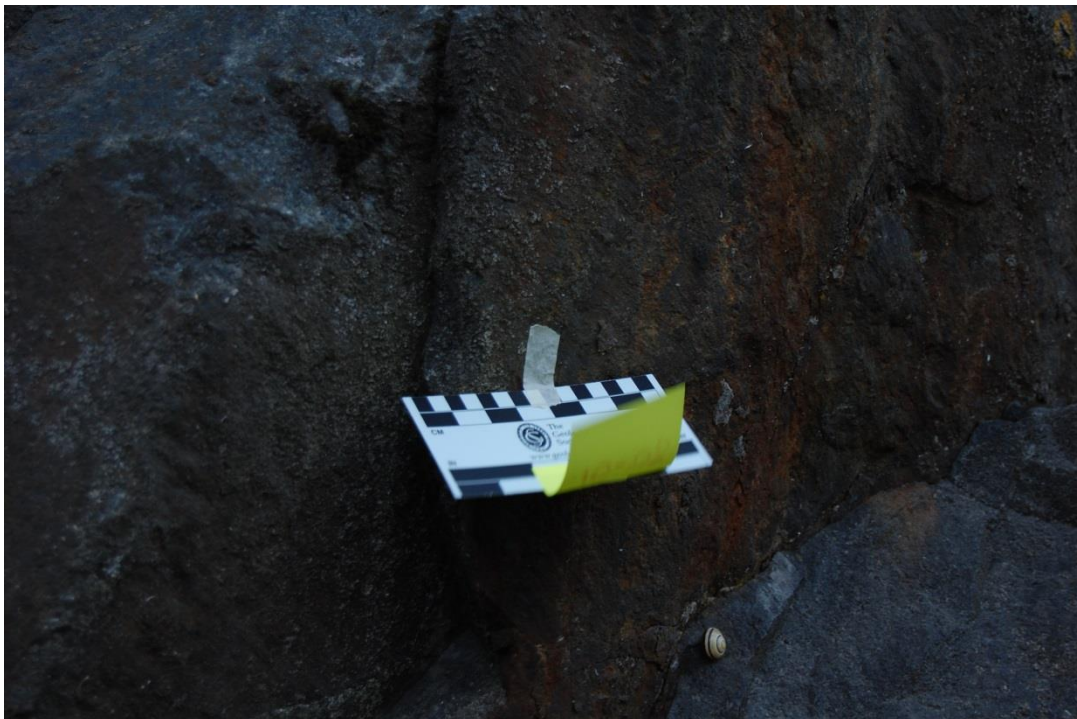
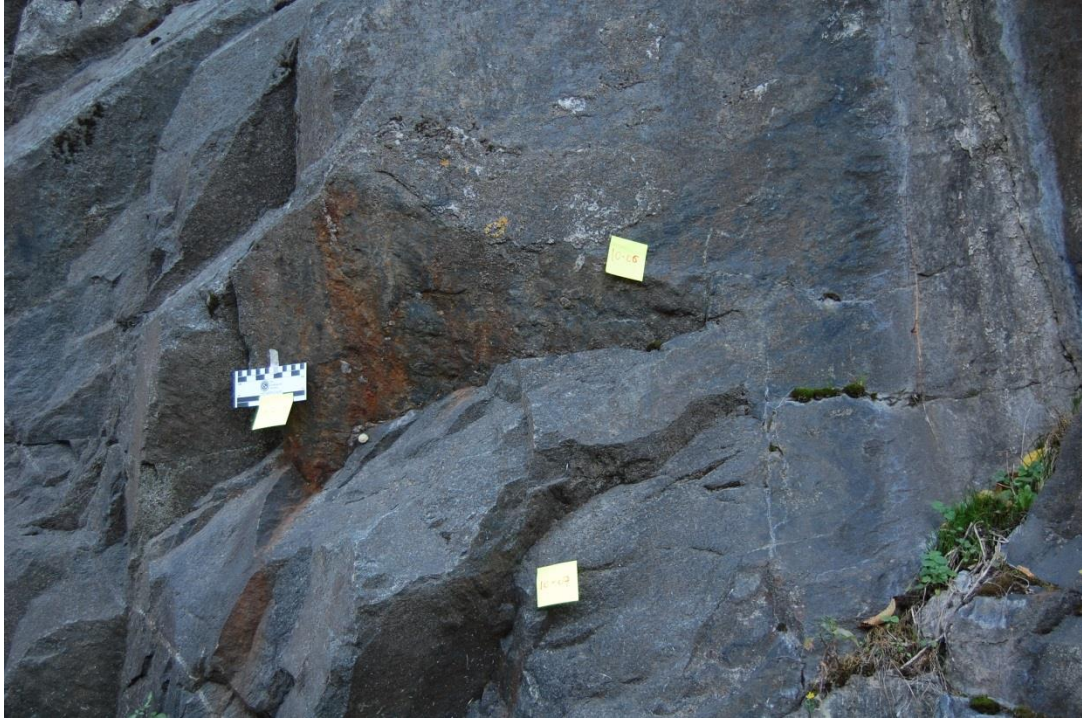
10008

Fracture data		Comments
Rock type:	Gneiss	Rostig yta
Fracture ID:	008	
Location:		
Fracture plane type:		
Fracture strike:	325	
Fracture dip:	70	
Rake of slip line:	+45

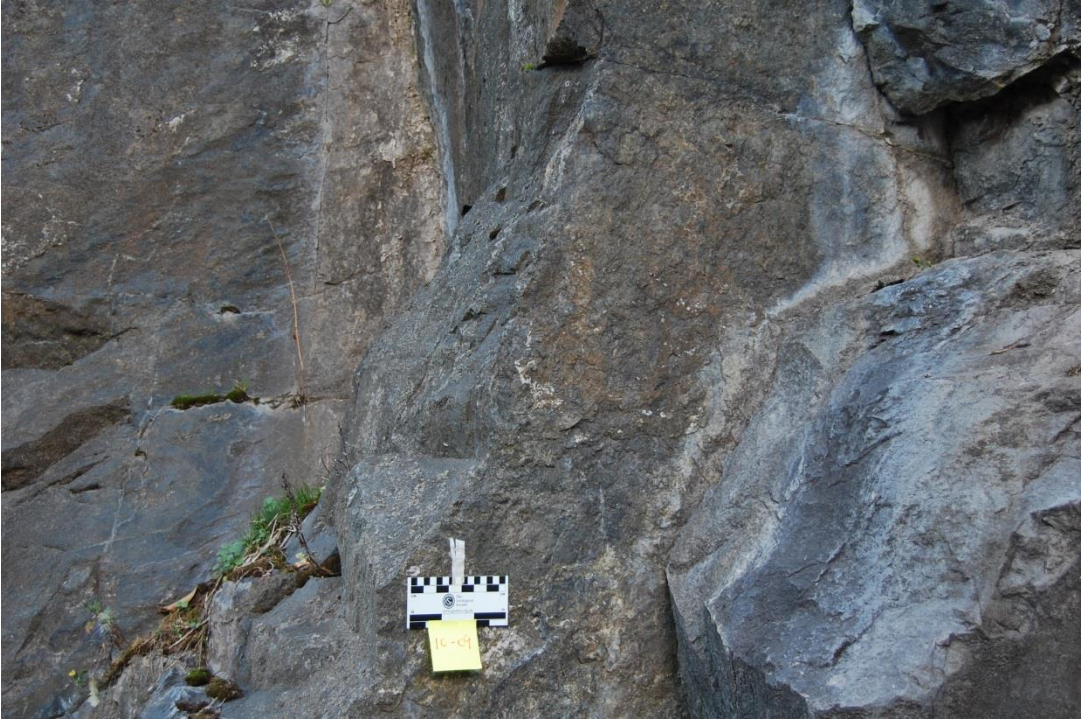
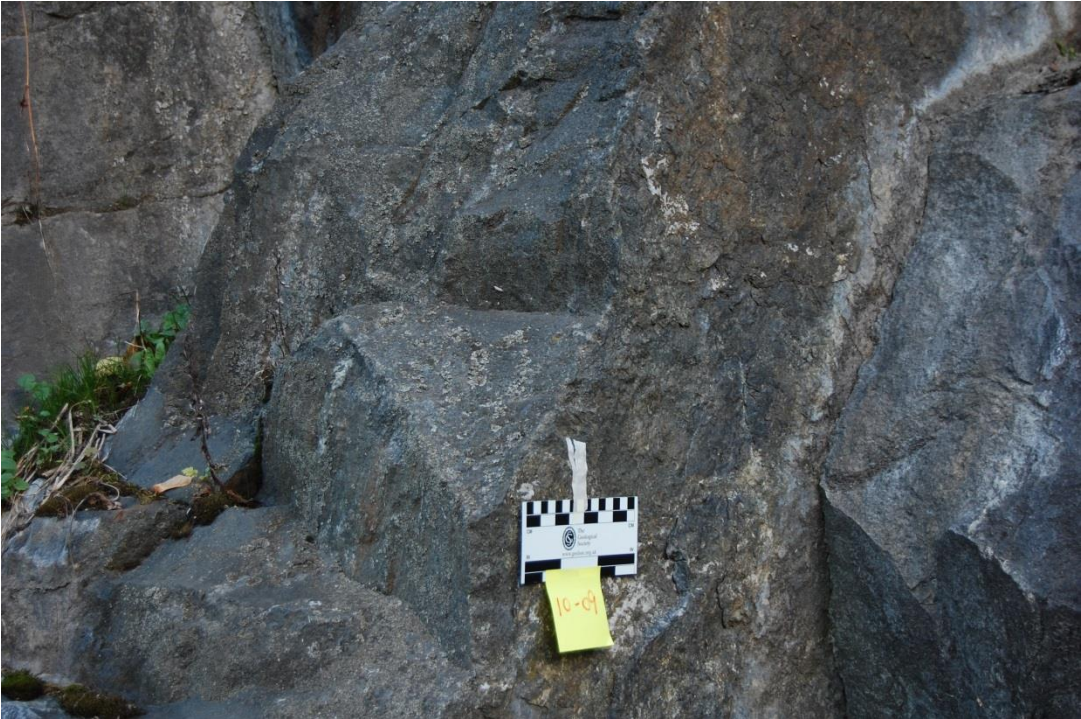
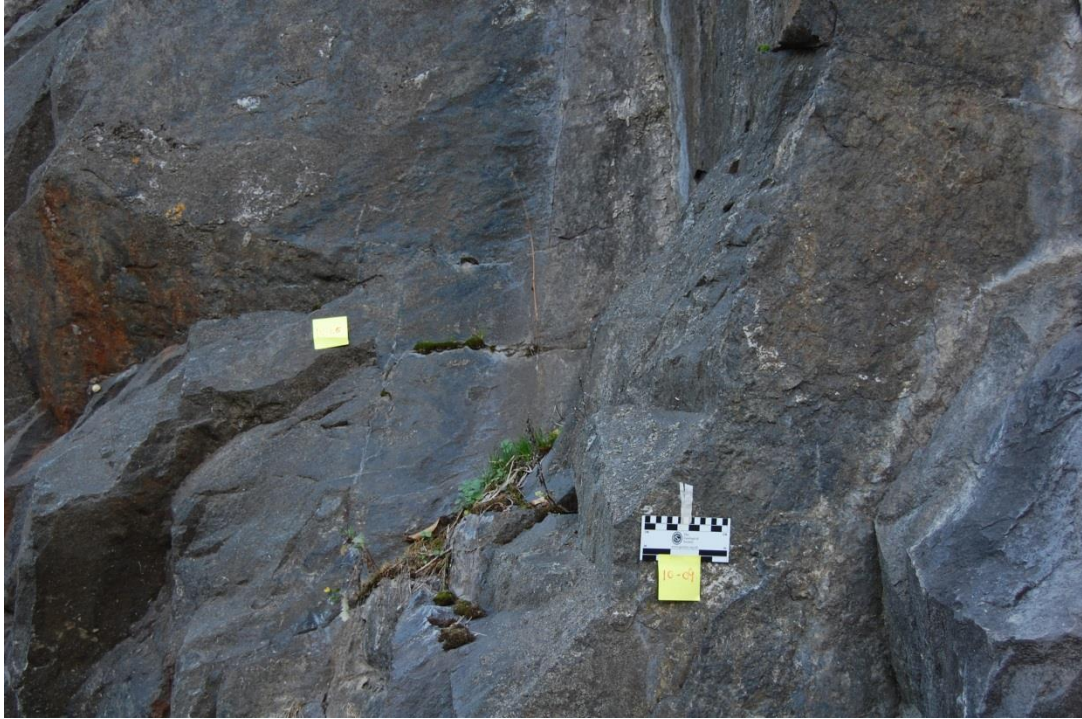
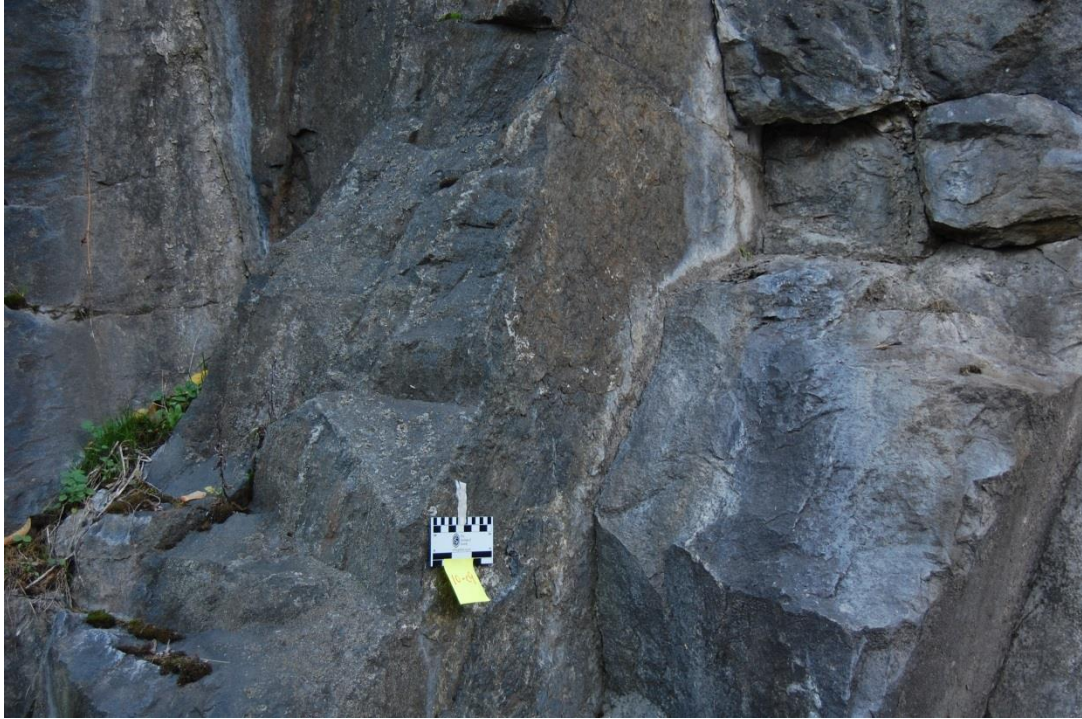
10009

Fracture data		Comments
Rock type:	Gnejs	Ej fol. riktn. tydligt syns i foto
Fracture ID:	009	
Location:		
Fracture plane type:		
Fracture strike:	110	
Fracture dip:	90	
Rake of slip line:	-130
