Karteringsblad för sprickor med rörelseindikationer

Project:	BeFo 369		
Site ID:	Hasselby (01)	Site name:	Hasselby
Geologist (s):	Ann & Yanling	Field date:	2015 08

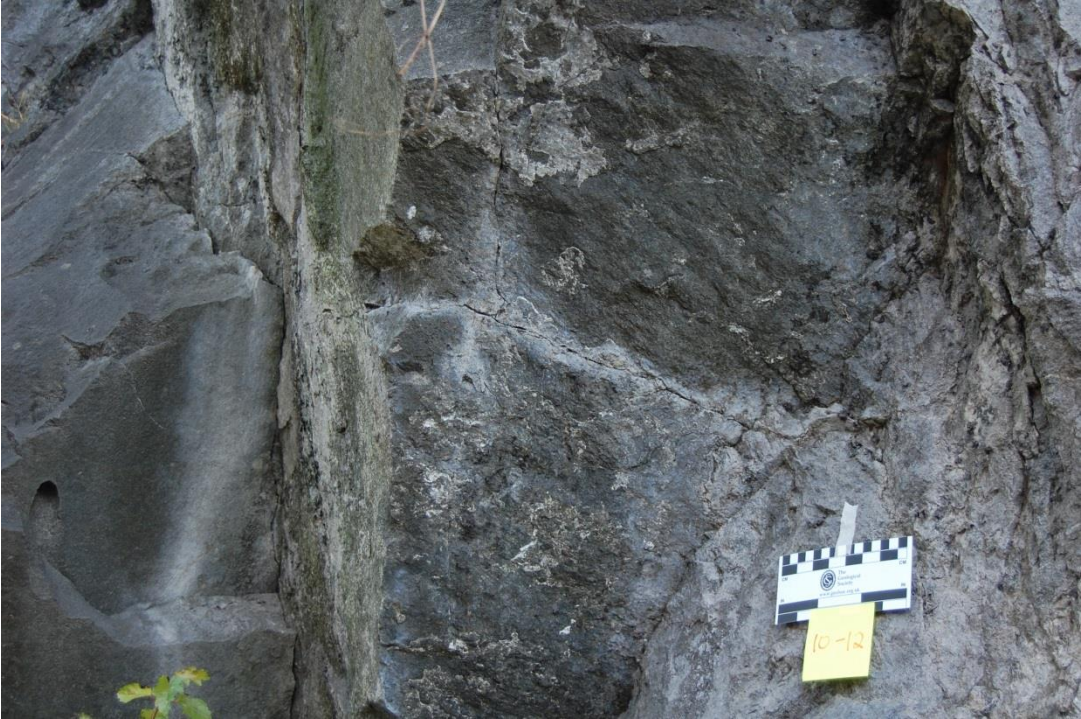
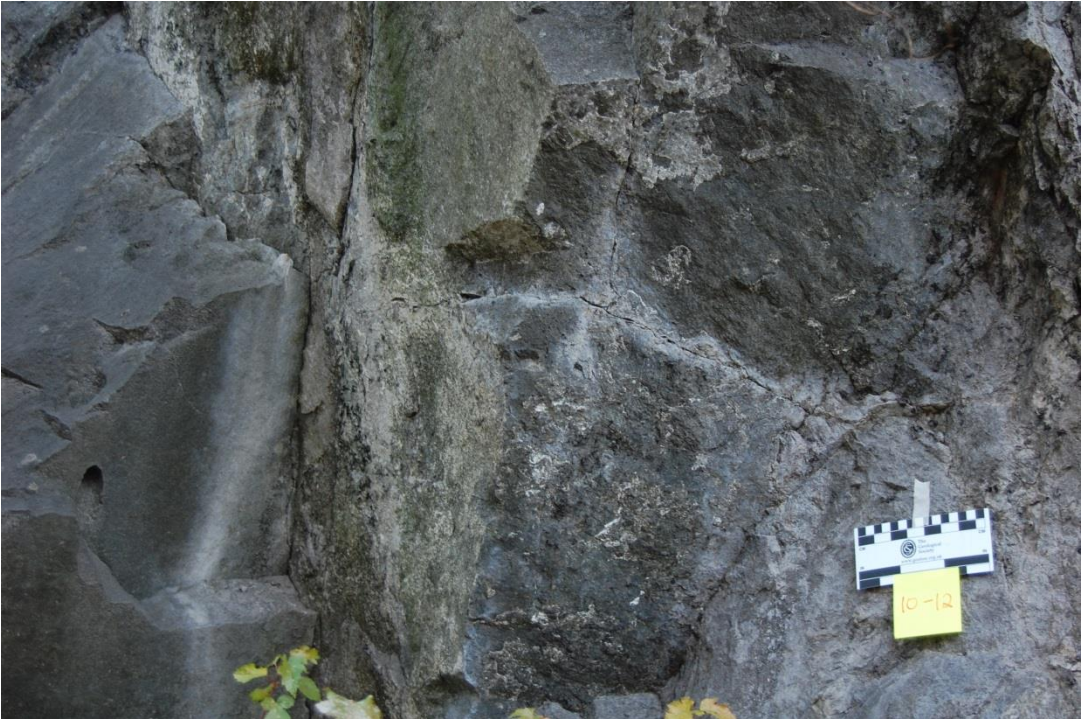
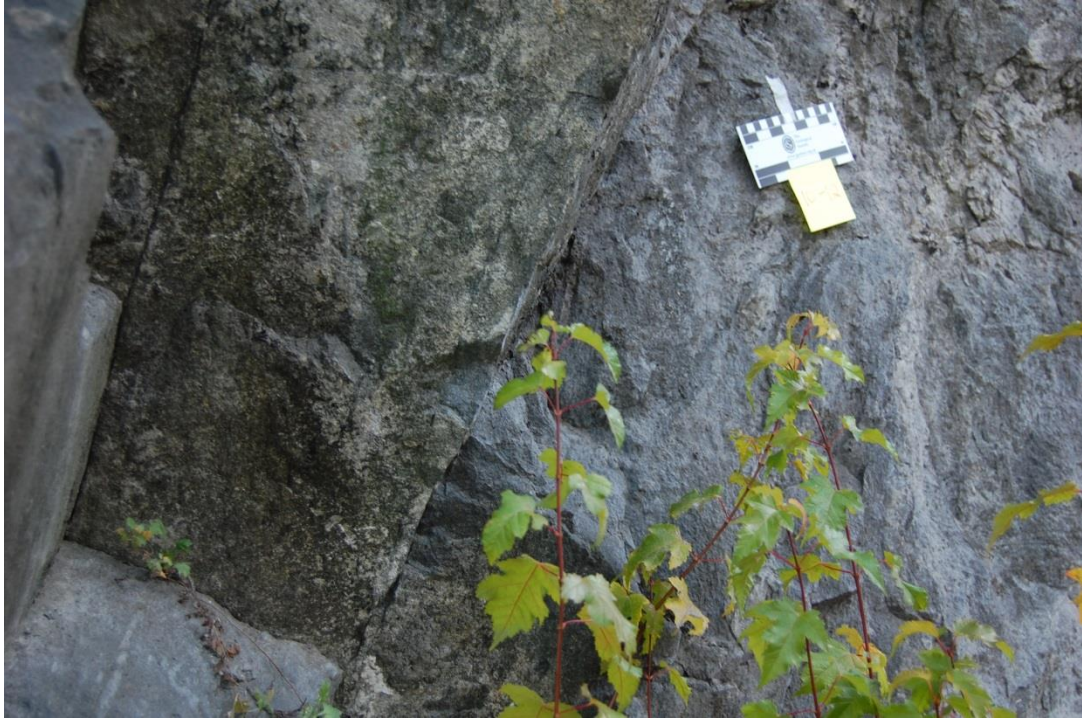
10012

Fracture data		Comments
Rock type:	Gnejs	fläckvis kalcit min
Fracture ID:	012	
Location:		
Fracture plane type:		
Fracture strike:	295	
Fracture dip:	60	
Rake of slip line:	+45

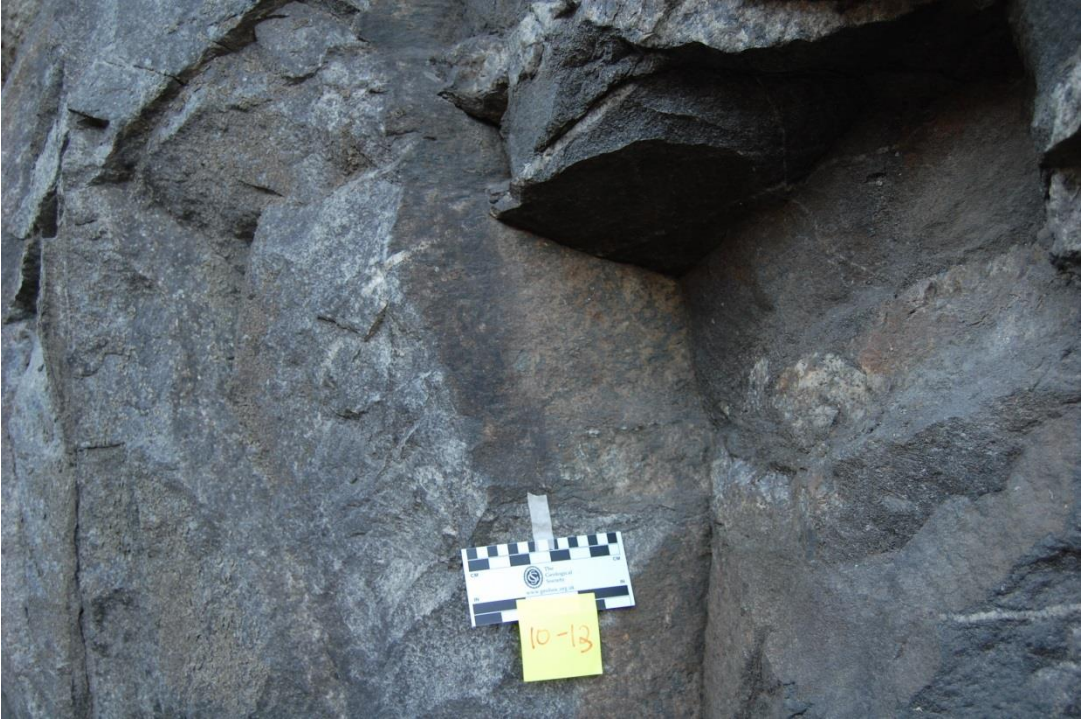
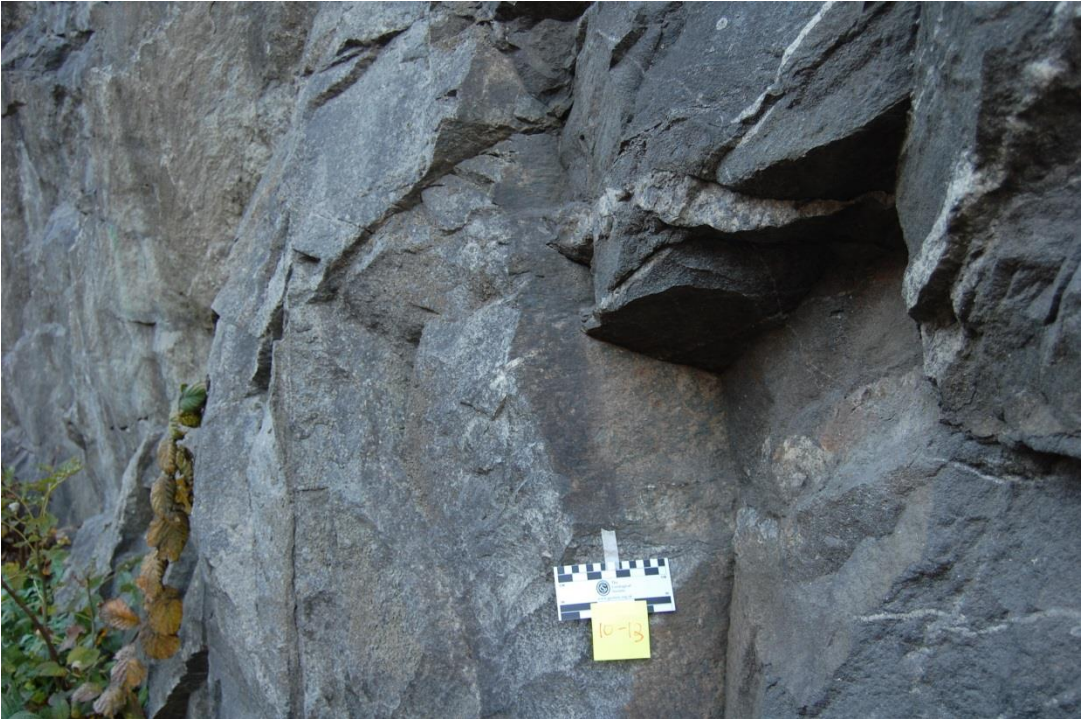
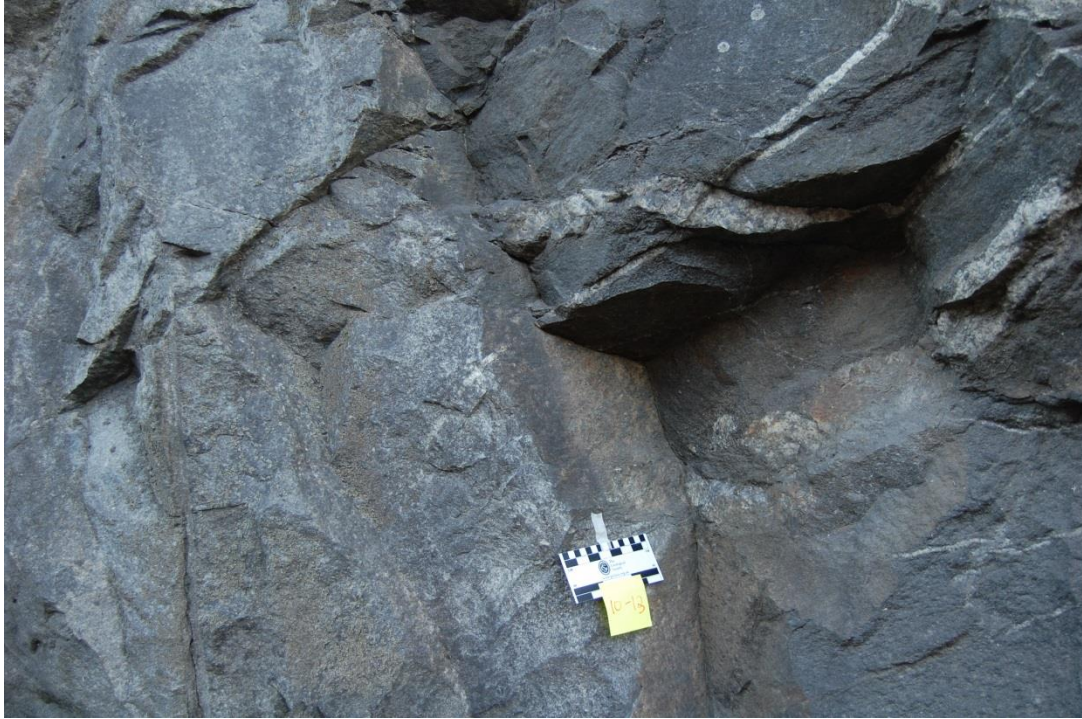
10013

Rock type:	Granitisk del av gnejsen		
Fracture ID:	013		
Location:			
Fracture plane type:			
Fracture strike:	85		
Fracture dip:	70		
Rake of slip line:	+165

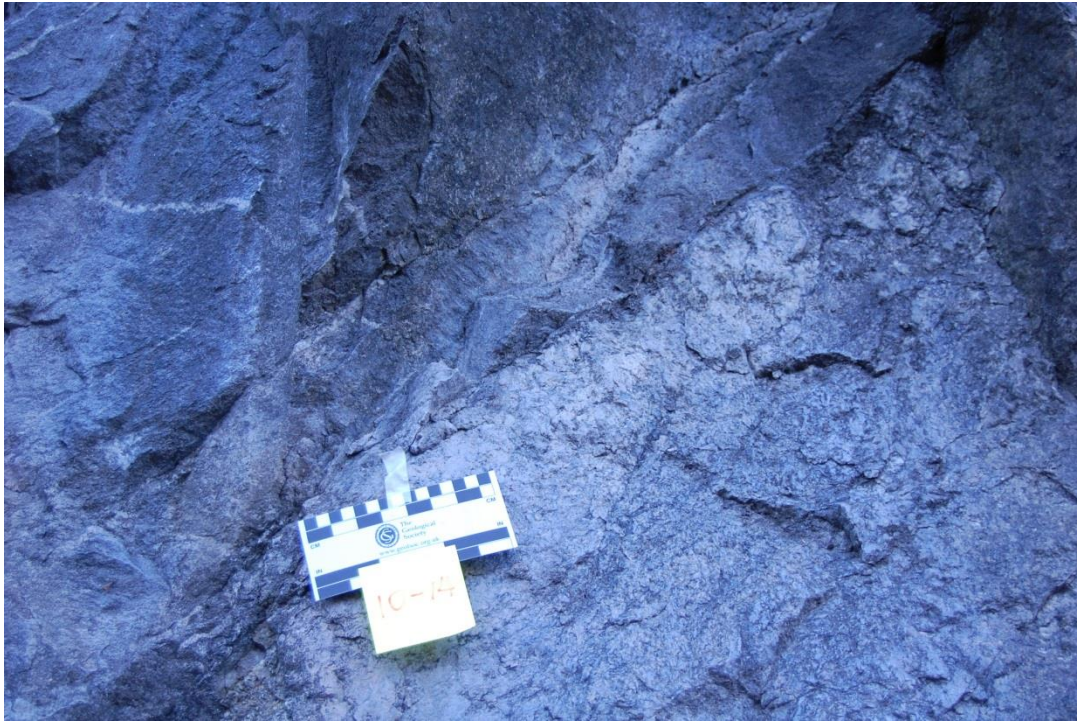
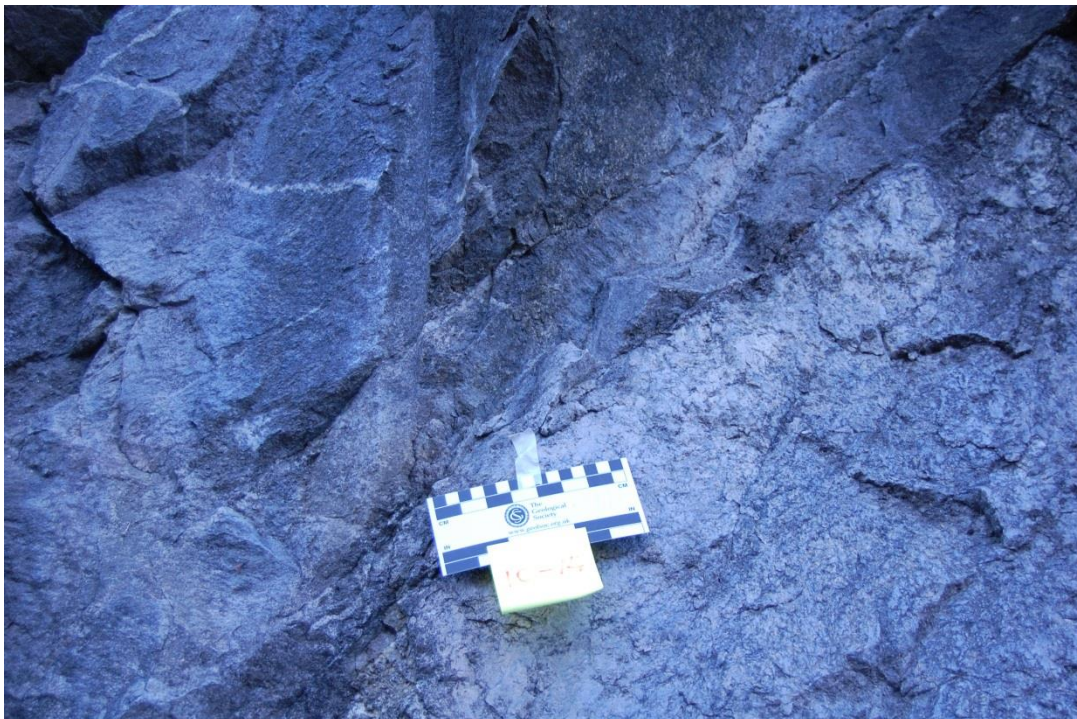
10014

Fracture data		Comments
Rock type:	Gneiss	
Fracture ID:	014	
Location:		
Fracture plane type:	1	
Fracture strike:	295	
Fracture dip:	70	
Rake of slip line:	+20 el -160
